Re: Letter of Report for San Luis Talpa, project site in El Salvador.

The purpose of this letter is to summarize our site visit to your San Luis Talpa project site and provide you with our findings and recommendations.

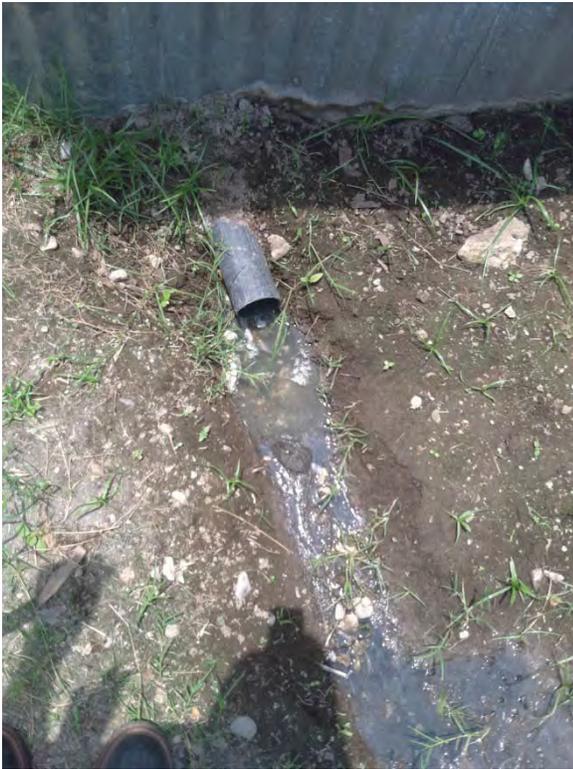
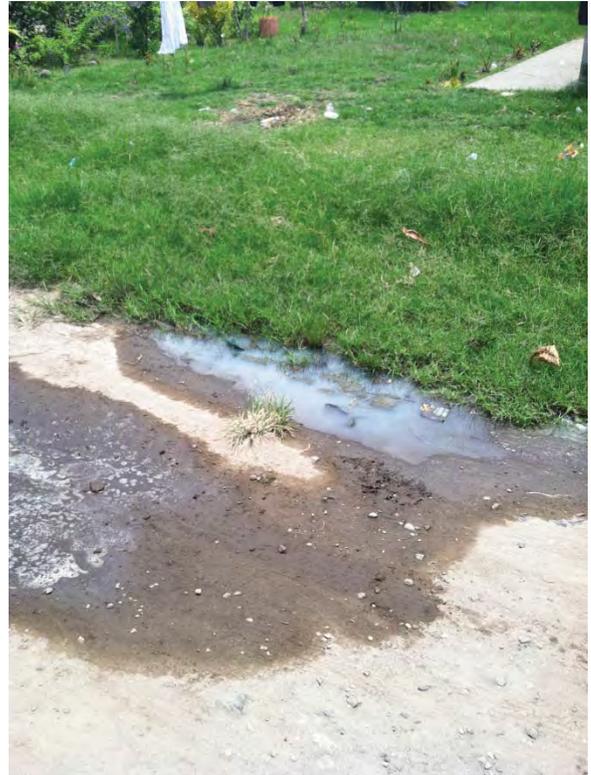
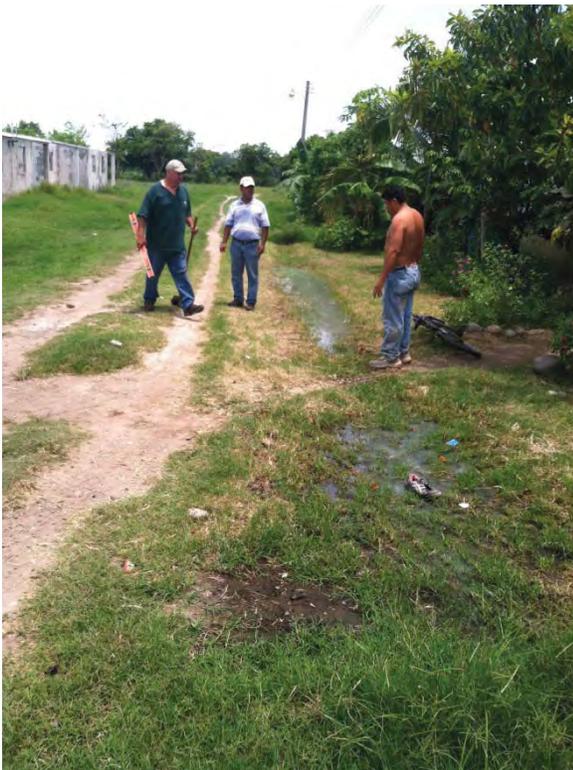
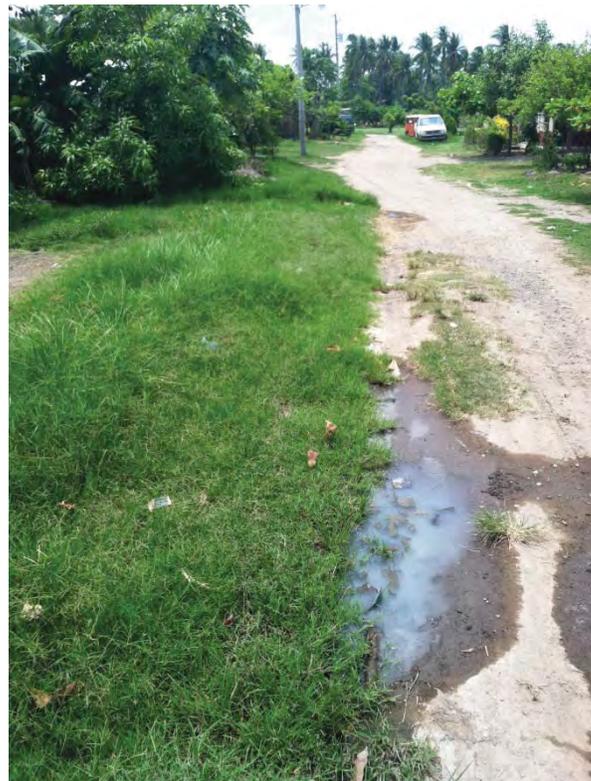
Water Ponding around Buildings

There was ponding water between buildings 2 & 3 and 3 & 4 and along the dirt drive in front of buildings 3 & 4 (see appendix A) Project Site Sketch. Upon further inspection it was determined that some of the sink drains from building 3 had been disconnected from the septic system and were draining directly onto the ground (see appendix B for pictures). Both the shower and toilet still drain to the septic system which appears to be functioning properly. We recommend reconnecting the sink drains to the septic tanks.

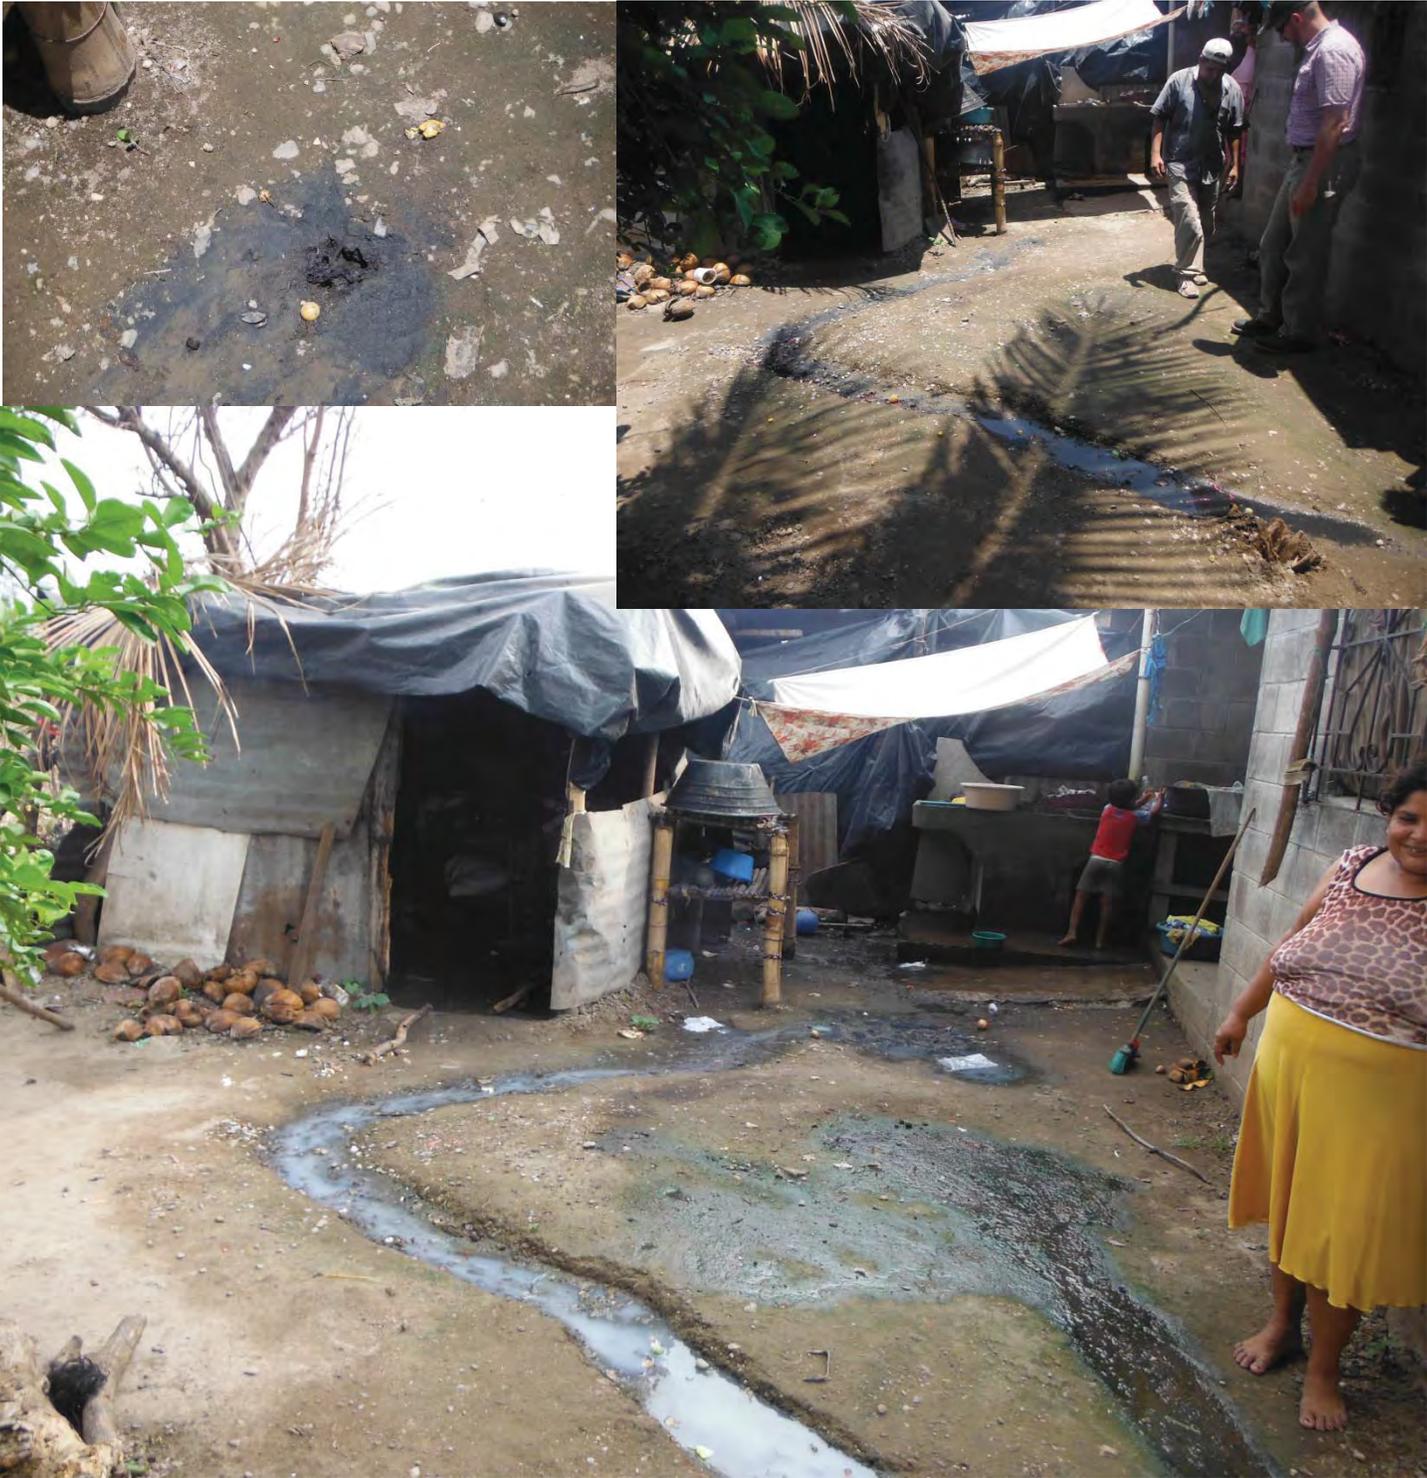
Surfacing Septic Tank Effluent

There was evidence of surfacing septic tank effluent behind and alongside building #14. Draining the sink shower or toilet resulted in effluent bubbling up through the ground in several places behind building #14(see appendix C for pictures). We recommend repairing/replacing this septic system, see section 3 "recommendations" below.

- Move the tenants from unit #14 to another available units and allow the sewer system to sit for a month and dry out prior to excavating and fixing/re-building said sewer system using a larger leach field as described above and possibly a larger tank.

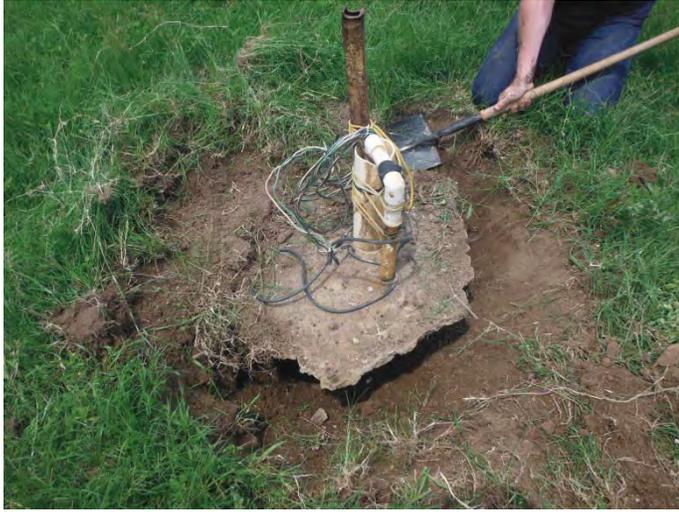
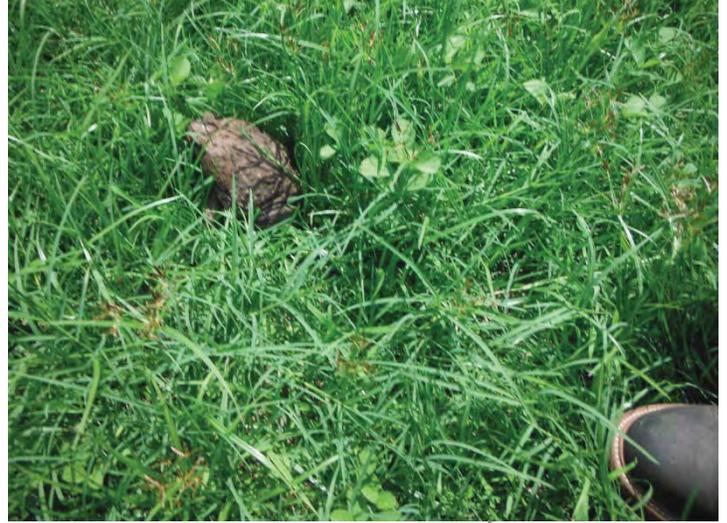
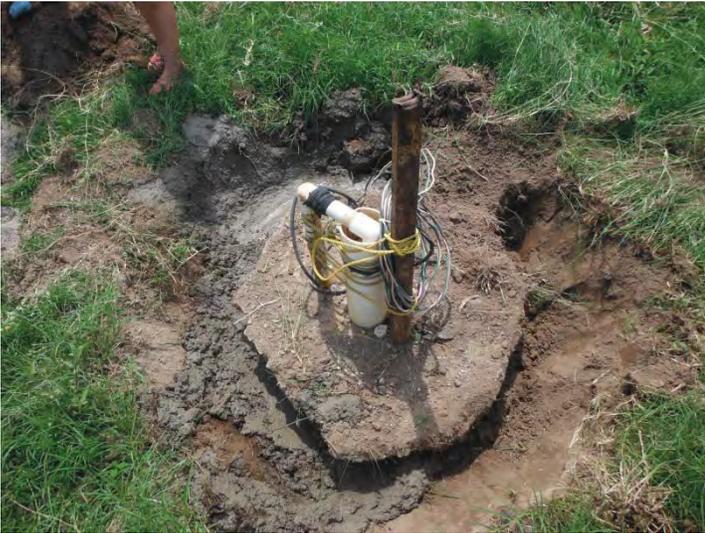
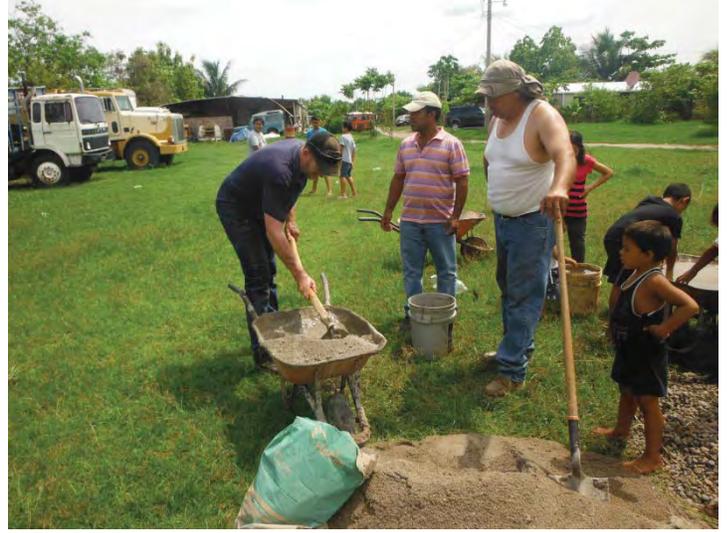
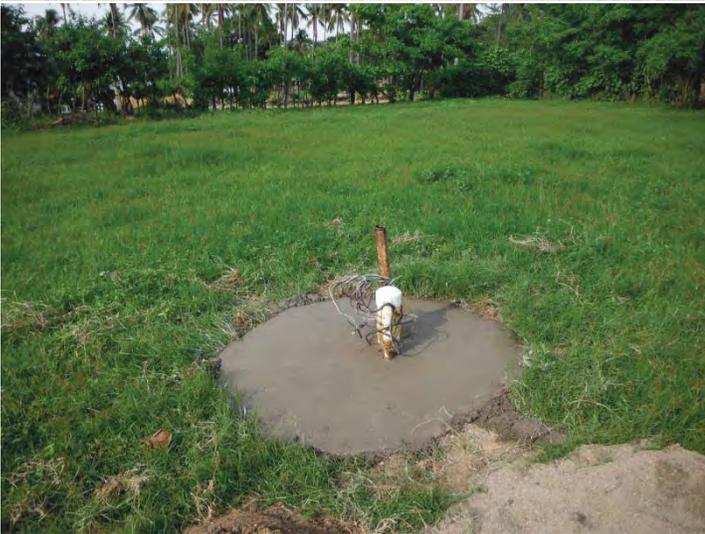
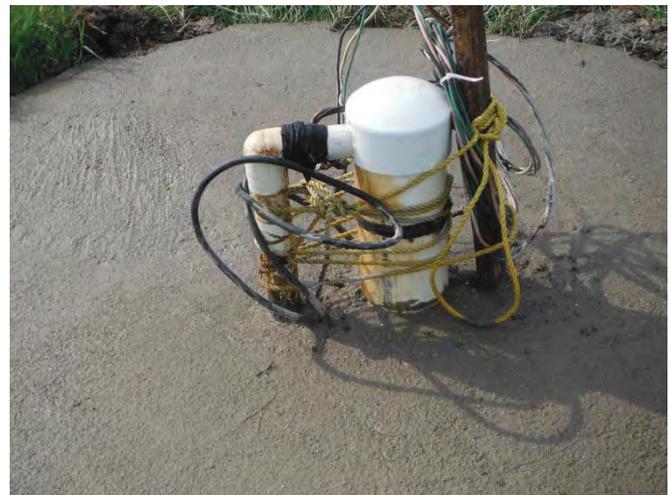
Well Pictures

The well did not have a sanitary seal so we fabricated one by using a 4" PVC cap that we modified to fit the actual well casing, water line and loose electrical wires. We then sealed the cap with silicone caulk. The concrete well collar around the well casing had eroded underneath and there was signs that surface water may have been running under the concrete and presumably into the well. The void under the concrete was approximately 6 to 8" and was the habitat for a large frog (see appendix H) for pictures. We filled under and up and around the existing concrete collar and sloped it away from the well casing to prevent future surface water infiltration.

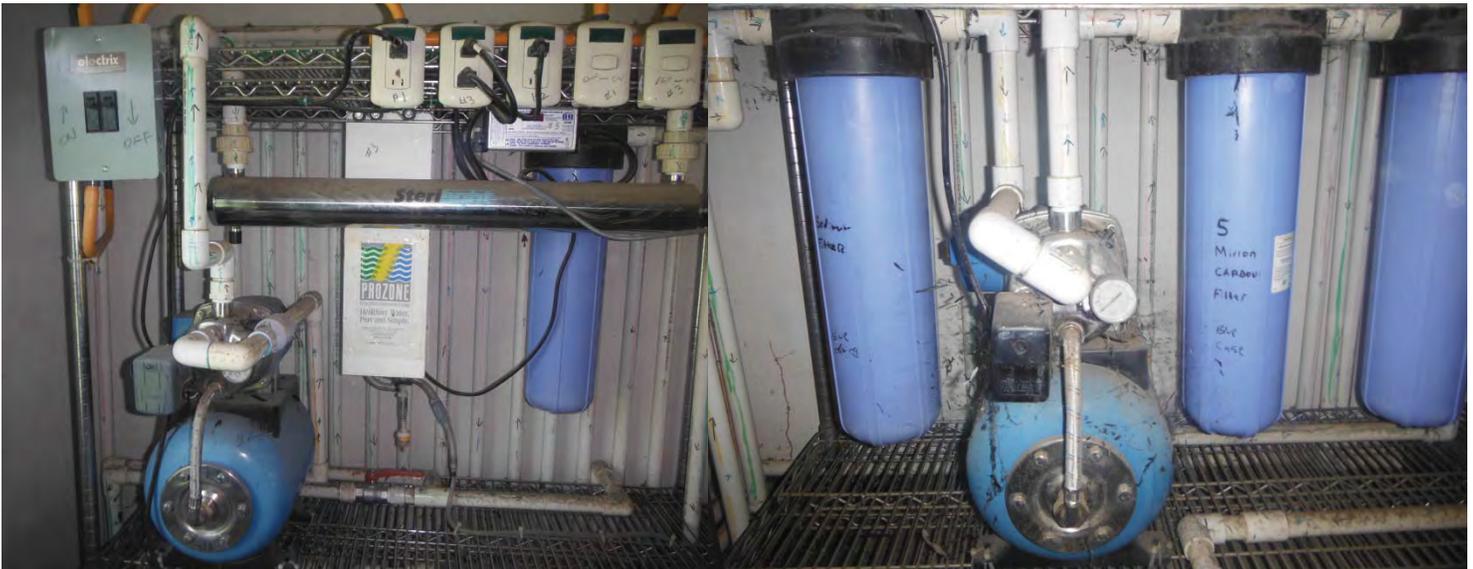
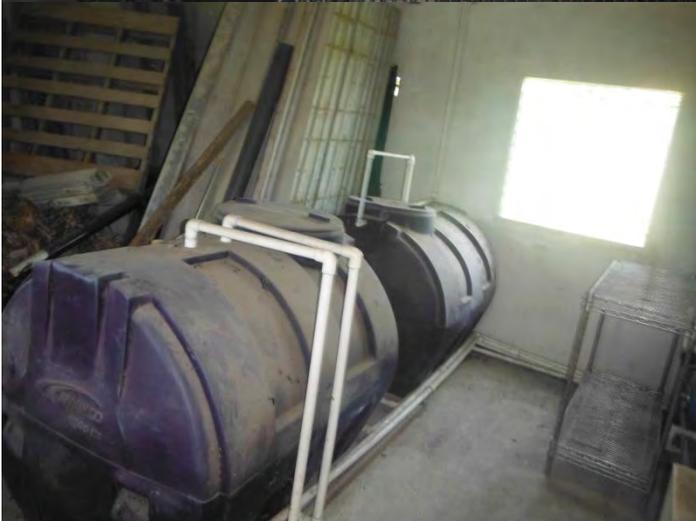
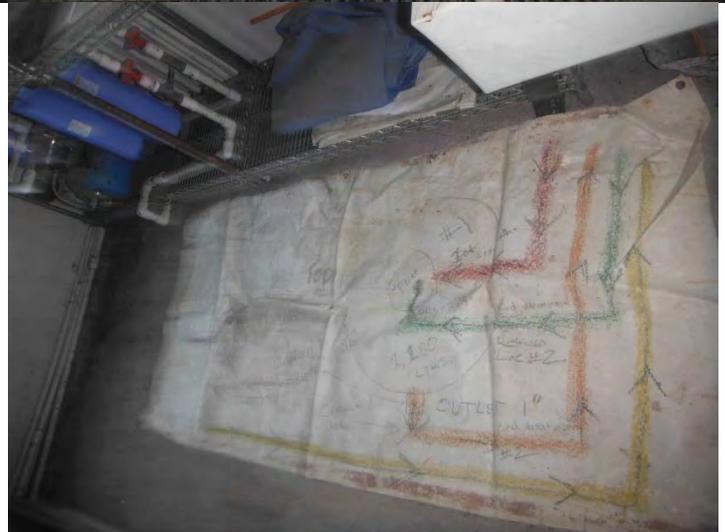
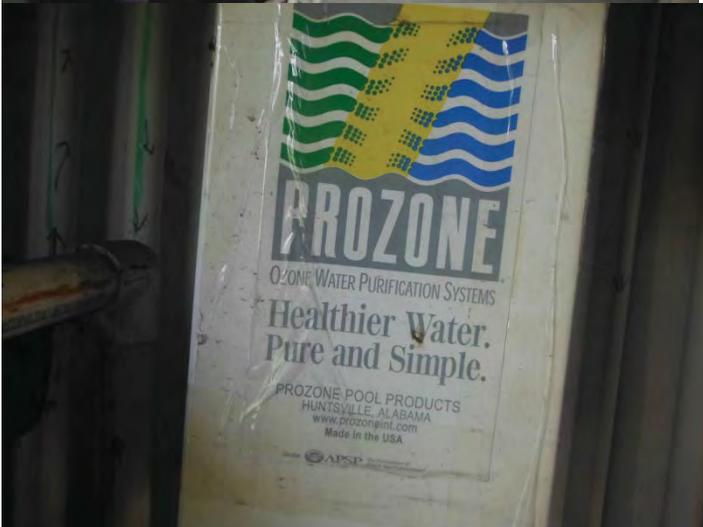
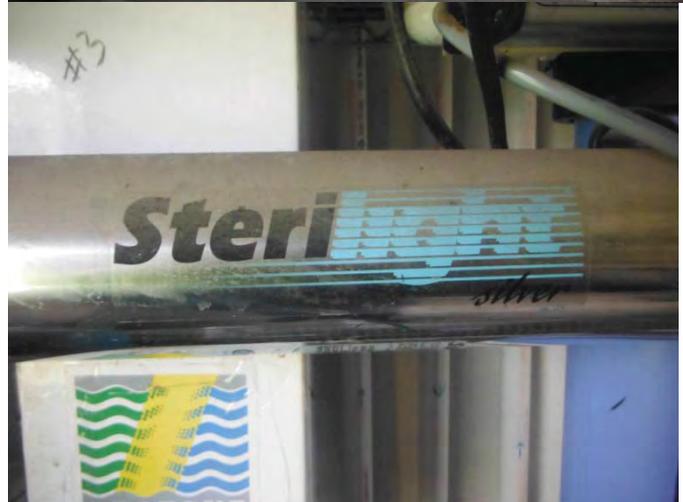
Water Purification Unit

There is water purification and disinfection system installed in building #12 that includes a sodium filter and 4 carbon filters, a U.V. disinfection and an ozone injection system (see appendix I for pictures). We turned on the system and tested it and aside from some very minor water leaks all components are in good operating condition. However, without knowing the chemical and biological makeup of the water at this time it is impossible to determine the potability of the water and therefore the system is not currently being utilized.
