**A WATER QUALITY ASSESSMENT OF THE RIO KATARI RIVER AND ITS  
PRINCIPLE TRIBUTARIES, BOLIVIA**

Professional Project

**Masters in Water Resources**

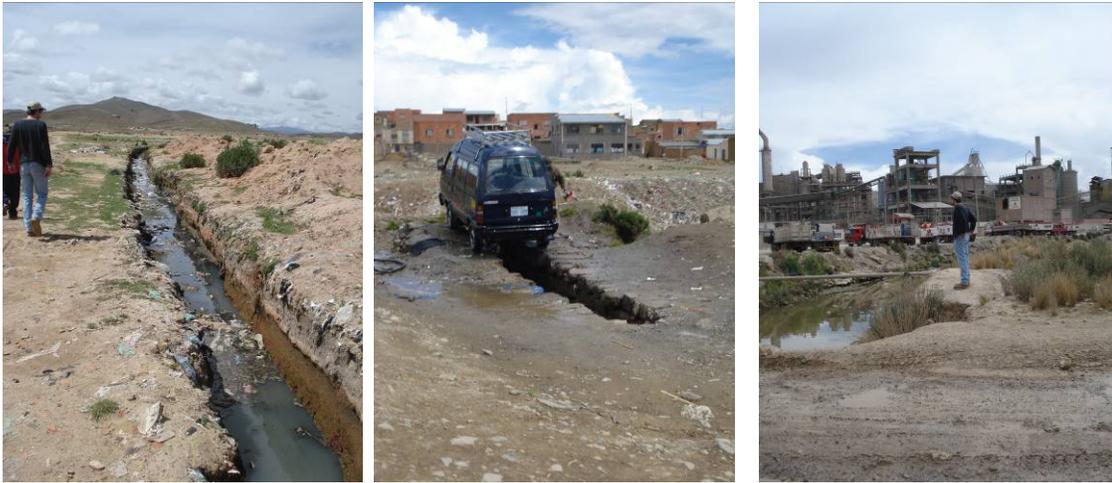
Figure 3. Three common types of contamination in the study region. The picture on the left is raw sewage and waste from a nearby slaughter house/tannery entering the Rio Pallina. The middle picture is an oil change business where the waste oil/fluids are being discharged into the Rio Seco. The picture on the right is the Viacha cement plant that increases sediment levels in the river and air.

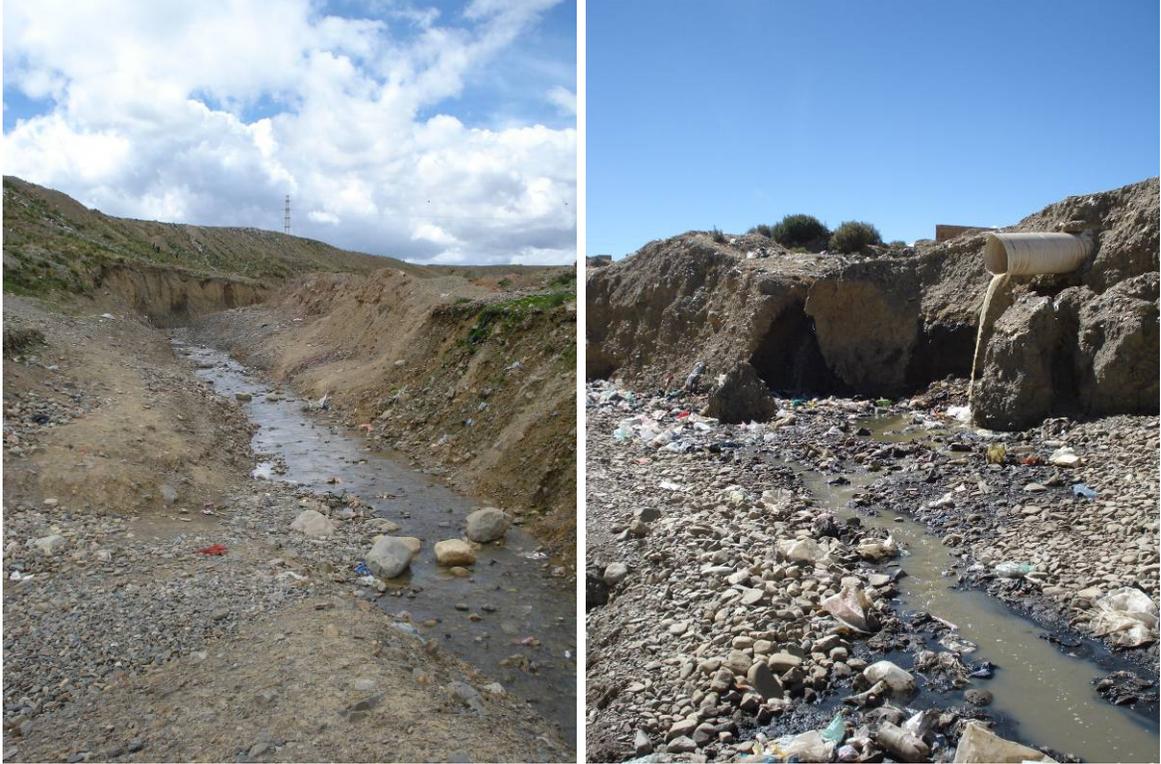
RS-1 is located at the headwaters of the Rio Seco, which is at the northern edge of El Alto. In January a ditch, lined with trash, from a cluster of nearby houses discharged into the river. Between the January and June sampling events the trash lined ditch was replaced with a plastic pipe. In January there was flow in the river upstream of the above mentioned discharge point. The water upstream of the discharge point was sampled, however in June there was no base flow and the water sample was collected from the discharge water that came from the nearby housing cluster. During both sampling events the water downstream of the discharge was grey and had a slight wastewater odor. During both sampling events the river was used for watering livestock, excavation of rocks and dirt, and as a dumping ground for trash. In addition during both sampling events children and adults were seen in the river. Figure 6 shows sample location RS-1 during the January and June 2009 sampling events.

Figure 6. Photo on left shows RS-1 during January 2009 when there was water in the river. The photo on the right shows RS-1 during June, when the only water in the river was from raw sewage being discharged into the river.

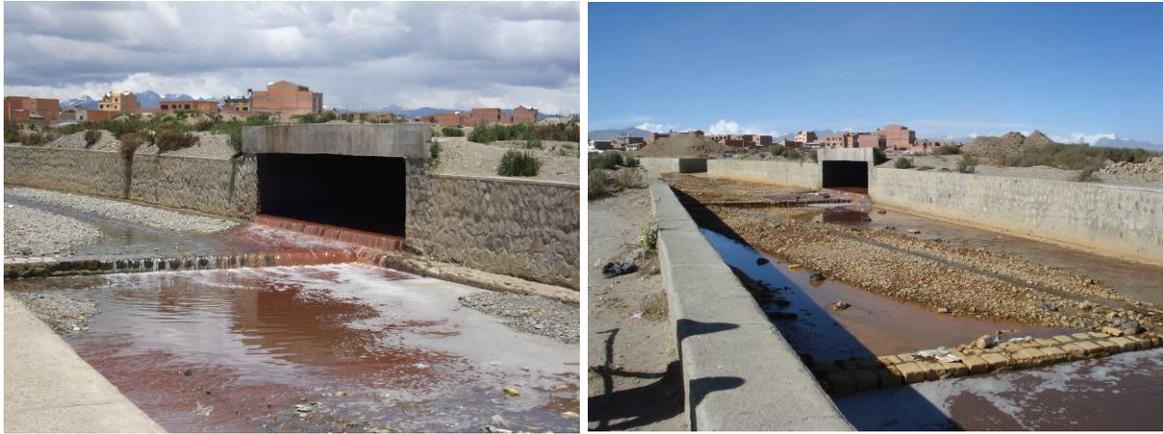
RS-6 wet season and dry season sampling sites are located in the Rio Seco in El Alto. In this reach the Rio Seco is confined to a cement channel with a rocky bottom. Between the two sampling points is a large ditch from the downtown portion of El Alto that enters the river (Ceja). At both sampling location the water had a slight wastewater odor and at RS-6 After the water contained blood. At these sampling points there were dead animals and trash in the water course. During both sampling events people were observed in the river utilizing the water for cleaning clothing, vehicles and recreational use (children playing in the water, adults and children walking in the water). Figure 7 is two photos of the sampling sites taken in January and June 2009.

Figure 7. RS-6 Before and RS-6 After sampling locations. The photo on the left shows the site in January 2009, during this sampling event the river was discolored because of animal slaughter waste being dumped into the river. RS-6 before was taken upstream of the canal on the right hand side of the photo, and RS-6 after was taken downstream of the canal after the two waters had mixed.

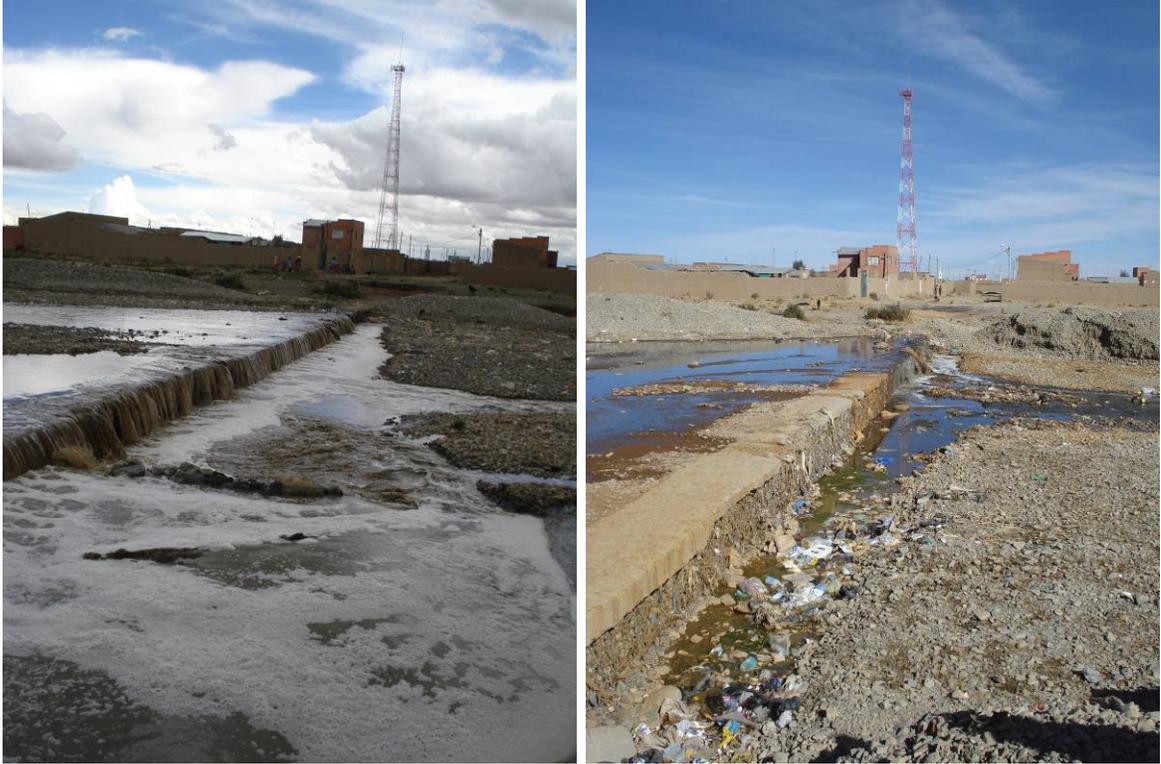
RS-10 is located in the Rio Seco. During the January 2009 sampling event this sampling point coincided with the end of development in El Alto. In January 2009 there was extensive foaming observed in the water and there was a slight wastewater odor. During June 2009 the river was dark grey and had a very strong wastewater odor. During both sampling events the river was used for livestock watering and recreational uses. In June 2009 new development at this point was observed, this consisted of installing a pipe (use uncertain) from the new houses to the river, as well as mining gravel from the river. Due to the removal of the gravel the course of the river had also shifted dramatically. Figure 8 is photos of sample site RS-10 during the January and June 2009 sampling events.

Figure 8. The photo on the left is RS-10 during the January 2009 sampling event and the photo on the right is from the June 2009 sampling event. Between the two sampling events water level in the river had decreased greatly. They were also developing more adjacent to the site and the course of the river had been moved and gravel was being excavated at the sampling site.

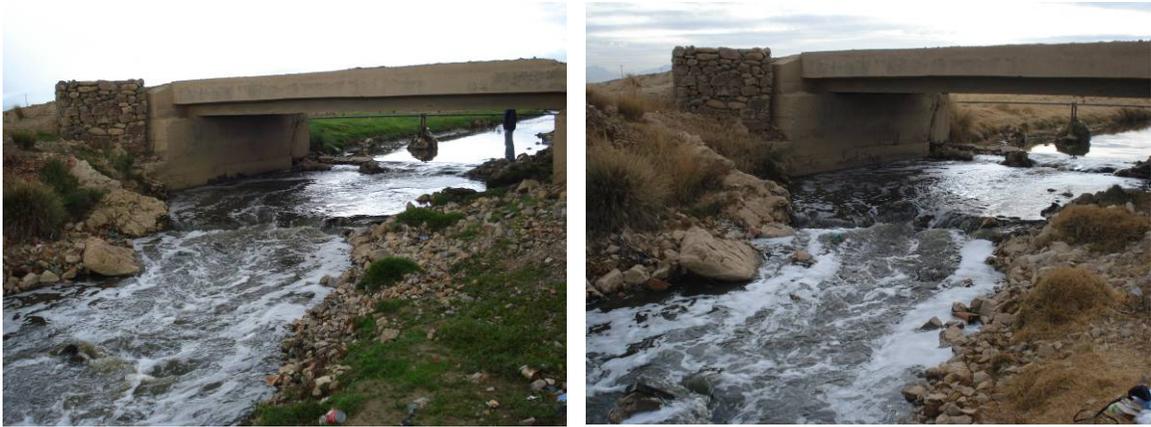
RS-11 is located in the Rio Seco, downstream of the WWTP and upstream of where the Rio Seco discharges into the Rio Pallina. During both events water was clear, with a slight wastewater odor and extensive foaming was observed in the water. Vegetation consisting of duckweed and algae was observed at this sampling point.

Figure 9. The left photo is from RS- 11 during the January 2009 sampling event and the photo on the right is from the June 2009 sampling event.

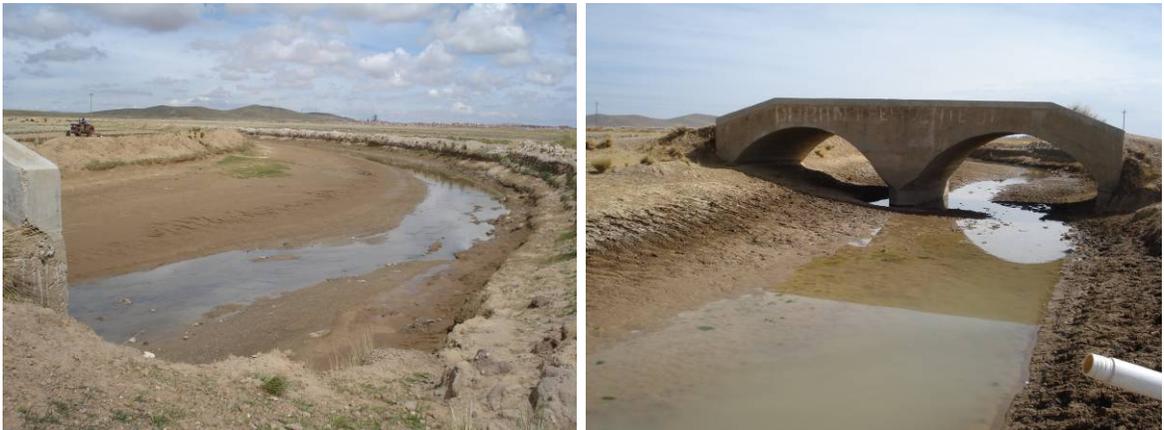
RP-1 is located at the headwaters of the Rio Pallina and upstream of Viacha. The water was clear and contained no odor. Upstream of this point is a small community, it is unknown if the community discharges wastewater into the dry bed portion of the Rio Pallina. Figure 10 is photos from the January and June 2009 sampling events.

Figure 10. Photo on right is RP-1 during the January 2009 sampling event and the photo on the right is from the June 2009 sampling event. Flow was very low during both events.

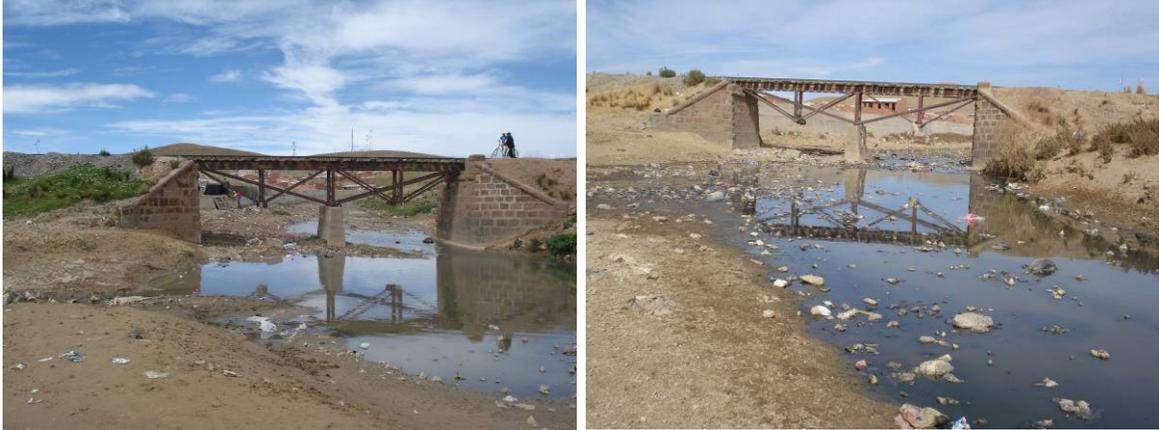
RP-6 is located in the Rio Pallina, downstream of Viacha. The water was dark grey and had a very strong wastewater odor. During both events garbage and dead animals were observed in the water. During both sampling events children were seen playing in the river. Figure 11 is photos from the January and June 2009 sampling events.

Figure 11. The photo on the right is RP-6 during the January 2009 sampling event, and the photo on the left is from the June 2009 sampling event. During both events people were using the river for recreation purposes, and the sewage odor was very strong.

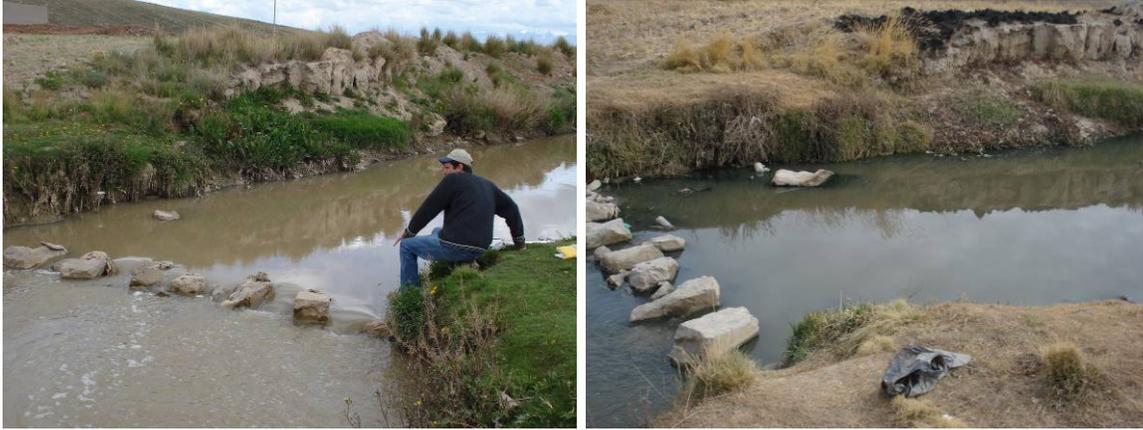
RP-7 is located in the Rio Pallina, upstream of the confluence with the Rio Seco. The Viacha cement plant is located adjacent to this sampling point. During both sampling events no discharge points from the cement plant were observed entering the river. The water was clear with a very slight wastewater odor. Vegetation consisting of duckweed and algae was present in the river. Along this region the air quality was compromised due to the cement plant, and suspended sediment was present in the river. Figure 12 is photos taken at RP-7 during the January and June 2009 sampling events.

Figure 12. Photo on the left is RP-7 during the January 2009 sampling event and the photo on the right is from the June 2009 sampling event. In January there was more sediment in the river.

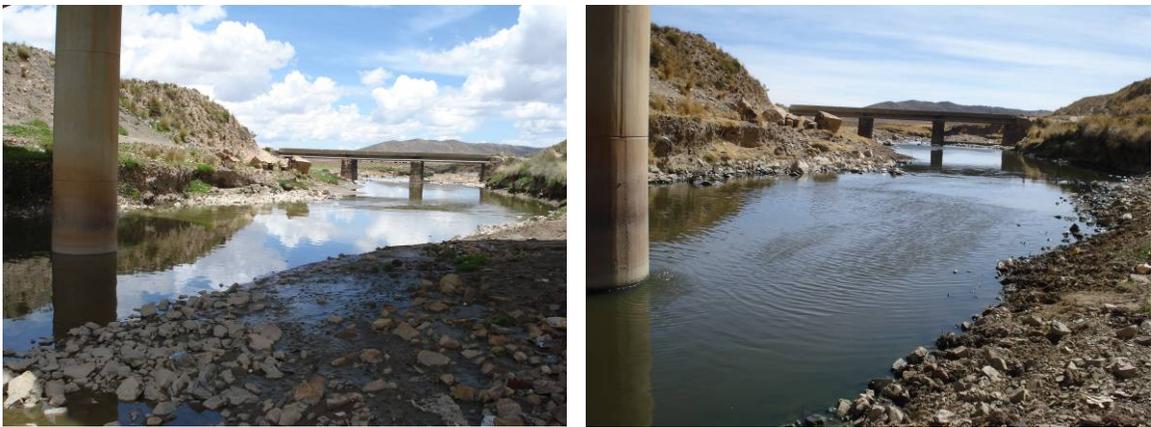
RP-9 is the in the Rio Pallina down stream of its confluence with the Rio Seco and upstream of where it discharges into the Rio Katari. The water was slightly turbid with a slight wastewater odor. Figure 13 is photos from the January and June 2009 sampling events.

Figure 13. Photo on the left is RP-9 during the January 2009 sampling event and the photo on the right is from the June 2009 sampling event.

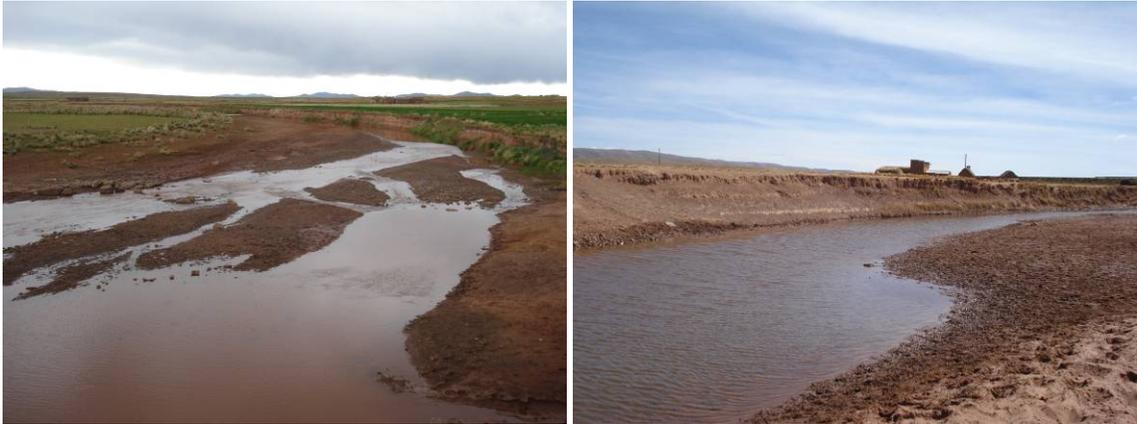
RK-1 is located at the headwaters of the Rio Katari. During the January 2009 sampling event the river was very turbid, in June 2009 the water was clear and some algae was growing on and around rocks. Adjacent to the sample point is agriculture fields and red windblown sands. Figure 14 is photos from the January and June 2009

Figure 14. The photo on the left RK-1 during the January 2009 sampling event and the photo on the right is from the June 2009 sampling event. The water level had decreased between the two events as well as the amount of suspended sediments. In June precipitates could be seen on the gravel along the bank of the river.

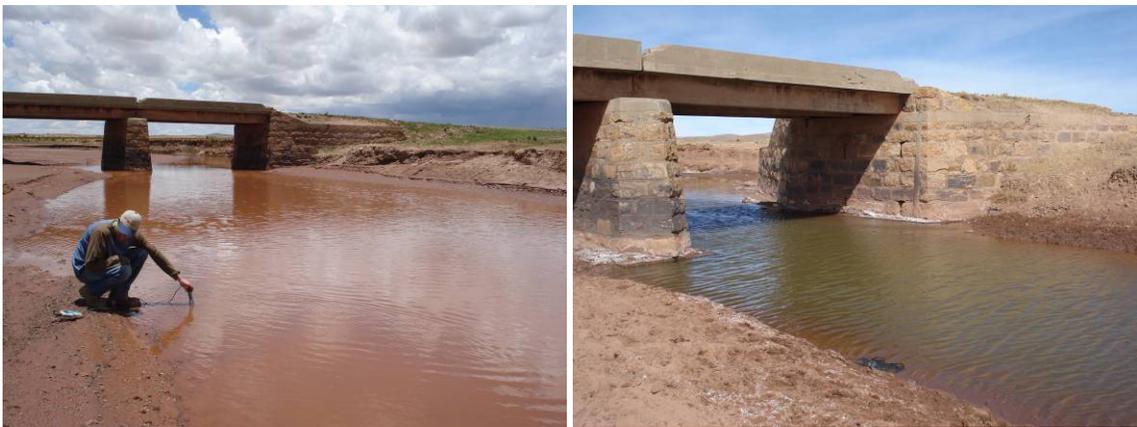
During January 2009 sampling event the river was very turbid, during the June 2009 sampling event the water was clear. Adjacent to the sampling point is agriculture fields and red windblown sands. Figure 15 is photos from the January and June 2009 sampling event.

Figure 15. The photo on the left is RK-2 during the January 2009 sampling event, and the photo on the right is from the June 2009 sampling event. The amount of flow and suspended sediment decreased between the two events. In June 2009 there was precipitates present on the bank of the river and algae in the river.

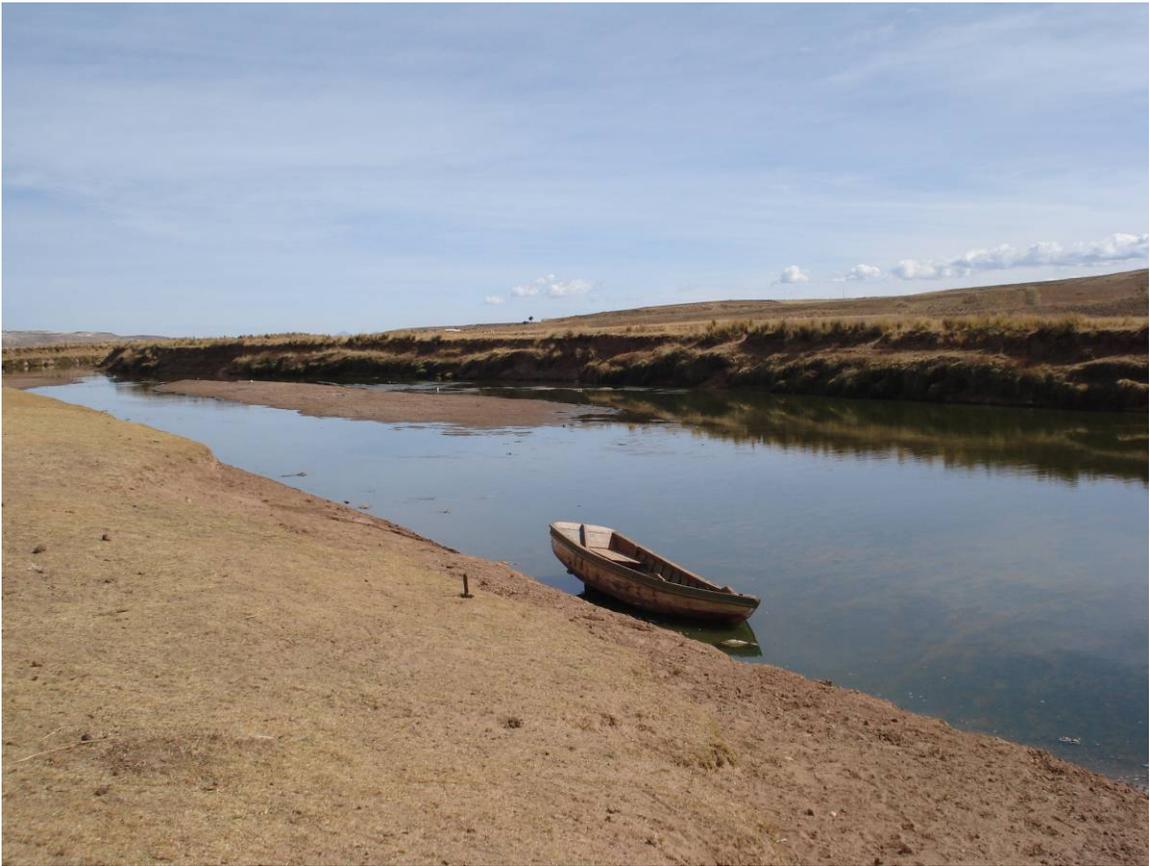
RK-4 is in the Rio Katari downstream of its confluence with the Rio Pallina. This point was only sampled during the June 2009 event. Water was clear with no odor; algae growth was observed in the river along the sides and attached to rocks and other objects in the river. Adjacent to the sampling point is an agriculture field and a single family home, no impact from the family was observed during sampling. Figure 16 is a photo from the June 2009 sampling event.

Figure 16. Photo of RK-4 during the June 2009 sampling event. The bottom of the river had lots of algae growth.

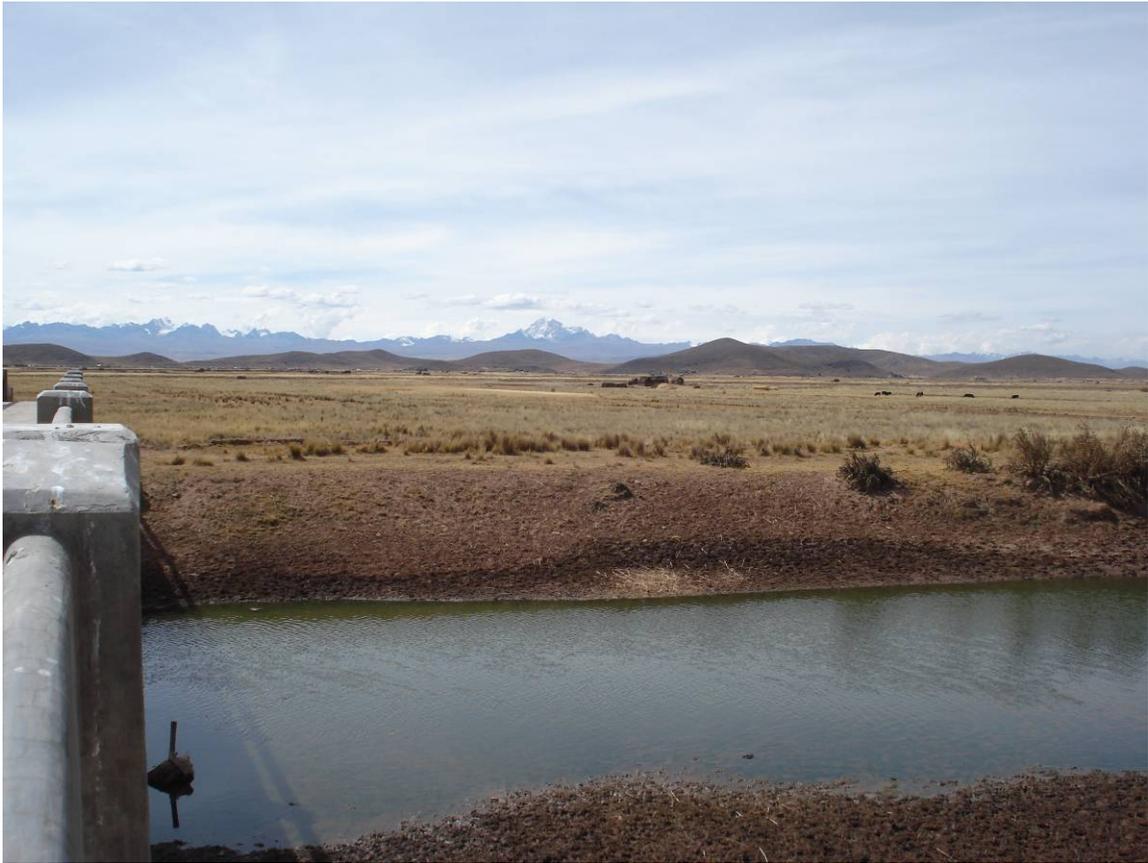
RK-5 is located in the Rio Katari, and was only sampled during the June 2009 event. The water was clear with no odor and algae was present in the water. Adjacent to the site is a foot bridge, agriculture fields, red windblown sand and an adobe wall (possibly from Tiwanaku raised bed agriculture). Figure 17 is a photo of RK-5 during the

Figure 17. Photo of RK-5 during the June 2009 sampling event.
