Trip Report

Hospital San Carlos

Chiapas, Mexico

The wastewater treatment system is the final phase of the Hospital San Carlos Water Supply and Wastewater System Improvements project under our WASH in HCFs initiative.

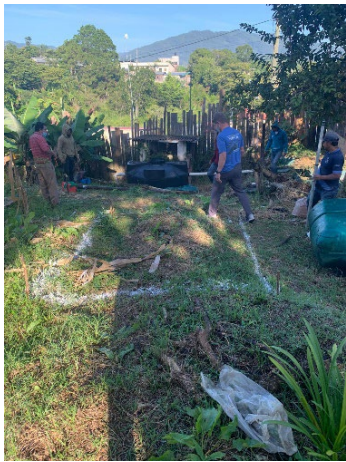
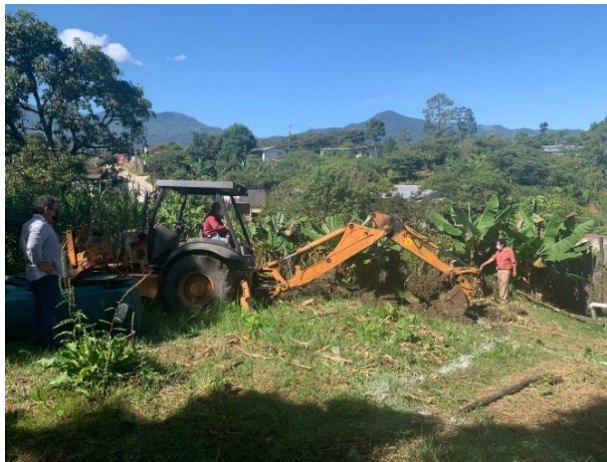
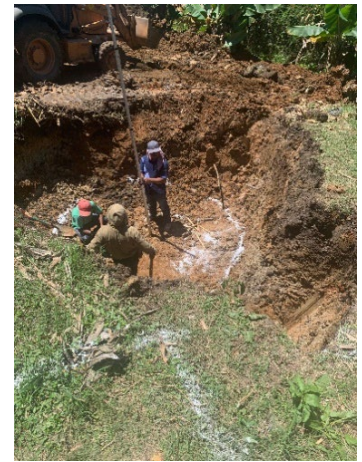
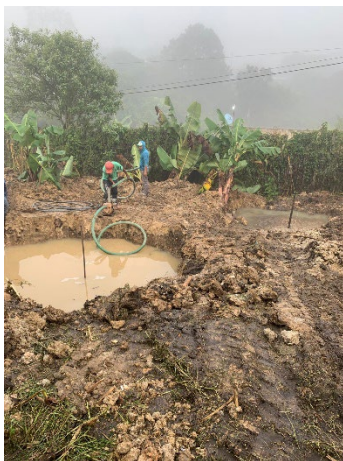
Today was excavation day. Alfredo had a large work crew of 6 men that worked at the site all day. They began by clearing the ground and laying out the exact tank locations. They also began digging around the existing tanks that were to be moved. A load of gravel was delivered and the fence adjacent to the road was removed to allow the backhoe to enter the property. Once the backhoe arrived, excavation began and proceeded for most of the day. The holes were dug, and gravel was placed in the bottom to level out the holes, bring them up to the correct grade, and provide a good base course/foundation for the tanks.

In removing the dirt fill around the existing tanks, the workers encountered they had been partially buried in concrete. Thus, moving them was not going to be viable. Some quick math was done, and it was determined that the tanks could remain even though they would be at a slightly lower level than the other 2 tanks.

It was also discovered that the collection lines would need to be found, as they were previously rerouted in the road to go a different direction. There was no indication of where they are located and how they are connected to the drains in the road. It was determined that the road will need to be cut to locate the pipes and make new connections to bring the sewage to the treatment plant.

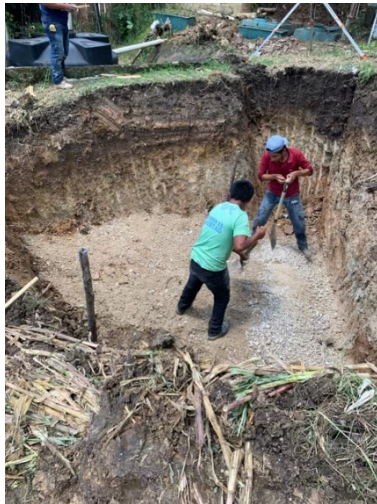
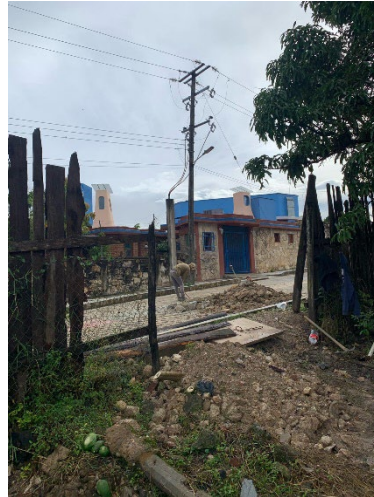
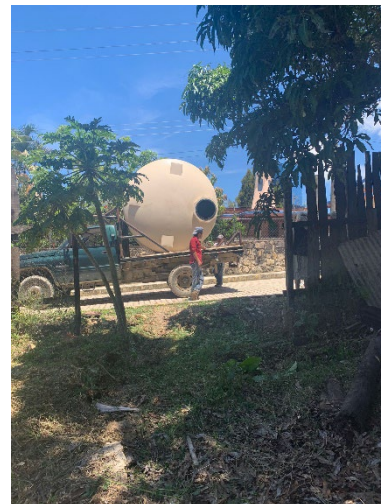
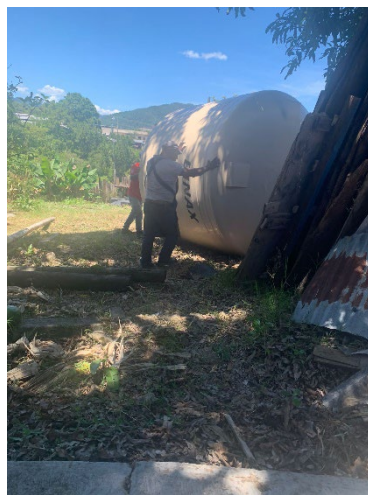
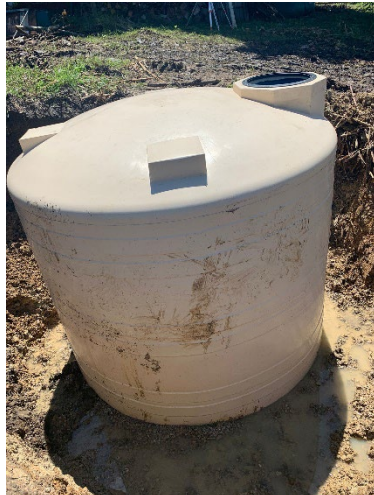
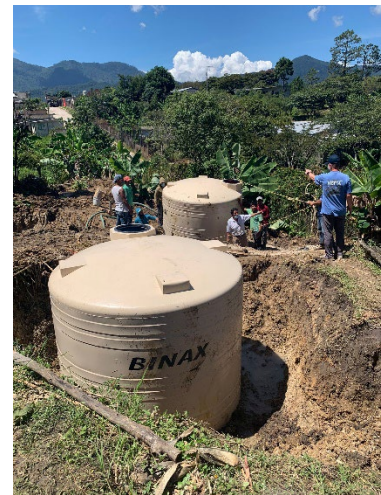
The recently excavated holes accumulated water from the heavy rains overnight. The water was pumped from one of the holes and removed from the other two as well. Mud had fallen into the holes, which also needed to be removed. Additional gravel was placed in the bottom of the holes to flatten the bottom and provide a solid foundation. The tanks were rolled to the holes and placed in each hole. The tank elevations were measured and tank 2 was lowered to be at the correct elevation by removing some of the gravel. A pipe was broken during excavation the day before, so a temporary pipe was installed using pieces from the old treatment system to reroute the drain from the kitchen and laundry area. This enabled the Sisters to continue doing hospital laundry.

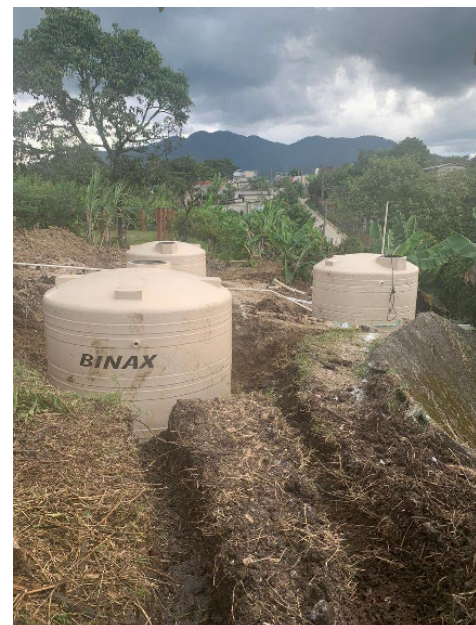
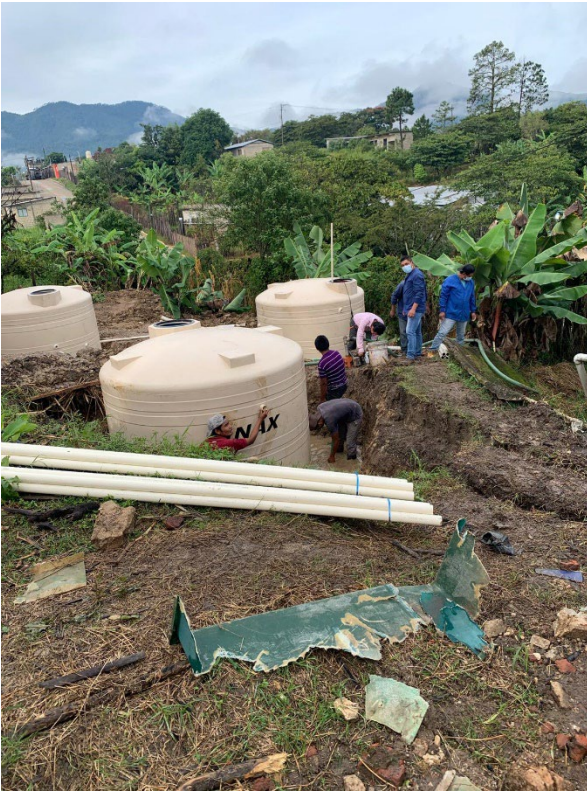
Today all the tank elevations were measured to make sure the water and piping would allow the correct flow and to make sure the penetrations in the tanks were at the correct elevations. Inge Freddy and Angelica added a breaker in the existing electrical panel and ran conduit and wire down to the tank where the pump will be installed. Taylor installed caps on the smaller outlets on the tanks that can't be used, and Inge Freddy caulked them with sealant. With the hole locations verified, the tank

inlets and outlets were cut into each tank using a drill and hole saw bit.

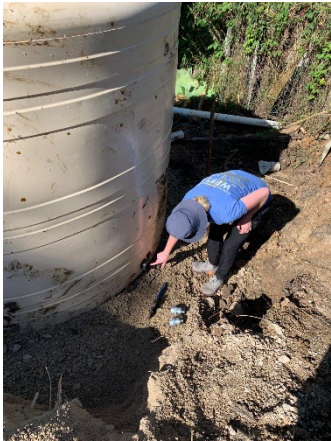
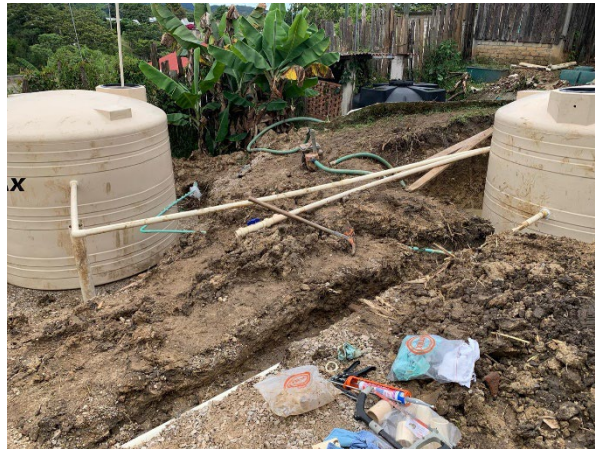
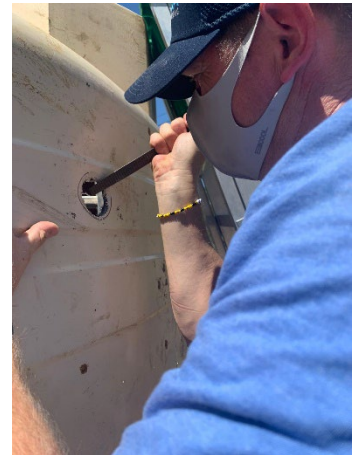
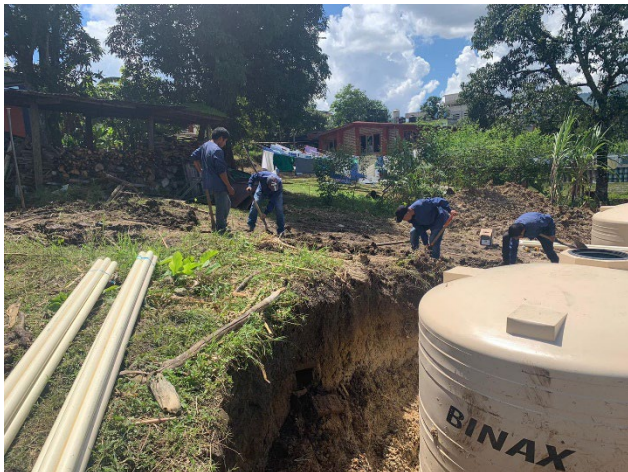
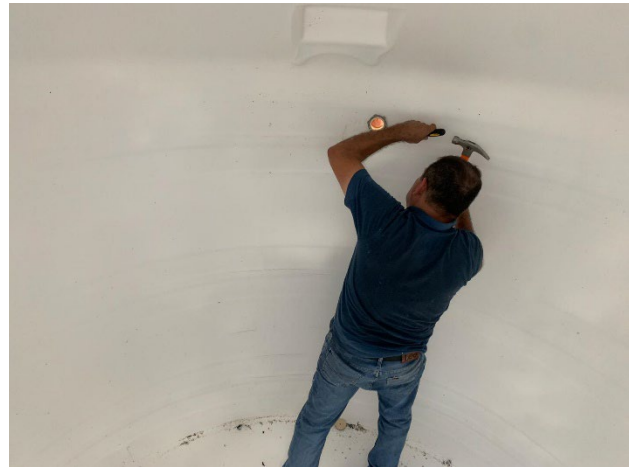
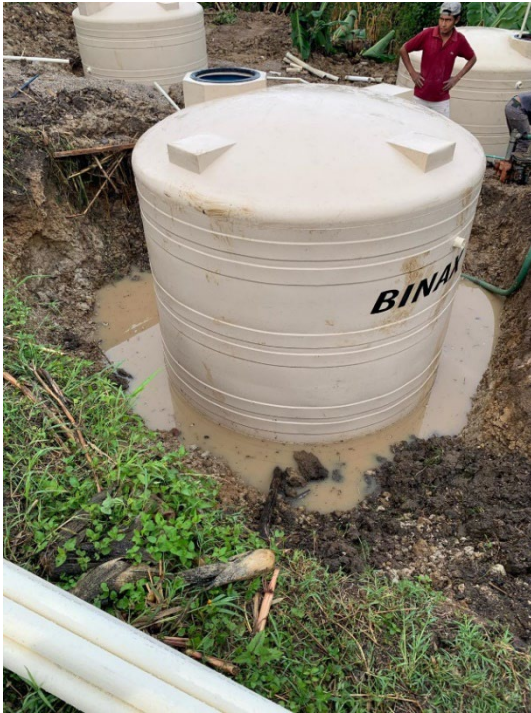
The old piping on the existing tanks was removed and the team was able to salvage enough of the threaded 4" fasteners to use with the new 4" connectors. The remaining trenches for the piping were dug, as was the trench for the electrical conduit going to the pump. The pump was lowered into the tank and the piping from the pump was connected. Two laborers worked on the piping in the street for the entire day. They continued breaking up the concrete trying to find the pipes in the road that have been connected to the drain in the middle of the road. These pipes need to be found and rerouted to the treatment plant. The team began the complex piping associated with the 4 existing small tanks, which requires level distribution to allow equal amounts of water to get to each of the tanks. Rain started about 5pm, forcing construction to end for the day.
