Implementation of Wash Circuit Riders for Improved WASH In Catholic Run Healthcare Facilities (HCFs)

Sanitation and Water Action (SAWA) and Water Engineers for the Americas & Africa (WEFTA)

WASH Circuit Rider Report on 4 Catholic Healthcare Facilities (HCFs)

Tanzania, 2024

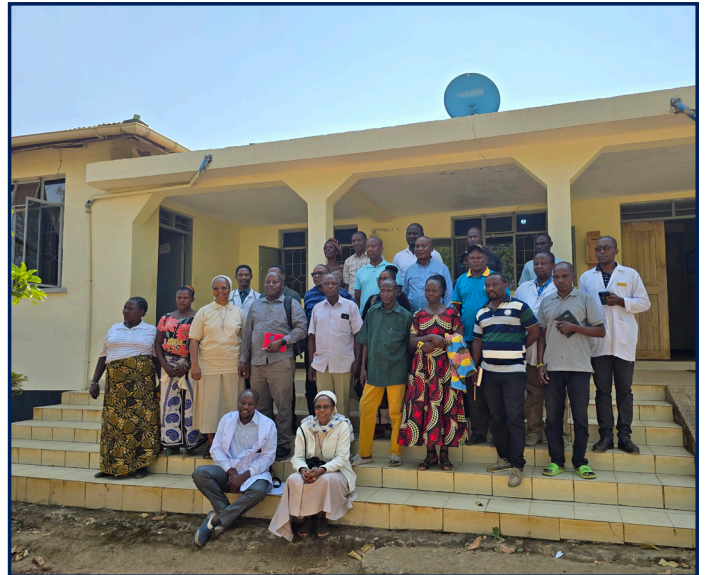
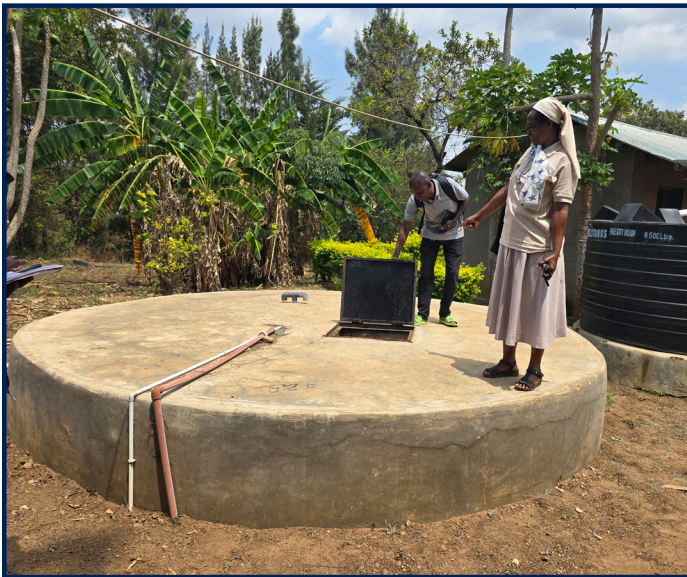
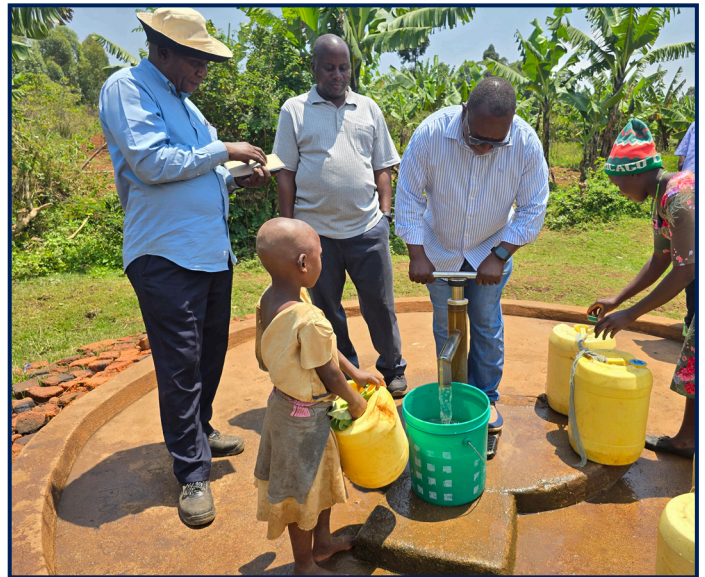
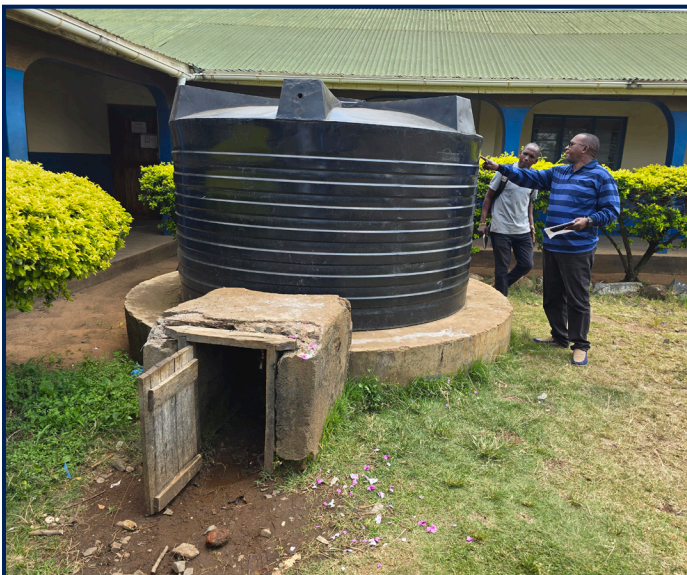
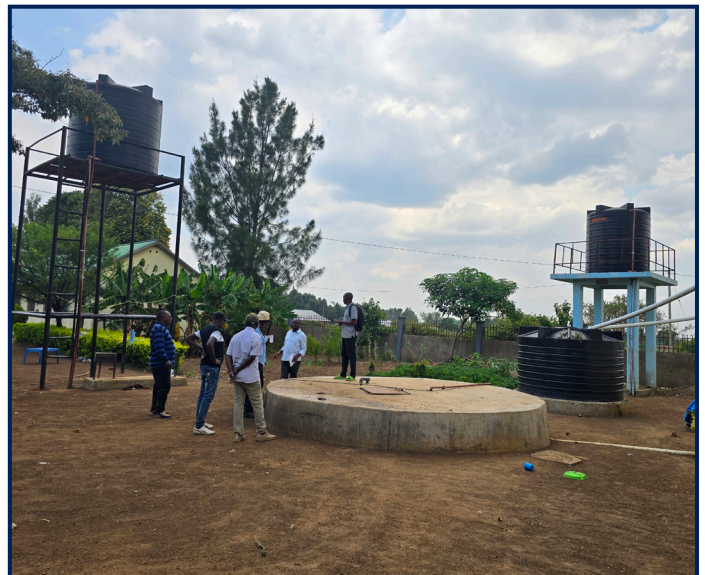
- **Water Supply:** The facility's rainwater harvesting system, with a 260m³ capacity, faces maintenance challenges, with 30% of tanks non-functional due to delayed repairs. The borehole backup system is underutilized due to poor maintenance.
- **Community Water Points:** Of the four supported points, three are operational, but Kenyamsabi Centre's hand pump requires replacement or motorization for efficiency.

Water Supply Project (completed 2020)

Masanga Centre includes the Bikira Maria Mama Wa Tumaini Health Center, a Church, St. Catherine Laboure Day & Boarding School, Association of Termination of Female Genital Mutilation (AFTGM), Vindalva VTC, Gorong'a Secondary School, and Masanaga Primary School.

- **Recommendations:** Establish a WASH management committee involving neighboring institutions and support tank and borehole repairs.

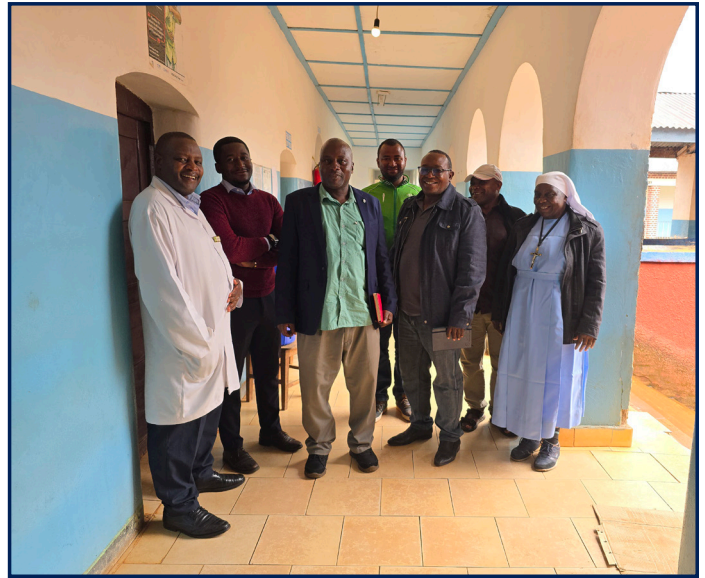
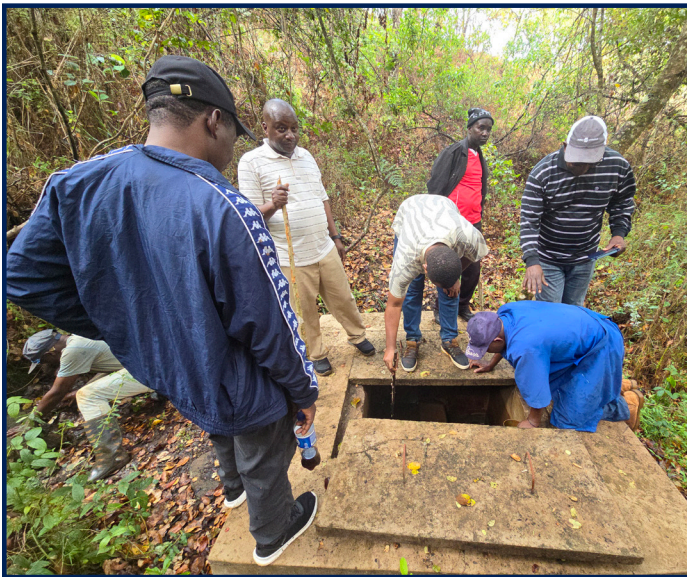
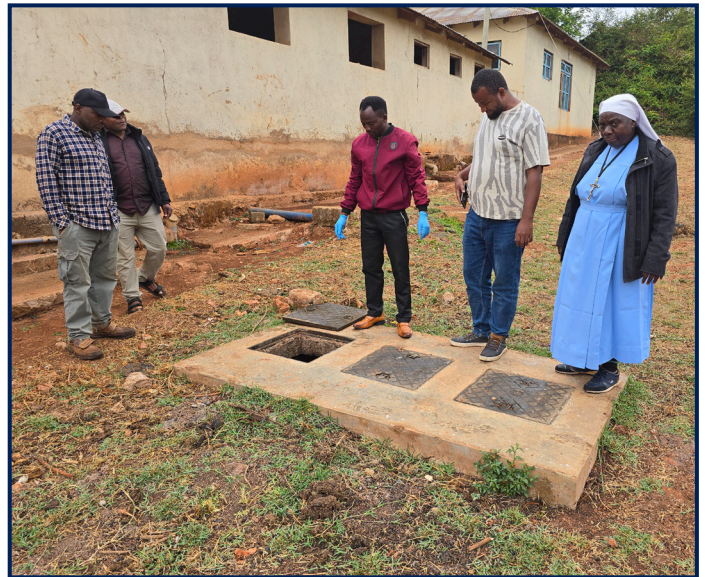
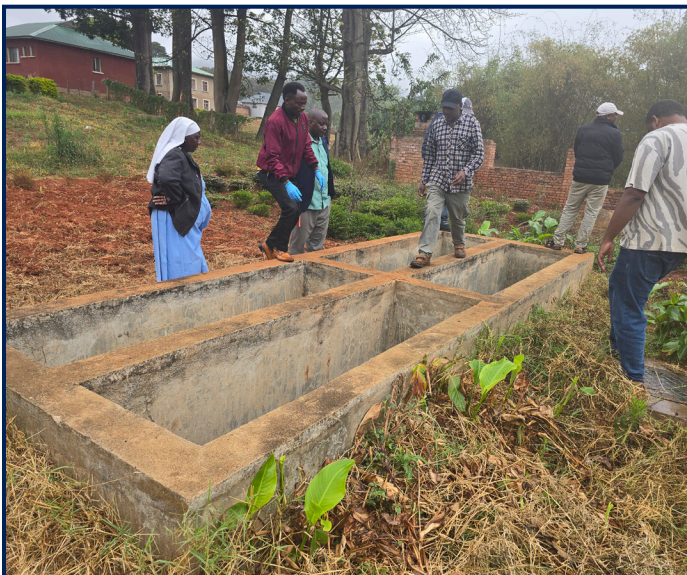
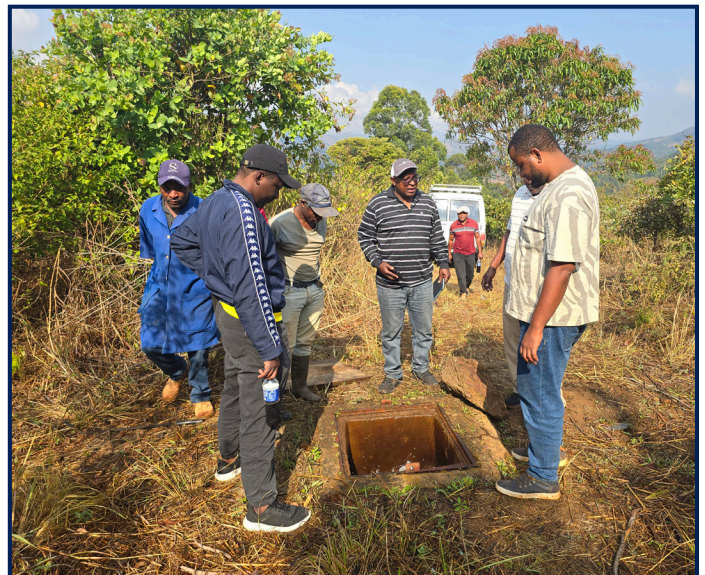
St. John's Hospital Lugarawa

- **Water Supply:** Well-maintained with increased yields due to catchment protection. Siltation during rainy seasons indicates the need for upgraded filtration materials.
- **Sanitation:** The sewerage system, though functional, requires enhancements to address treatment plant overloading and maintenance frequency.
- **Recommendations:** Schedule O&M and upgrade filtration and treatment units.

Water and Wastewater System Improvements (completed 2021)

St. John's Lugarawa includes the Hospital, primary and secondary schools, a vocational training institute, and several religious institutions.

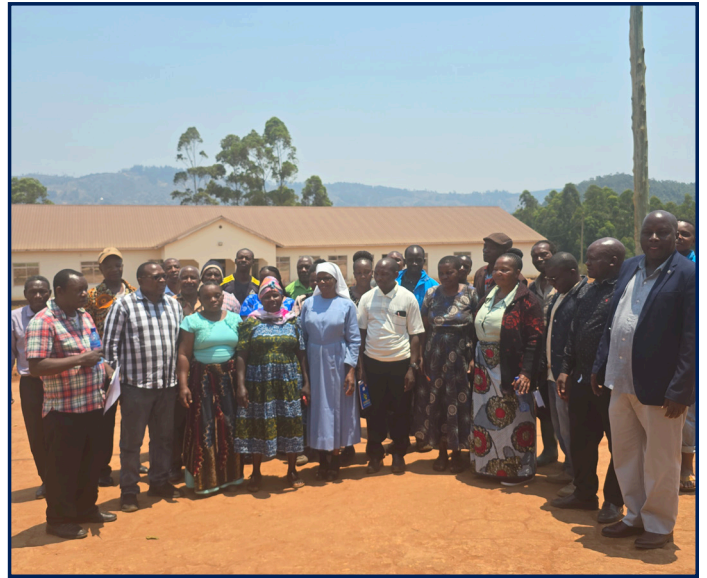
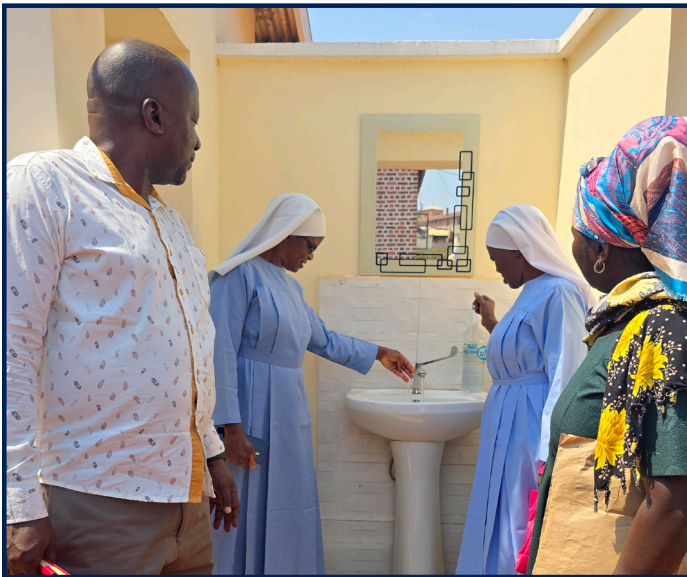
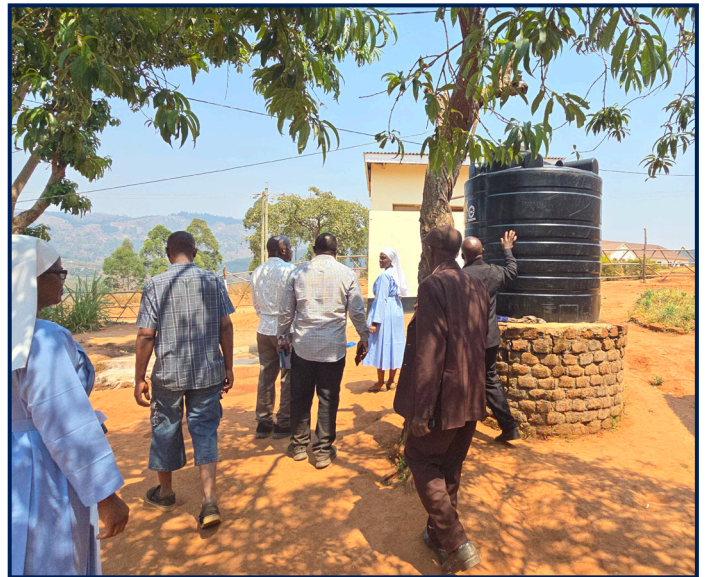
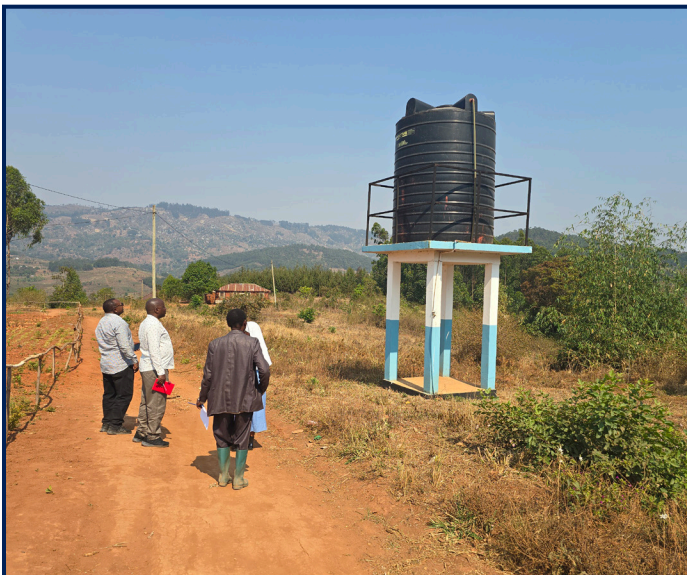
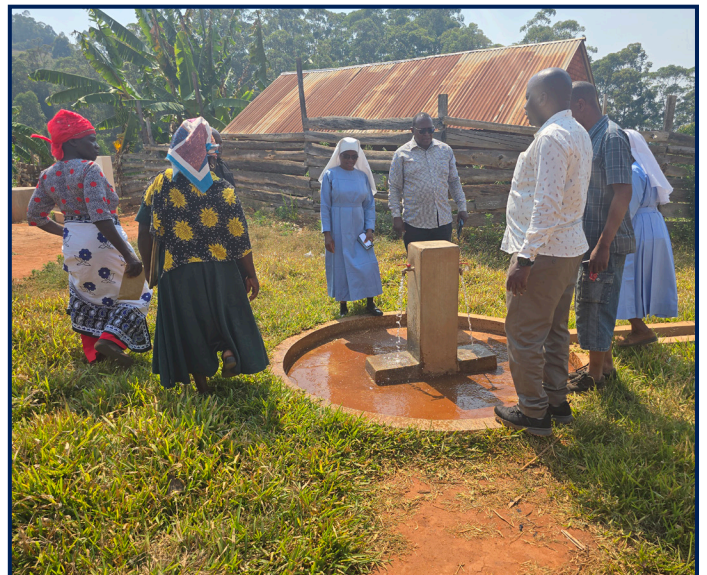
Mpapa Center

- **Water Supply:** Despite community-side challenges like illegal connections and misuse, the spring water source remains clean and sufficient.
- **Sanitation:** The partially utilized sewerage system will require monitoring upon full operational capacity. Hygiene practices need improvement, particularly in handwashing facilities.
- **Recommendations:** Strengthen community accountability through enforcement of by-laws and enhance hygiene practices.

Water and Wastewater System Improvements (completed 2023)

Mpapa Health Center serving the surrounding villages includes the Hospital, a Church, a Vocational Education Training Center (VETA), and a primary school.

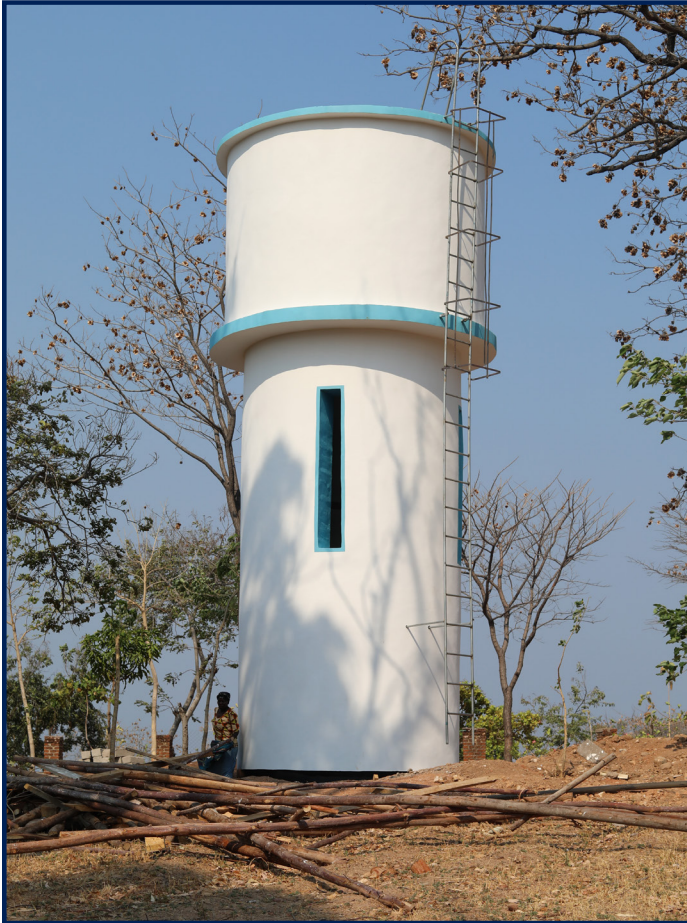
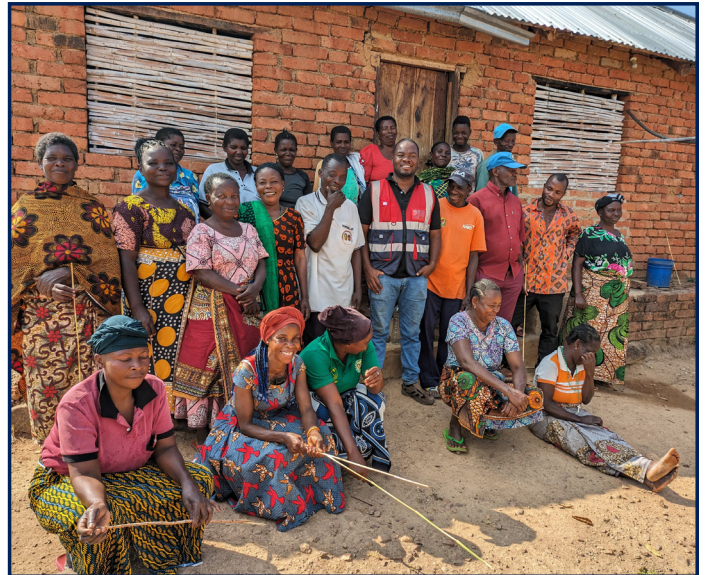
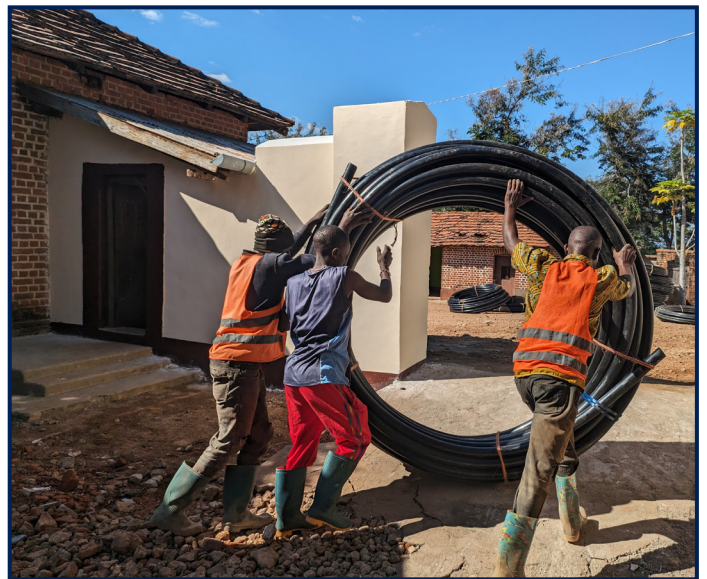
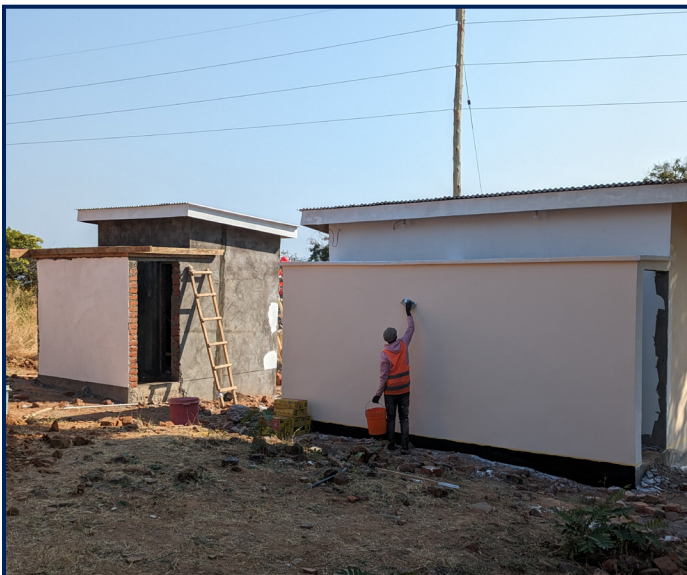
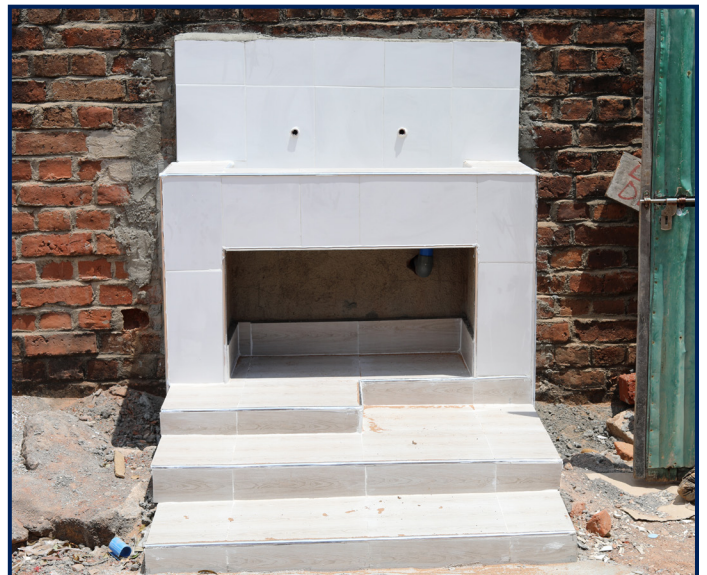
Lundu Dispensary

- **Water Supply:** The water supply project funded by WEFTA is 90% complete.
- **Sanitation:** The sanitation components funded by WEFTA are 90% complete.
- **Biohazard Management:** Facilities fully meet government standards with a fenced incinerator, ash pit, and placenta pit.
- **Recommendations:** Continue routine operation, maintenance and management.

WASH Improvements (in final stages 2024)
