## ETHIOPIA 2025 TRIP REPORT (NOVEMBER 1<sup>ST</sup> TO 14<sup>TH</sup>)

Water Engineers for the Americas and Africa (WEFTA) has been involved in water and sanitation projects in Ethiopia since 2019. In the West Omo Zone (WOZ) and Bench Sheko Zone (BSZ) of southwestern Ethiopia, WEFTA has partnered with Village Health Partnerships (VHP) to improve access to clean water and improved sanitation at six (6) health centers and three (3) hospitals, along with the regional teaching hospital in Mizan Teferi. Additionally, WEFTA has partnered with the Daughters of Charity International Project Services (DCIPS) to provide improved access to clean water at several schools within the capital, Addis Ababa, as well as in a few other cities throughout Ethiopia. In November 2025, two engineers with WEFTA, Marty Howell and Nathan Stormzand, traveled to Ethiopia with several members of VHP to conduct assessments of the water, sanitation, and hygiene (WASH) infrastructure at the health facilities and schools and to evaluate projects that had been completed since previous visits to these locations.

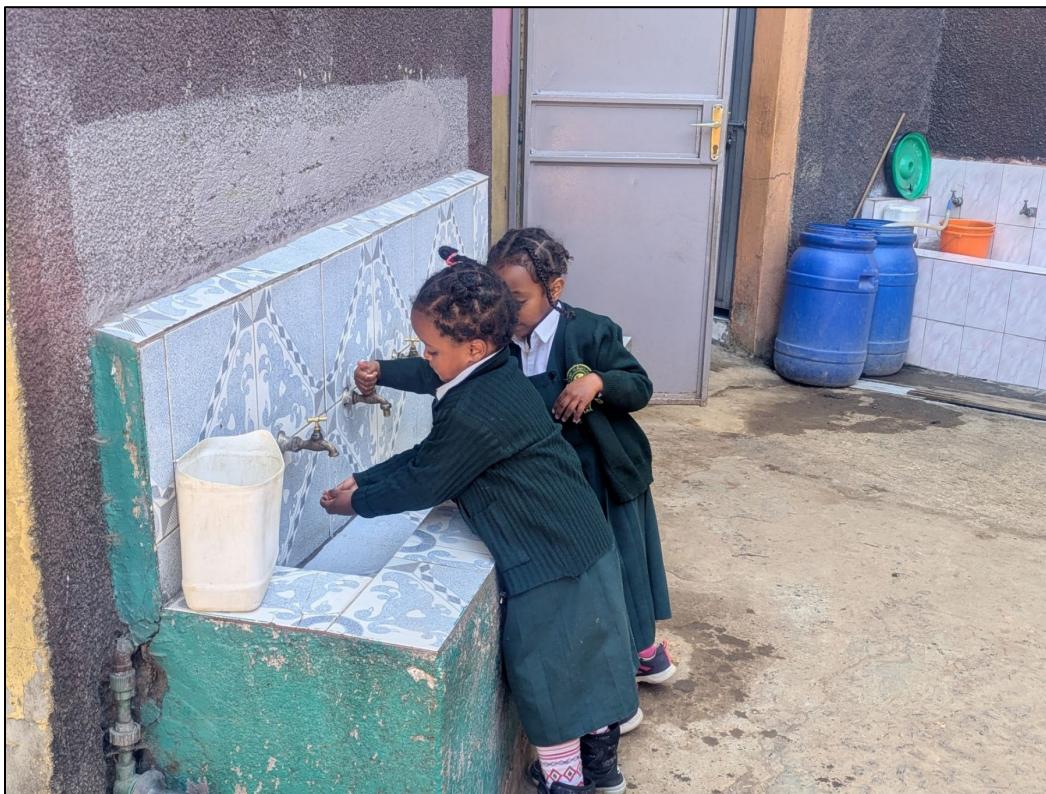
Figure 5: Children at St. Mary's Catholic School using the Hand Washing Station

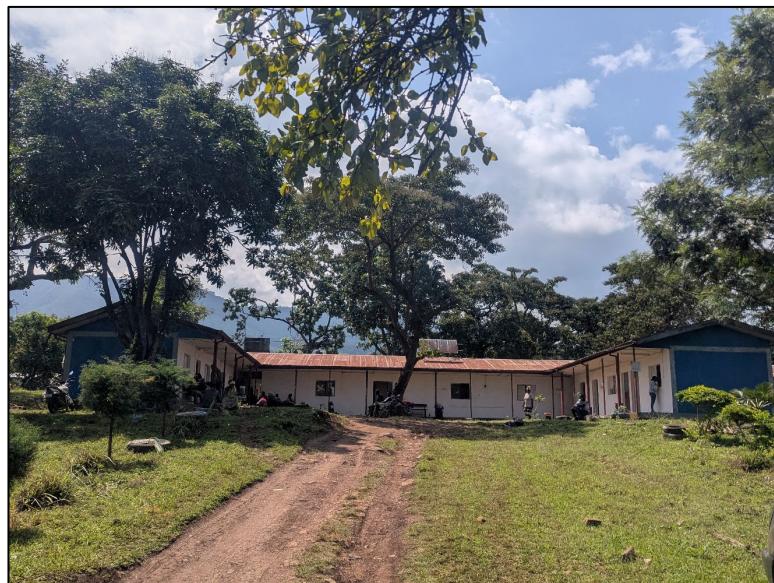
The Tum Health Center is located in the Maji Woreda and serves a catchment of 17,530 people. Previous project team infrastructure improvements at the health center includes the construction of a MWA; installation of a dedicated 10,000 L tank at the MWA that serves the shower and various tap stands; raising of the health center's 10,000 L tank to improve water delivery at the center; construction of a chicken coop; original connection to the town water system; construction of concrete pit latrines; and replacement of damaged solar panels for the center's solar power system.

Figure 6: Tum Health Center

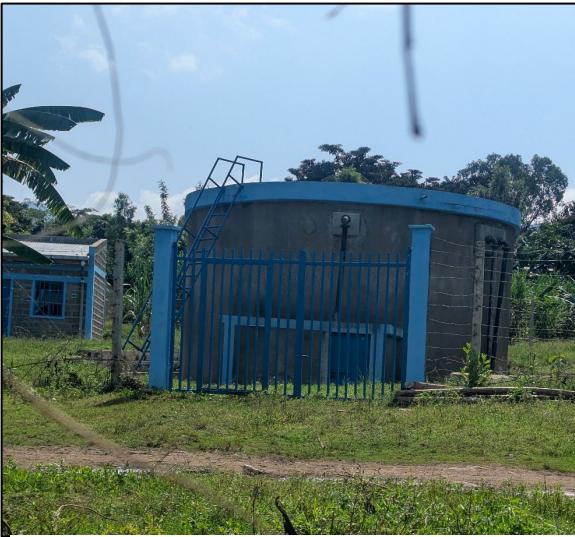
Water to the Tum Health Center is supplied by Tum's community system. The source of this water is a series of large springs located several miles above the town on the road to Maji. In 2024, the regional or federal government concluded a large water system improvement project that rebuilt the spring box, ran new distribution piping (where necessary), constructed a 100,000 L storage reservoir above the town marketplace, and constructed another 50,000 L storage reservoir at the administration buildings, immediately adjacent to the health center. At the time of the team's visit, the MWA and health center water distribution systems had been connected directly to a new supply line leading from the new 50,000 L reservoir, bypassing the two 10,000 L tanks onsite. It is believed that this was done as there is no mechanism to prevent the 10,000 L tanks from continuously overflowing if they were connected to the larger reservoir; shutoff float valves seemingly unavailable in the WOZ. These new connections are not necessarily an issue in and of themselves. However, the connections were incomplete as the

MWA shower, and MWA latrine handwashing station were not connected to the new supply line. Moreover, the supply line was sitting on the surface and had not been placed in a permanent trench. Woreda officials agreed to correct these issues and finished properly installing and connecting the new supply line. They also agreed to add a new tap stand for the future MWA garden behind the chicken coop and regrade and/or cut drainage channels to remove standing water around in the facility.

Figure 7: New 50,000 L Storage Reservoir next to Tum Health Center Constructed by the Government

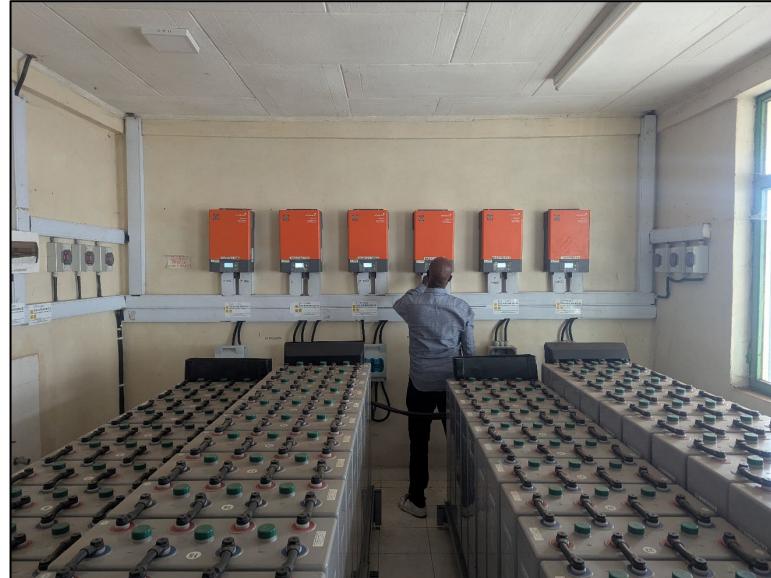
The Maji Hospital has two solar systems: an 8.9 kW system for the pump installed by STT/SEF in 2022 and a 33.6 kW system for the hospital installed by STT in 2020. Because both of these systems were installed recently and are in good repair, no issues were discovered during this year's assessment besides the need for the panels to be cleaned regularly. Now that cellular and data coverage has expanded in the Maji area, VHP will have STT install a remote monitoring system similar to that already installed at the two other district hospitals so that system consumption, operations, error codes, etc., can be monitored from Addis Ababa. This will eliminate the need for frequent trips to the WOZ to check on the systems and also alert the STT engineers of any issues.

Figure 9: Battery Room for Maji Hospital Solar System

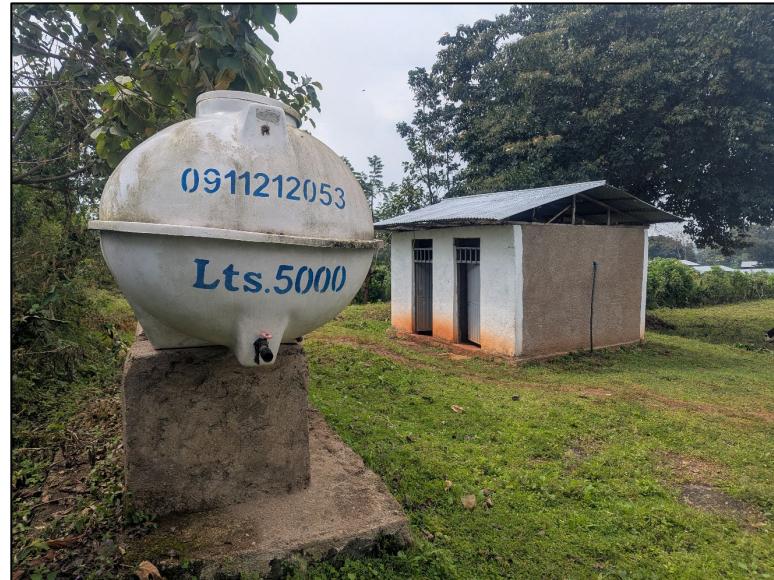
Assuming that the repairs and improvements to the community system do result in water reaching the health center, there are a number of issues that need to be addressed. Mainly, the water system for the MWA has seemingly been either vandalized or cannibalized during the years without water. The inlet and outlet lines to the 5,000 L tank were cut and several sections missing along with many of the connections. Since the disconnections, a colony of bees has used the opening where the fill line used to be to build a hive. The size and extent of the bees was not determined during the site visit. Additionally, the washing station near the tank does not have any taps and the drainage is insufficient. According to several people, this is actually how AEID left the washing station at the end of construction. Zonal administrators agreed to repair the tank and connections so that the MWA will have water once service is restored. As the condition of the internal plumbing is unknown, VHP has agreed to hire Markos to assess the existing plumbing and make any repairs needed.

Figure 11: Disconnected Tank at the Chiruharoot MWA

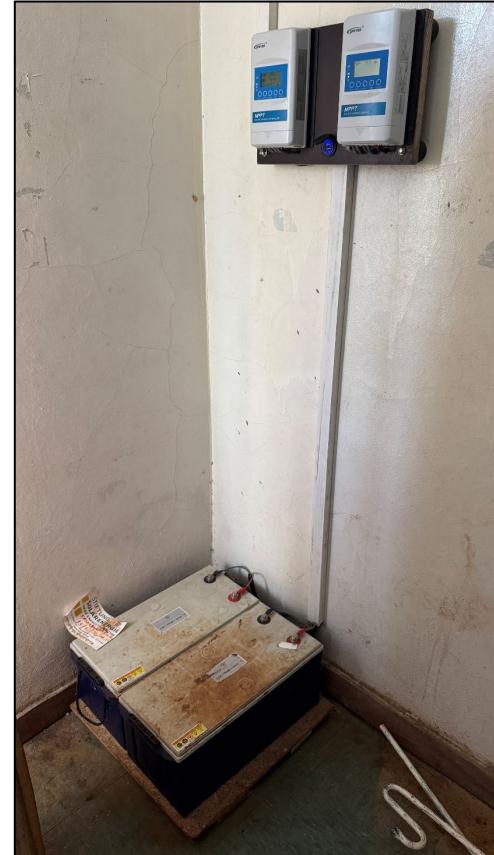
Figure 13: 460W System at Jomu with dirty batteries due to people stepping on them to reach the phone charging port. (Typical of all small systems at the health centers.)

Jomu Health Center	2	1-Small L&D dedicated system installed by VHP/SEF/Green Lamp 2-Small system for laboratory created from salvaged components installed by unknown party.	None known.	People are standing on the batteries to gain access to reach the phone chargers.	Batteries to be placed atop a small table or otherwise protected. Clinic to clean panels regularly. Markos to check that battery raise occurred	Clinic with support from Woreda/Zone	
Chebera Health Center	2	1-Full Health Center 2.04kW system installed by Government and repaired by VHP/STT. 2-Small triangular rooftop system that runs second fridge installed by SunDanzer.	None at the moment.	New batteries installed by STT do not have as much capacity as old batteries and so do not meet all demands.	Clinic to prioritize L&D. Clinic to clean panels regularly.	Head of Clinic	May want to add new small L&D system to avoid overload and keep power to fridge.

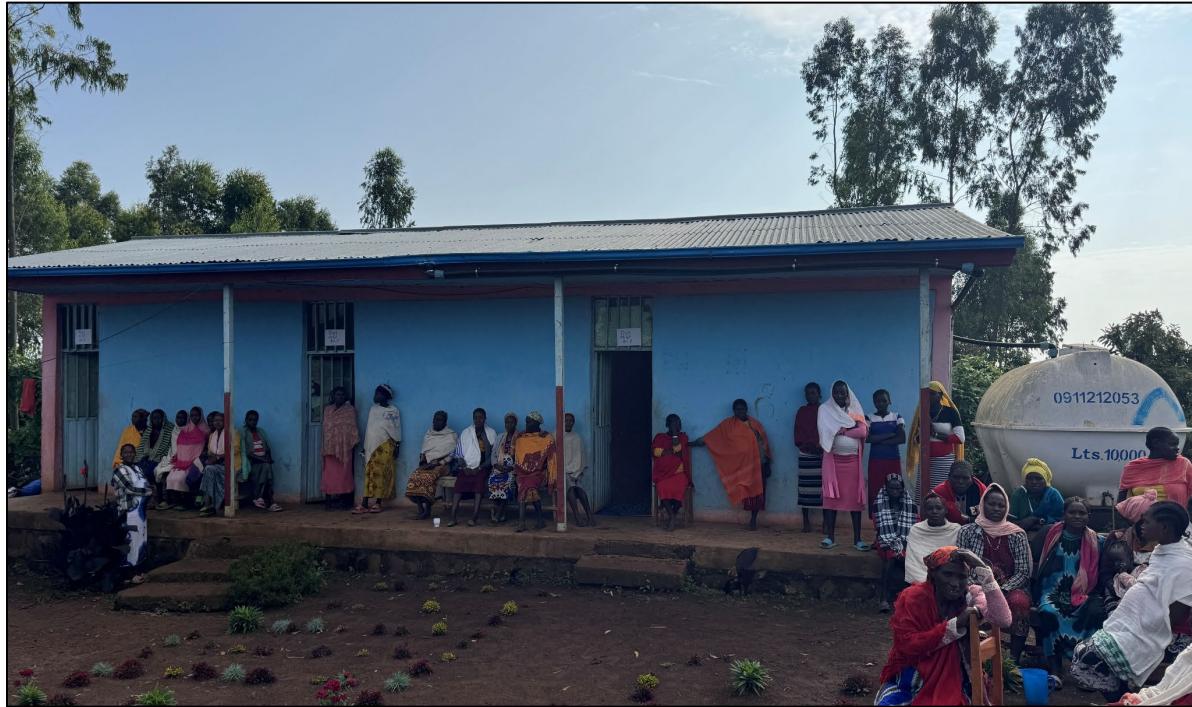
During the 2025 assessment, it was noted that there is an existing 5,000 L tank that is collecting a small amount of rainwater runoff in an inefficient manner from the eastern half of the east building of the health center, north of the MWA building. This tank appears to have been originally intended to collect rainwater for use at the MWA latrines and showers, but the piping had all been disconnected. WEFTA and VHP have agreed to hire Markos to create a new rainwater catchment system for this building similar to those he constructed and repaired at the other buildings last year. He will also repair, reconnect, and/or install piping and fixtures as

Figure 14: MWA at Chebera Health Center with Rainwater Catchment System

necessary to bring water to the MWA shower and construct a new handwashing station outside of the MWA latrines.

Chebera Health Center	Limited access to water. RWH system on east building nonfunctional.	Install new gutters, faces, and pipes to 5k L tank. Repair pipes around tank and run to MWA latrine / shower.	WEFTA/VHP/Markos to perform.
Bachuma Hospital	Current systems runs off Solar system and is turned on manually.	Plan for dedicated system.	VHP/STT to review
Siz Health Center	Currently no water at the center. The 10k L tank on pedestal and the front of the building was disconnected to allow for new pedestal curing. Even when online, neither this nor the 10k L tank on pedestal in the rear has sufficient head to supply water to the interior.	No outside action proposed. Woreda said that it would take the lead in implementing all fixes at the Health Center including on the water system.	Woreda to fix water system. WEFTA/VHP to assess next year.
Siz Hospital	Minor leaks in storage tanks and distribution lines.	No outside action proposed. Hospital/Woreda should address line fixes.	WEFTA/VHP to assess next year.

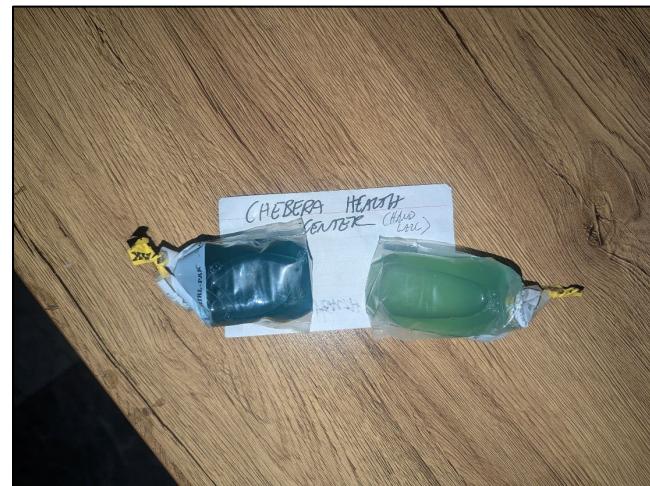
Water samples were taken from the tap stand located next to the primary health center rainwater storage tank and the hand-dug well for biological testing. After the appropriate incubation period, both samples were visibly blue/blue-green which means that they are positive for both E. Coli and Total Coliform bacteria. Though it was not tested, it is very likely that the water in the MWA storage tank also contains similar bacteria. As there are no alternative sources of water and few sustainable treatment options, it is recommended that the people at the health center and the women at the MWA boil any water from the tap stands for a minimum of 3 minutes prior to consumption. This is admittedly a temporary solution, and a more sustainable, long-term solution should be developed by WEFTA, VHP, and in-country partners.

Figure 15: Blue-Green color of Chebera water samples indicating presence of E. Coli and Total Coliform

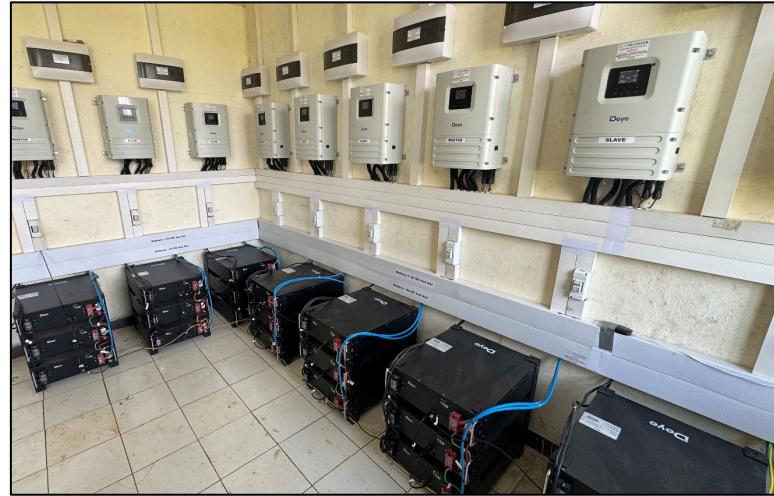
The Siz Hospital has two solar systems: one 16.5 kW system that powers the submersible pump and a new 58.9 kW system that supplies power to the hospital. Because both systems were installed recently and are in good repair, no issues were discovered during this year's assessment besides the need for the panels to be cleaned regularly. Also, during this site visit, STT completed installing the remote monitoring components to the hospital solar system, so this, like Bachuma Hospital, can now be monitored by STT personnel via a phone-based application from their office in Addis Ababa.

Figure 17: Siz Hospital Solar System Installed in 2025

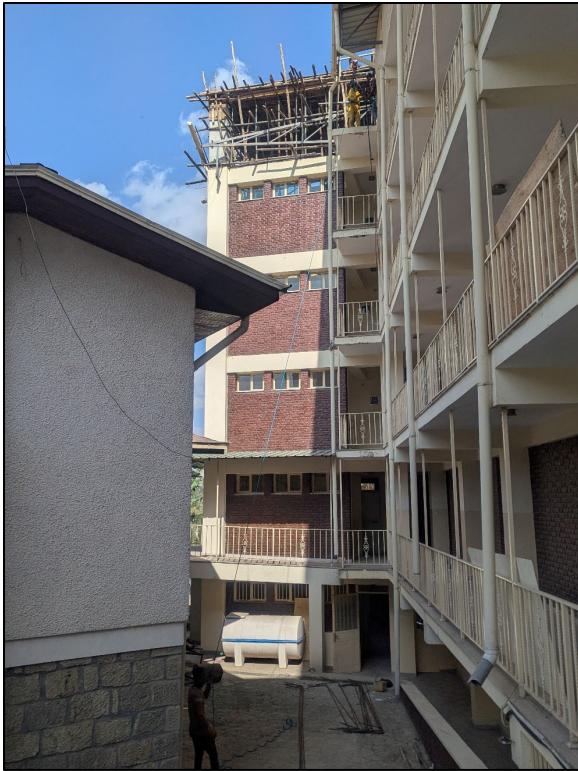
A small St. Catherine's facility has been present in the Nifas Silk Lafto Sub-City of Addis Ababa for decades. Circa 2020, construction began on a large, new house with 28 bedrooms and a chapel that will serve as a retreat for church members as well as a novitiate for prospective nuns and housing for the elderly. In 2021, DCIPS requested help from WEFTA to develop a water project at St. Catherine's that would serve not only the house but also provide water to the surrounding community. In the intervening years, the project was scaled back to only supply water to the compound.

Figure 20: Construction of Water Tower atop New Building

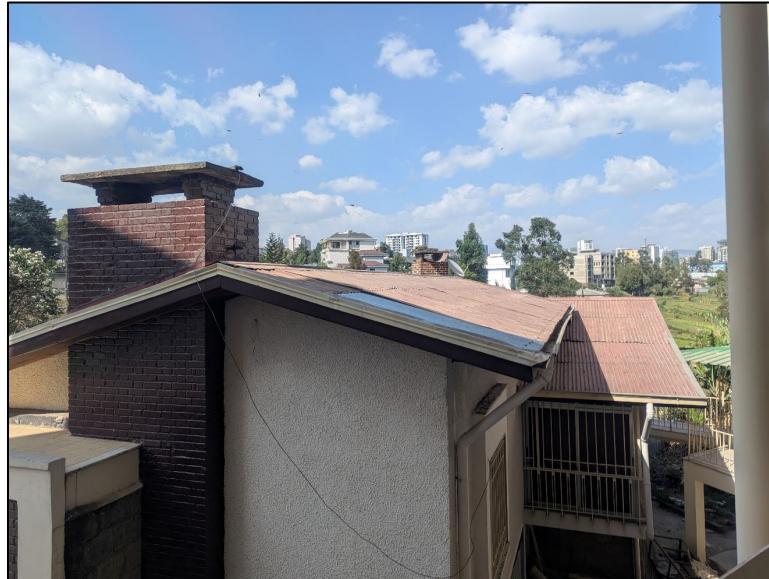
As the new well is highly beneficial to St. Catherine's, there is one major issue that could severely impact the function and longevity of the pumping system. The pump is currently hooked up to the city's power grid and is highly unreliable. According to Sister Aster, there is only enough power to operate the pump in the middle of the night when the nearby industrial shops are quiet. Currently, the pump is only turned on for a few hours 2-3 times a week to fill up the ground-level tanks. This is a workable solution at the moment but will not be sustainable once the housing project is complete and St. Catherine's starts receiving regular visitors. The sisters have asked DCIPS for funds to install solar panels on the east-facing roof of the old building to supply power to the pump, but they have not yet heard back regarding this request.

Figure 21: Potential Location of Solar Panels for the Pump

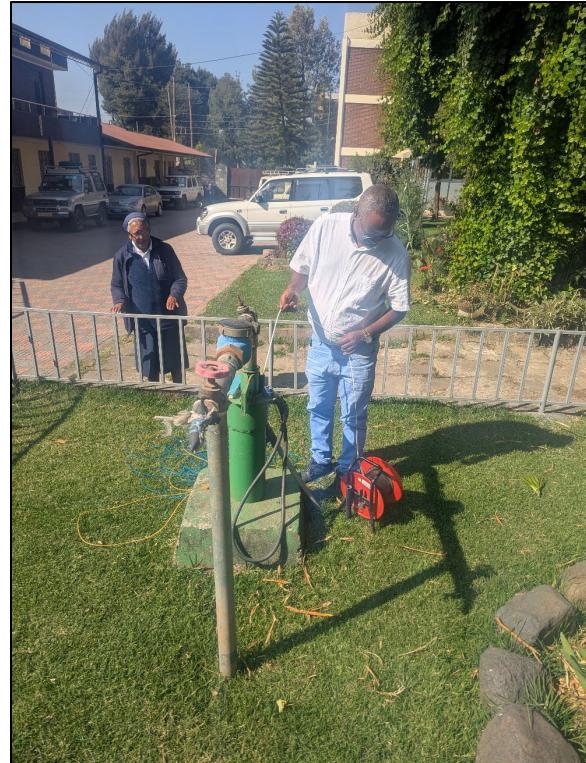
Lazarist Catholic School is a co-ed school very close to St. Mary's that has approximately 1,600 students and 130 faculty. Unfortunately, Lazarist School does not have the water security that is present now at St. Mary's. The school has an old well and pump that is estimated to supply water at roughly 0.35 lps, which means that it takes up to 8 hours to fill only a 10,000 L tank. When Peter visited Lazarist in May 2025, he talked with the Brothers and school officials about potentially helping facilitate a water project at the school. Dr. Tilahun was hired by WEFTA to study the hydrogeology of the area of Lazarist School and recommend solutions. This report was provided to WEFTA and Lazarist School in September 2025. It recommends the construction of a new borehole to a depth of 250 meters (+/- 15%) which is estimated to cost

Figure 22: Dr. Tilahun measuring the Depth to Water while Sister Aster watches closely.

approximately \$43,000. The total cost of the school system is not known at this time as additional assessments are needed to determine what existing infrastructure can be reused and what must be upgraded or replaced. At the very least, a new pump and an elevated water tank will be needed along with an increase in the number of tap stands and handwashing stations at the school. The next steps are for the Brothers to find a potential funding source for the project.

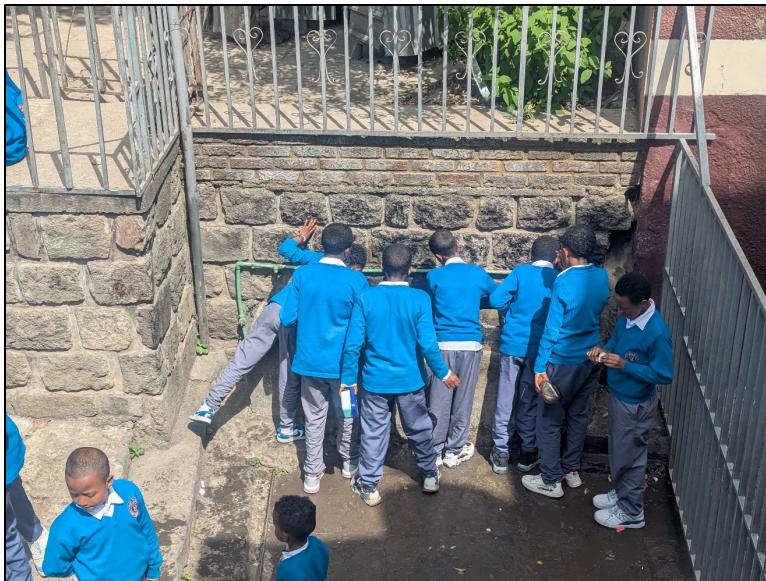
Figure 23: Boys lining up to use the limited taps at Lazarist School
