## **WEFTA Trip Report**

San Miguelito, El Salvador

## San Miguelito Water System Project Scoping

# Preliminary Engineering Report San Miguelito, El Salvador

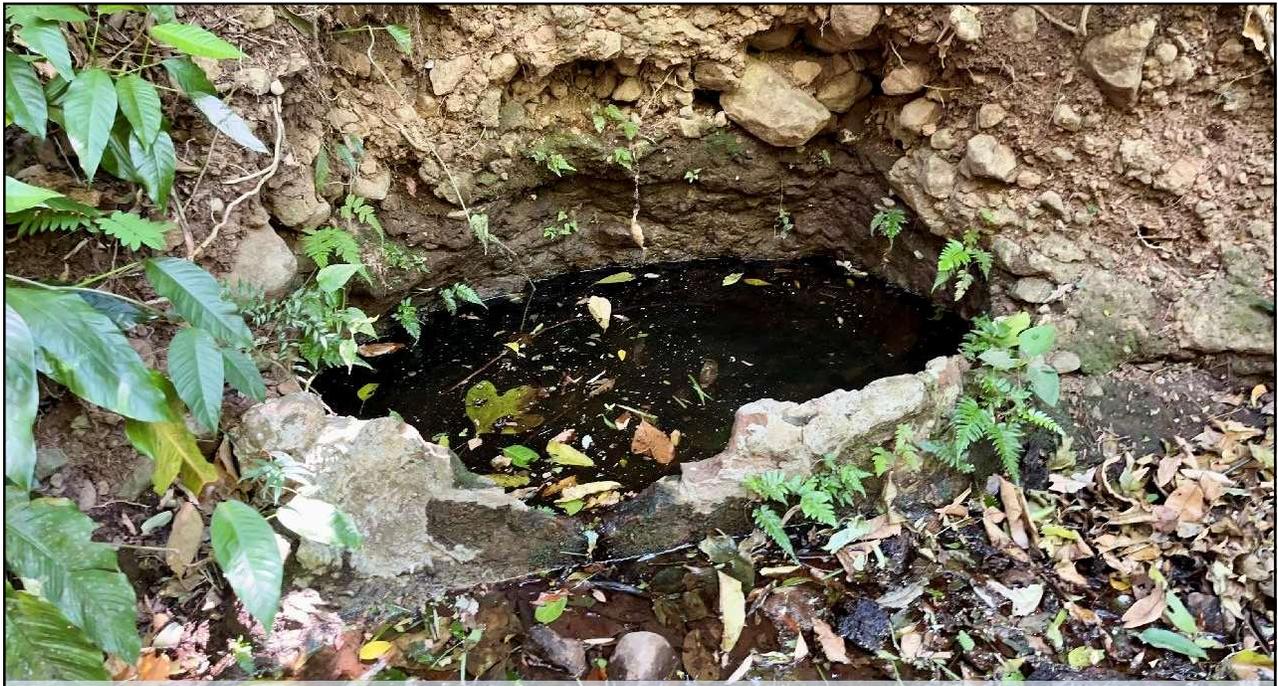
Typical unprotected spring still used by community members during dry season.

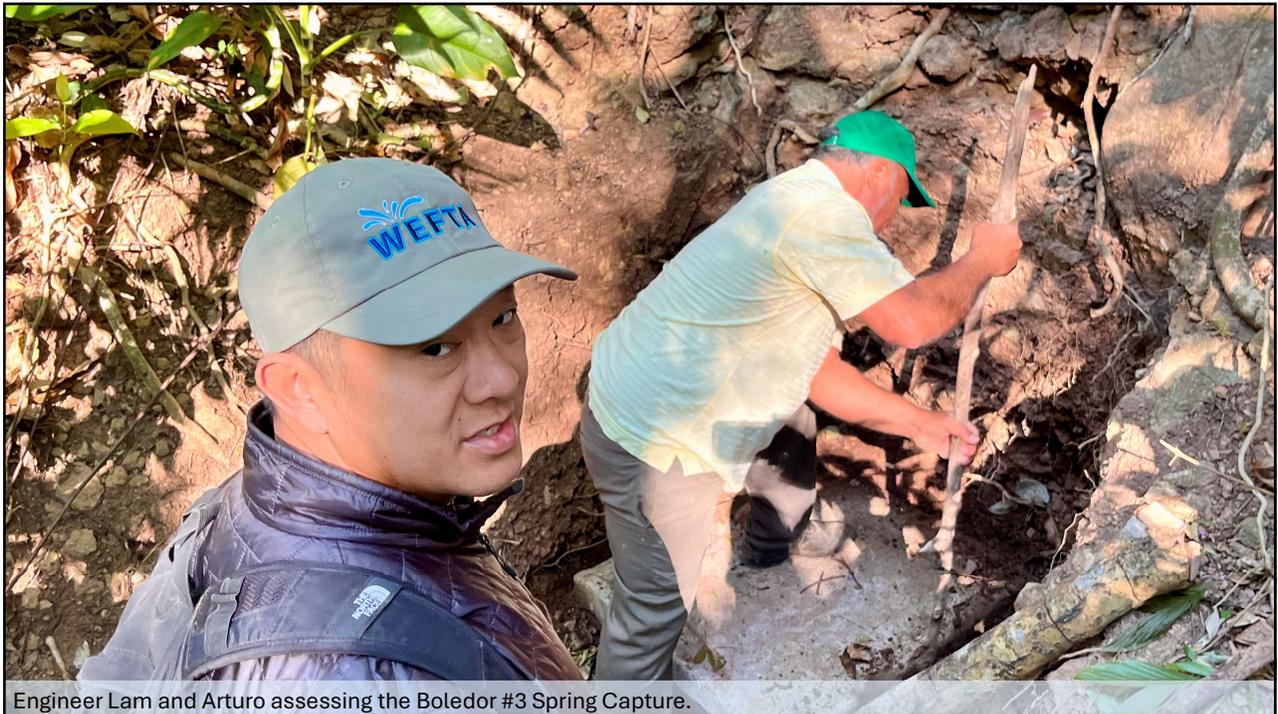
Engineer Lam and Arturo assessing the Boledor #3 Spring Capture.

At Boledor 2 and Boledor 3, signs of root intrusion were observed within or adjacent to the spring catchment structures. Root intrusion may reduce effective flow capture and could lead to further degradation of the catchment structures over time if not addressed.

It is recommended that all spring infiltration galleries and catchment structures within the San Miguelito water system be rehabilitated to improve effective flow capture and reduce bypass losses. Priority should be given to Boledor 1 and Boledor 2, as these sources support the Boledor sub-system, which serves the largest number of users and these two springs would benefit the most from rehabilitation.

Field observations identified root intrusion, partial blockages, and gravel pack clogging at multiple spring sources. These conditions reduce hydraulic efficiency and divert water around, rather than into, the catchment structures.

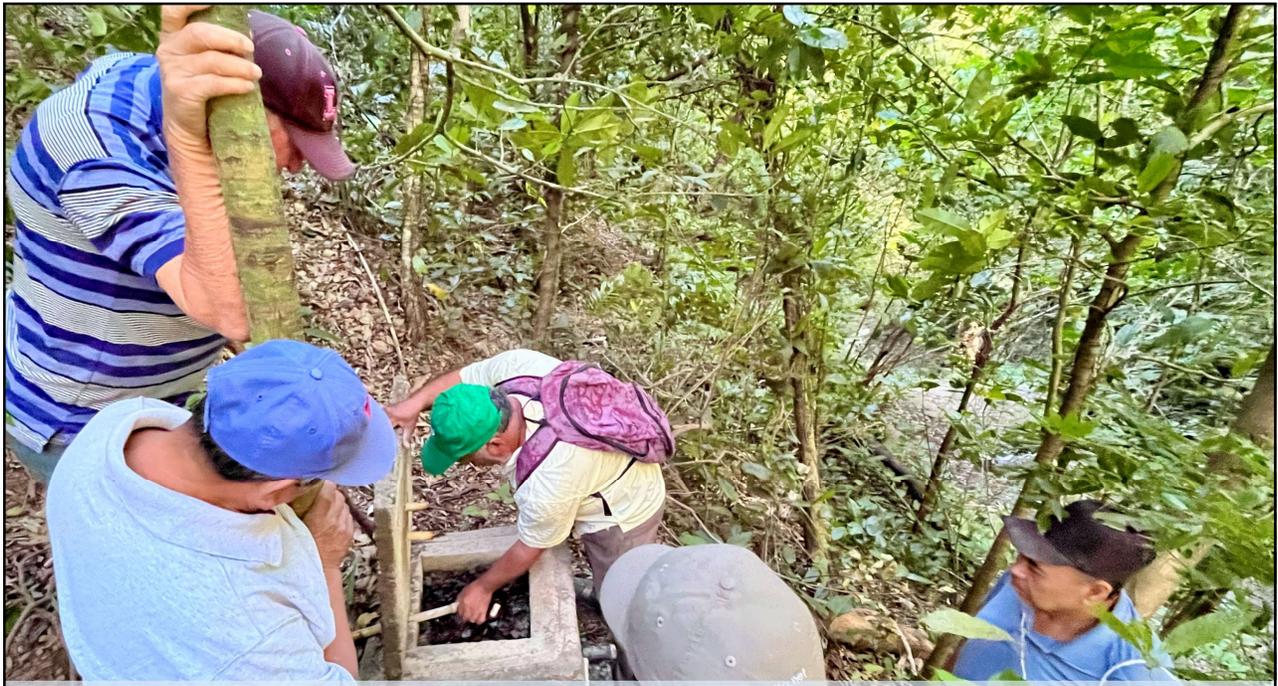
WEFTA Team and water committee members assessing Boledor #2 Spring Capture.

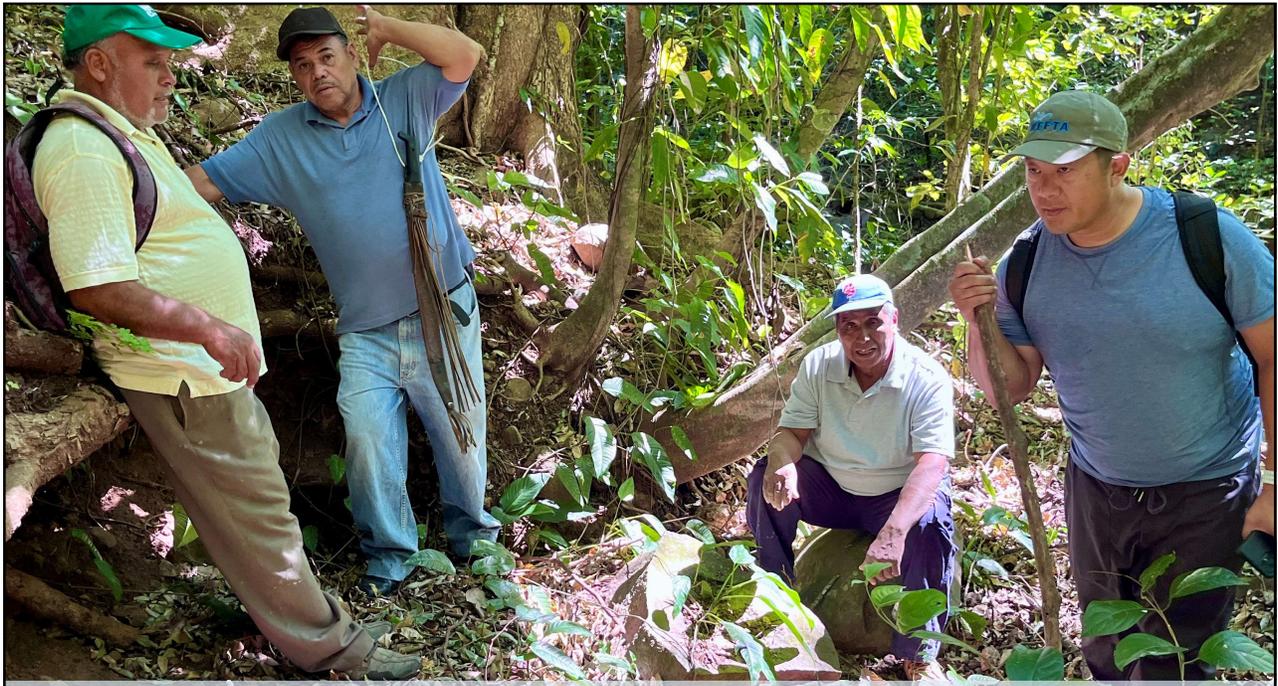
WEFTA Team and water committee discussing the improvements to be made at the El Cuche Spring Capture.

The El Cucho sub-system is supplied by a single spring source located within El Imposible National Park. Spring flow was measured by WEFTA volunteers at approximately 8.5 liters per minute (L/min), equivalent to approximately 12,240 liters per day (L/day) at the time of inspection.

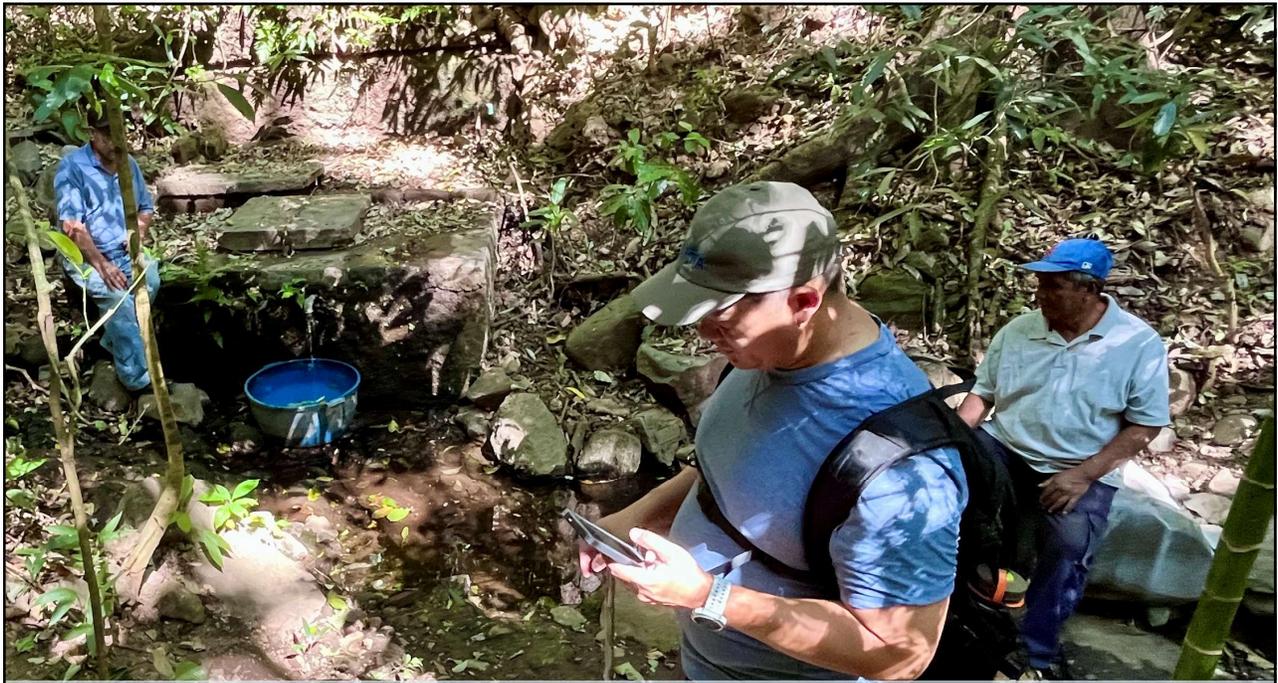
Engineer Lam taking GPS data points at the El Mango Spring Capture.

The Mango sub-system is supplied by a single spring source located at approximately 2,450 ft-AMSL. The observed spring flow was approximately 2.4 liters per minute (L/min), equivalent to approximately 3,456 liters per day (L/day) at the time of inspection.

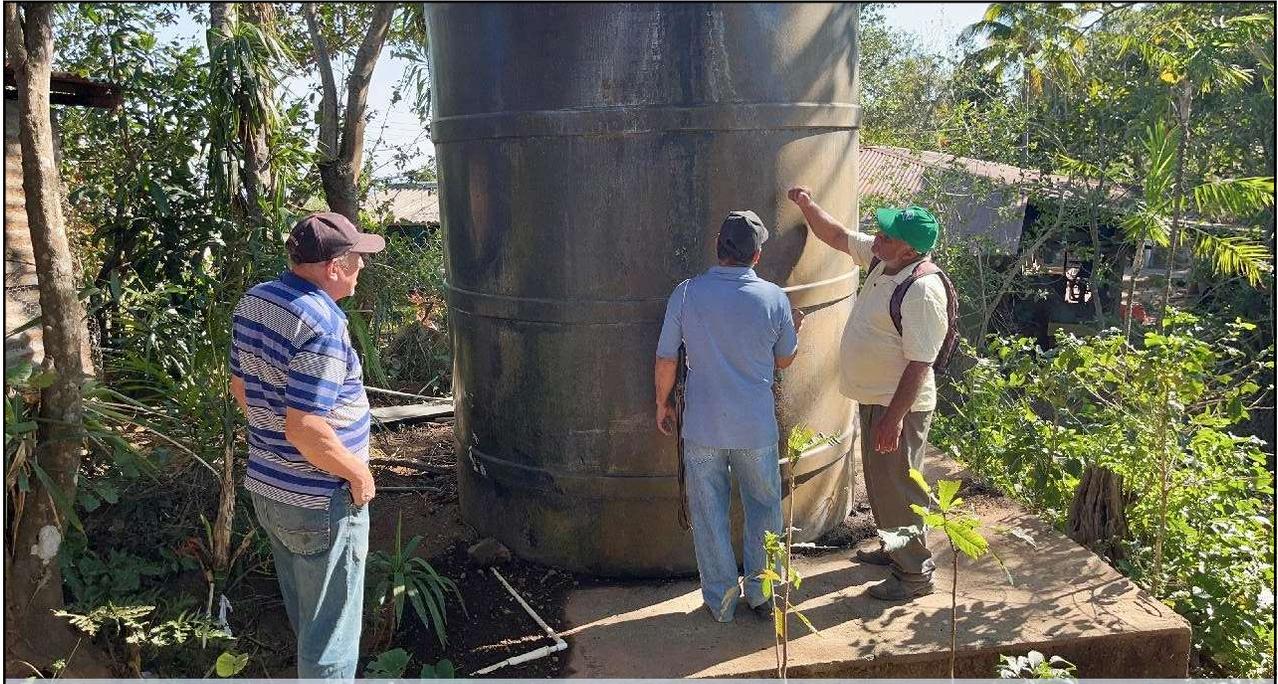
San Miguelito Water Committee checking water levels in the Mariogil water storage tank.

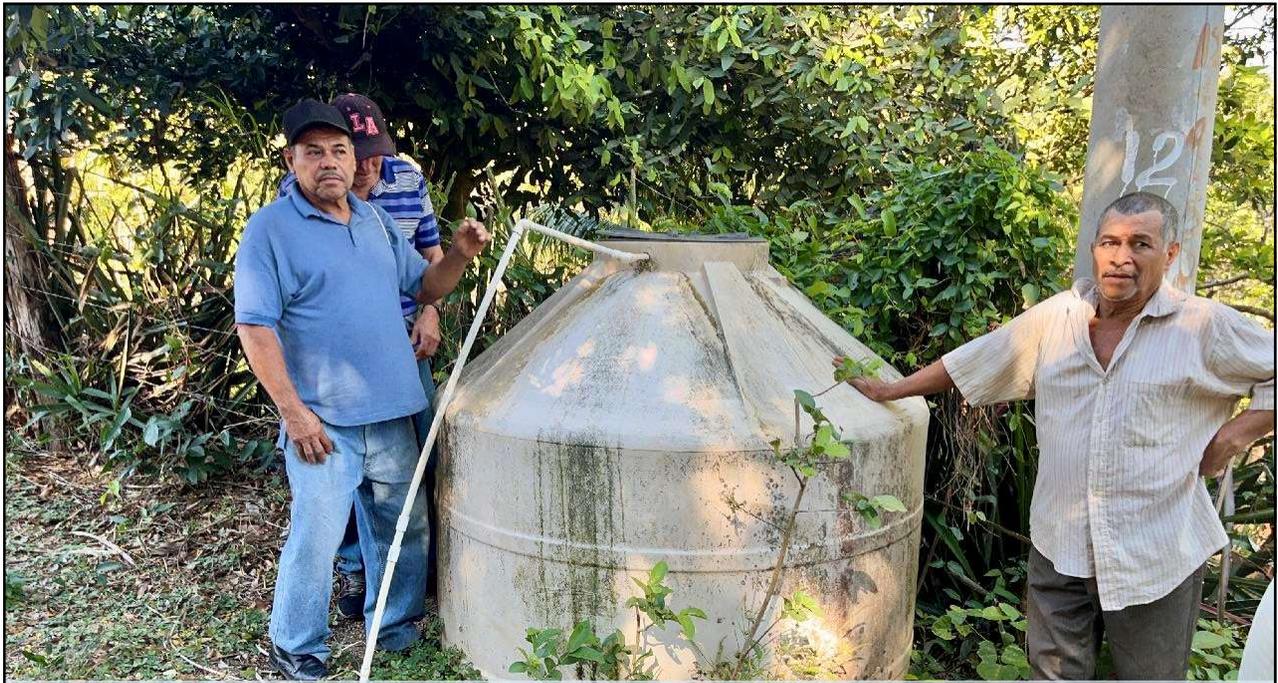
Water committee and community member assessing the status of the El Cucho water storage tank.

Water from the spring is conveyed via an approximately 3,150-foot transmission line to a storage tank with an estimated capacity of approximately 2,280 liters. The spring box is located at an elevation of

It is recommended that a second 1000-liter polyethylene storage tank be purchased and installed for the El Cucho sub-system to improve operational flexibility and redundancy.

The new tank should be constructed at the same ground elevation and hydraulic elevation as the existing tank, if feasible, to maintain consistent pressure conditions and simplify operations and maintenance.

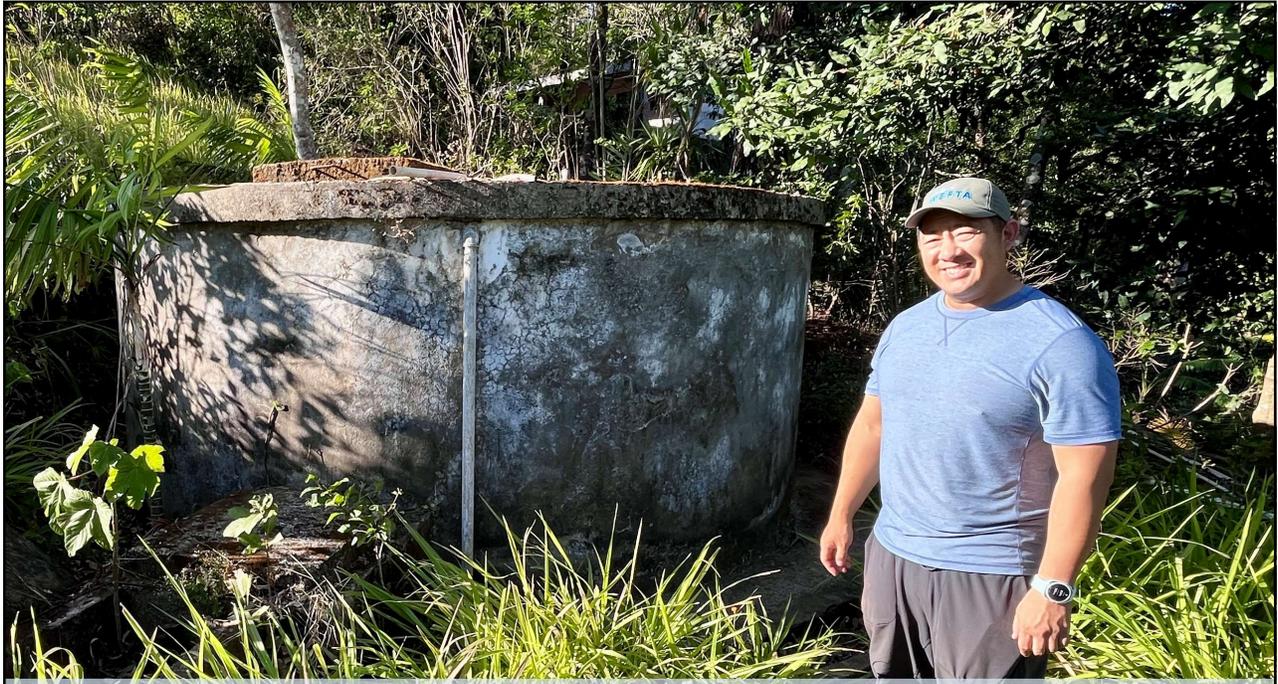
Engineer Lam assessing the status of the Boledor Water Storage Tank #1.

Localized deterioration and spalling of concrete were observed at the upper rim of the Boledor 1 storage tank. While this condition does not currently appear to compromise tank watertightness or structural performance, continued deterioration could result in falling concrete debris and accelerated degradation if left unaddressed.

Localized concrete repairs should be performed at the upper rim and top edge of the Boledor 1 storage tank, where spalling and deterioration were observed during the site visit.

Repairs should include:

- Removal of all loose and unsound concrete to expose sound substrate.
- Cleaning of exposed surfaces and any exposed reinforcement.
- Application of cementitious or polymer-modified bonding agents.
- Placement of non-shrink cementitious repair mortar suitable for potable water infrastructure.
- Use of wire mesh or fiberglass mesh where repair depth exceeds approximately 1.5–2 inches.
- Proper curing to minimize shrinkage cracking.

Anchors or dowels are not anticipated unless more extensive deterioration is encountered.

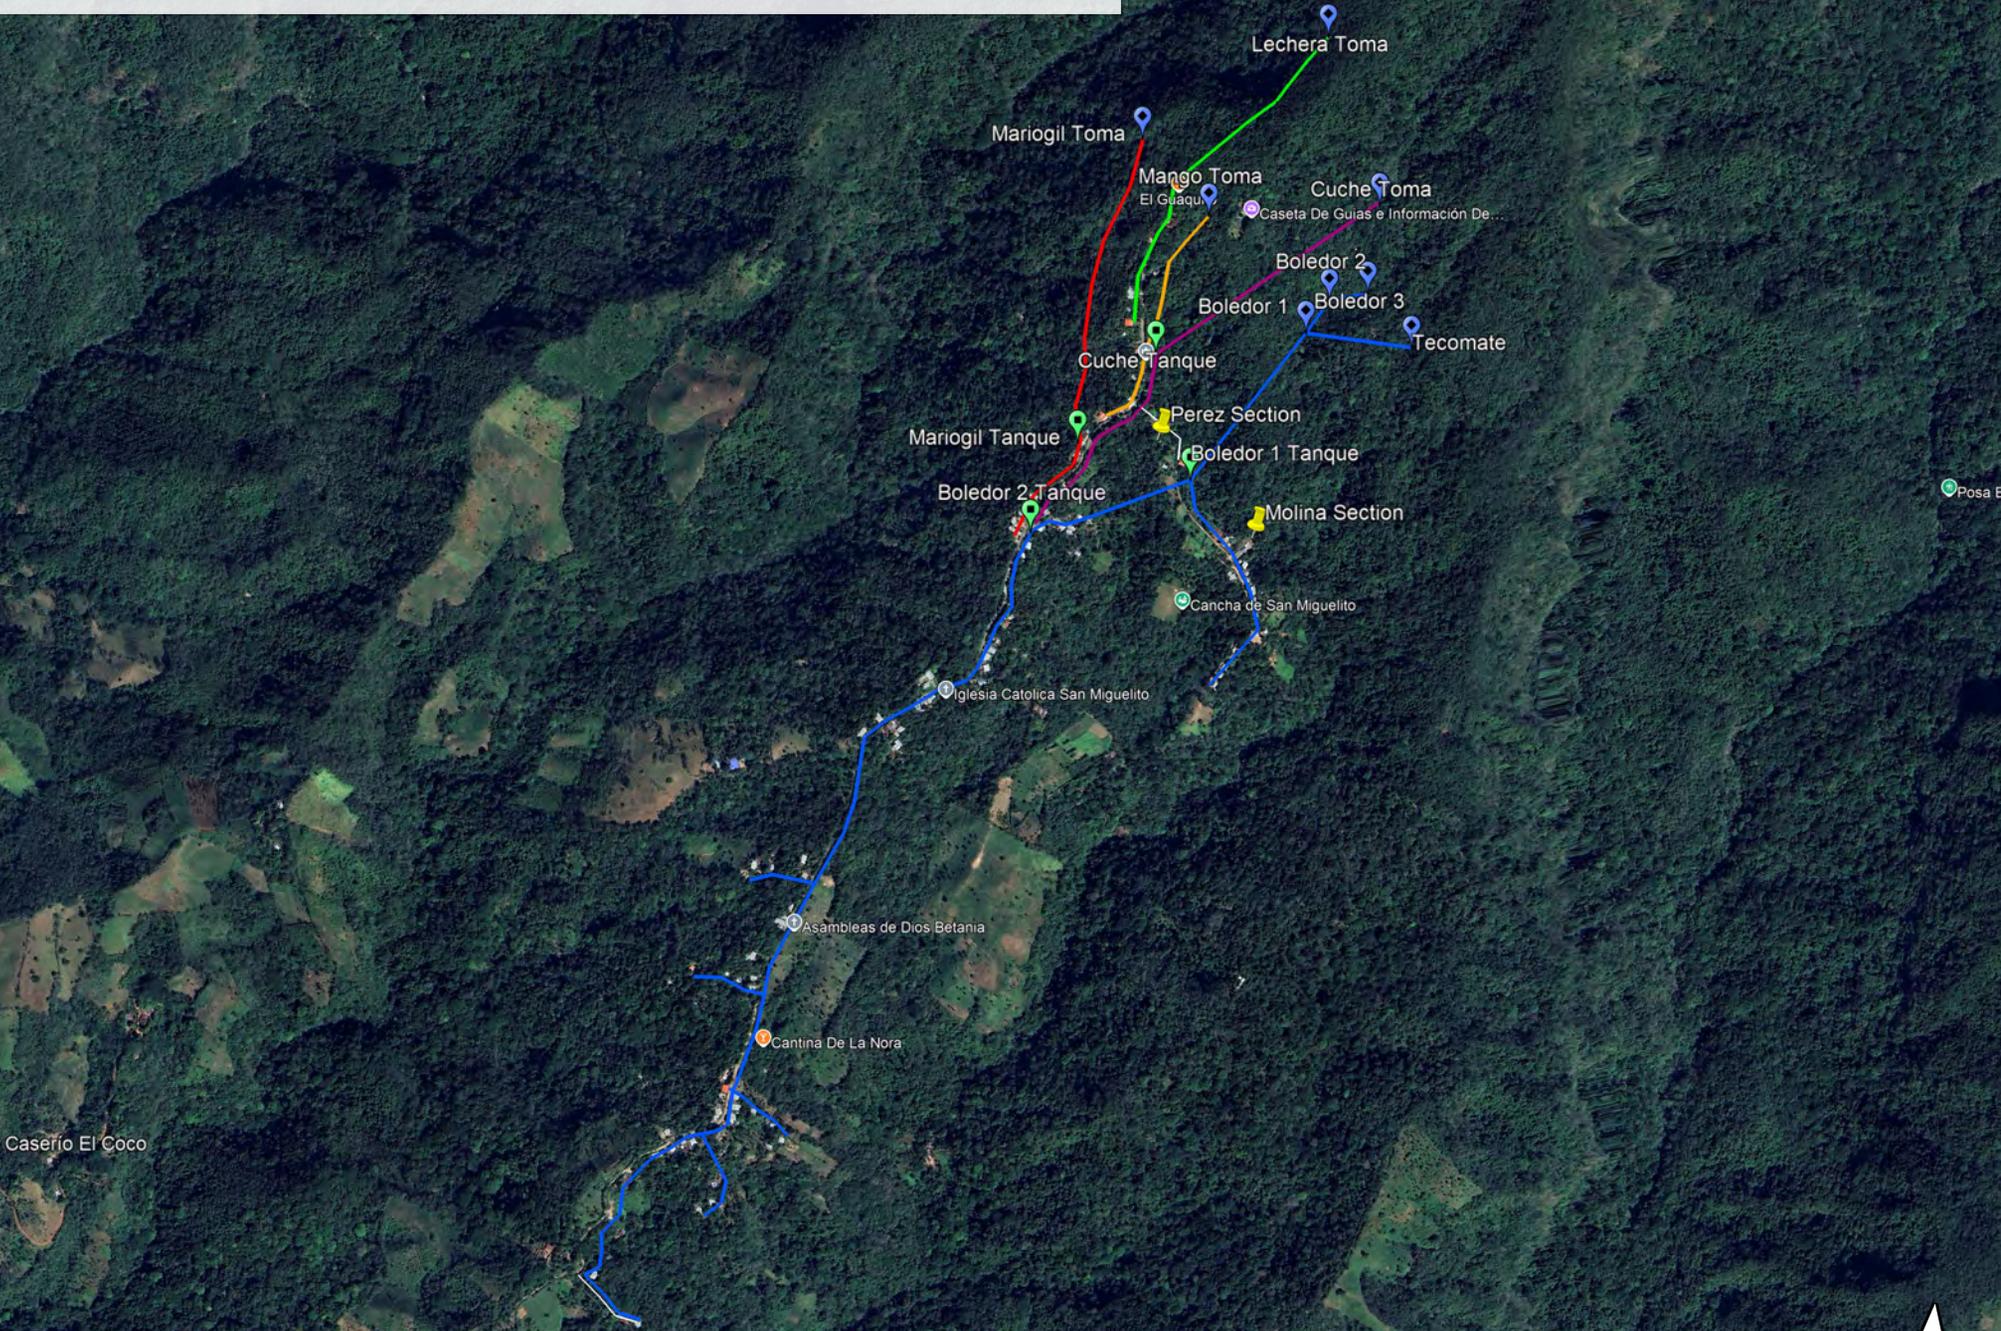
Map of Water System Attributes

The San Miguelito water system consists of five (5) independent sub-systems: Boledor, El Cucho, La Lechera, Mango, and Mariogil. Each sub-system operates with its own source(s), conveyance infrastructure, storage (where available), and distribution system. As a result, system capacity, redundancy, and operational reliability vary significantly between service areas. Tank and source elevations were acquired using mapping data provided in the project KML file (see Water System Map in Annex 1).
