COMPLETION REPORT FOR LITUHI PARISH WASH PROJECT NYASA DISTRICT COUNCIL

Name of Project:	Improvement of WASH Infrastructure
Location:	Nyasa DC, Ruvuma Region
Subject:	Completion Project Report – Phase 1
Reporting Date:	November 30 th , 2025
Name of Client:	Catholic Diocese of Mbinga
Implementing Agent	SANITATION AND WATER ACTION (SAWA) www.sawatanzania.org
Funding Agent	WEFTA; www.wefta.net
Project Cost	\$ 126,305.20

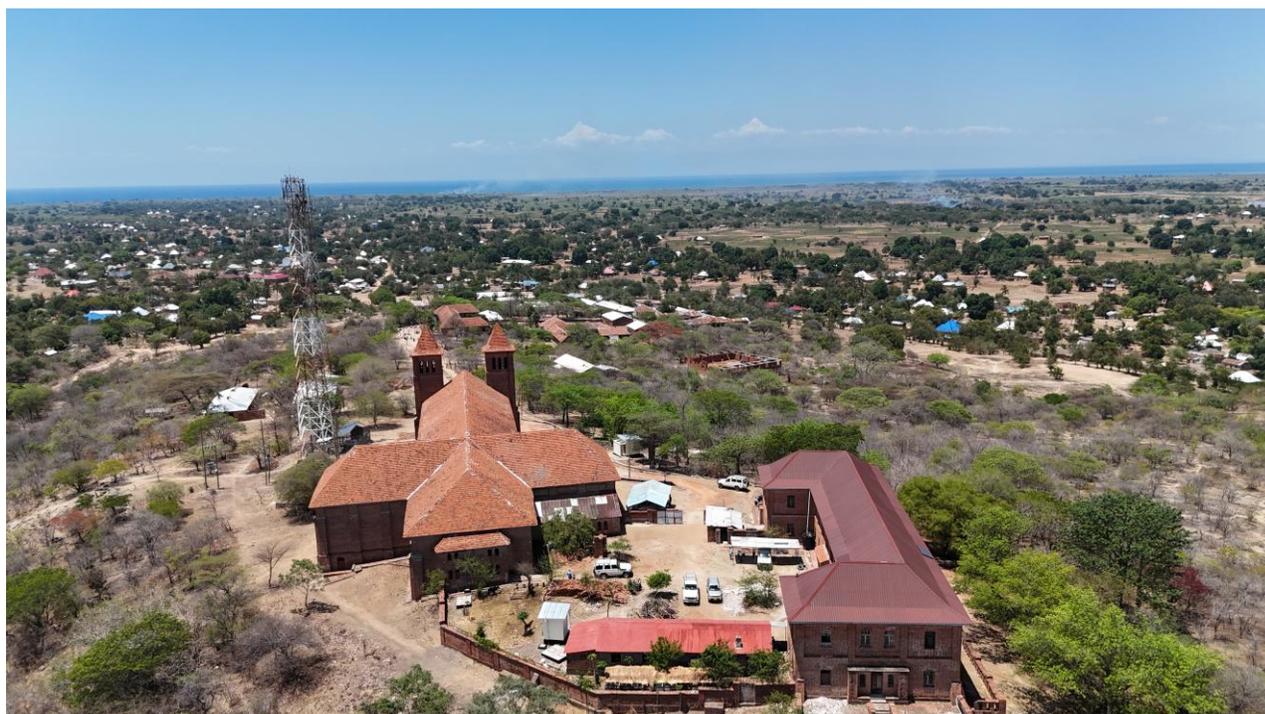
On 27th of November 2025, Kihuru village in Lituhi Ward - Nyasa DC, photo shows constructed infrastructures at the Lituhi Parish. Photo captured by Daniel Masubo

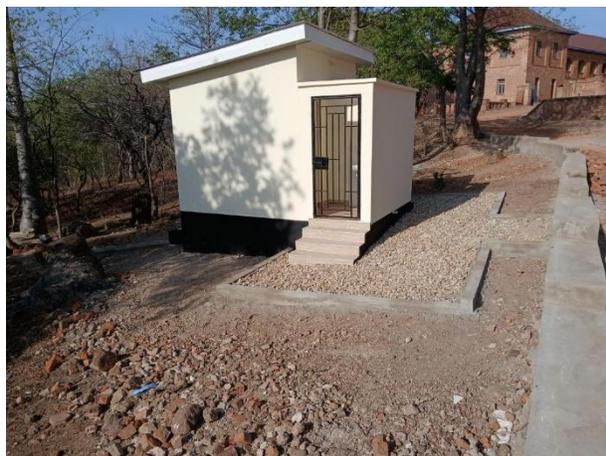
Constructed toilet block for congregation

The congregation toilet block consists of two stances, one designated for males and the other for females, and is intended to serve worshippers attending church services and other religious gatherings. The facility was constructed with properly installed clean water and sewage systems to ensure safe and effective use. Each stance is equipped with a handwashing basin to promote good hygiene practices. In addition, wastewater chambers, a septic tank, and a soak-away pit were constructed to ensure environmentally safe disposal of wastewater and sewage.

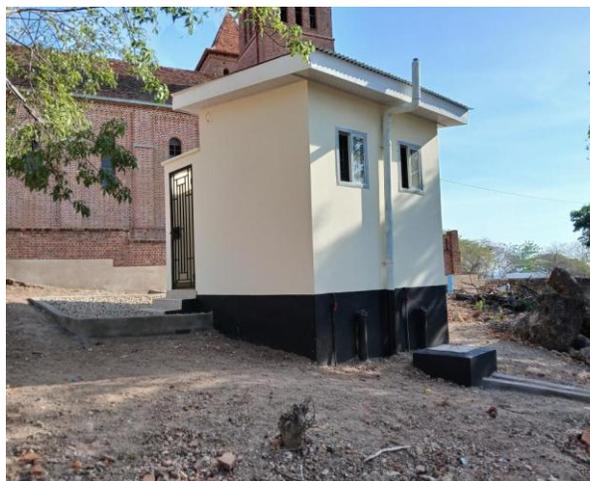
Constructed toilet block for congregation

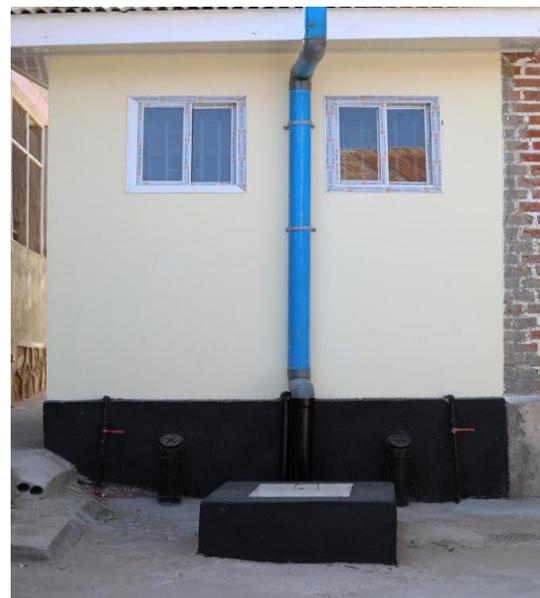
Constructed toilet block with two stances for OPD

The OPD toilet block comprises two stances (male and female) and serves outpatients visiting the health facility. The toilet block is fully equipped with all key facilities required for hygienic use, including reliable clean water supply and a functional sewage system. As part of this intervention, the project also rehabilitated four existing wastewater chambers that were previously out of use. The new toilet block was connected to the existing wastewater system, which was also

rehabilitated due to challenges such as clogged chambers, thereby restoring full functionality of the sanitation system.

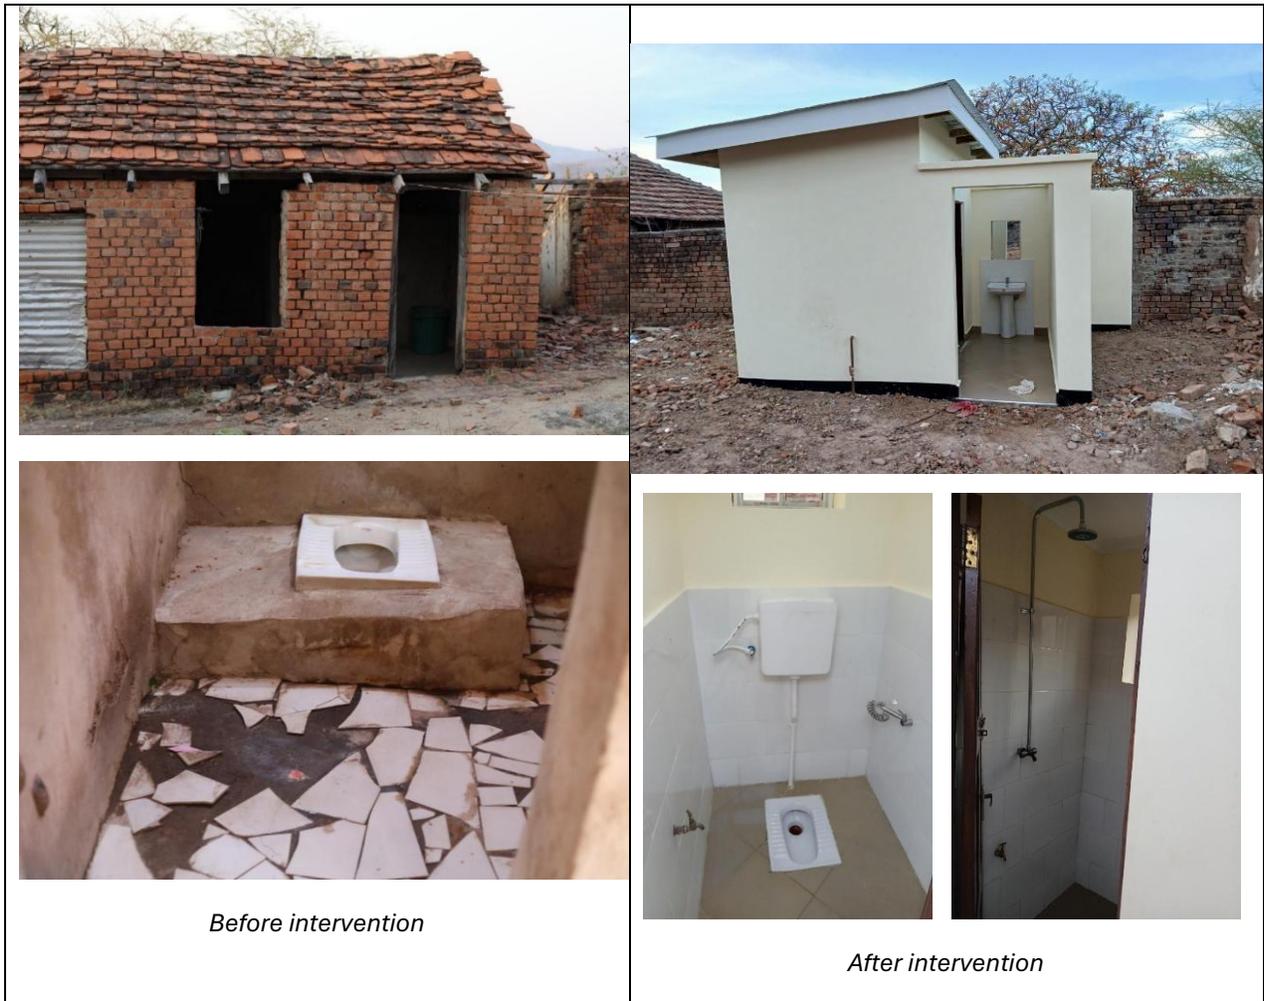
Constructed toilet for priest's house workers.

The construction of a one-stance toilet block for priests' workers was successfully completed. The activities undertaken included the construction of one stance fitted with all necessary facilities, including a handwashing basin, rehabilitation of the wastewater pit (combined septic tank and soak-away pit), and connection to a clean water supply. The completed toilet block now adequately serves all workers at the priests' house, significantly improving sanitation conditions and hygiene standards.

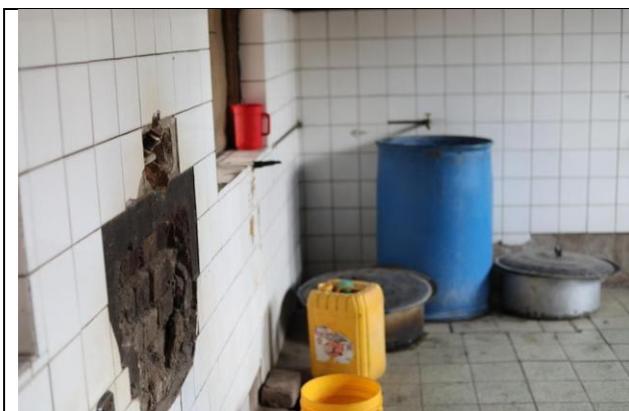
Before installation of kitchen basin
Construction and installation of kitchen basin
on progress

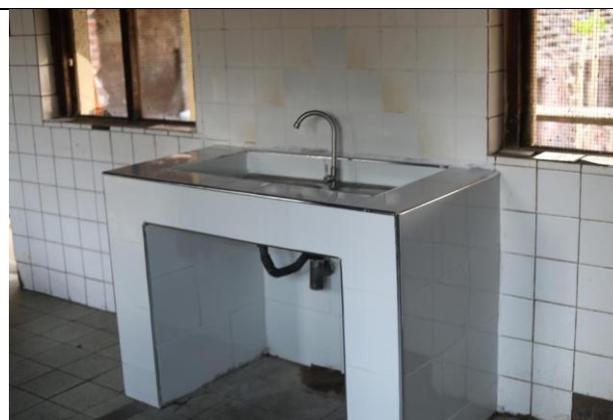
After construction and installation of kitchen
basin
Installed kitchen basin

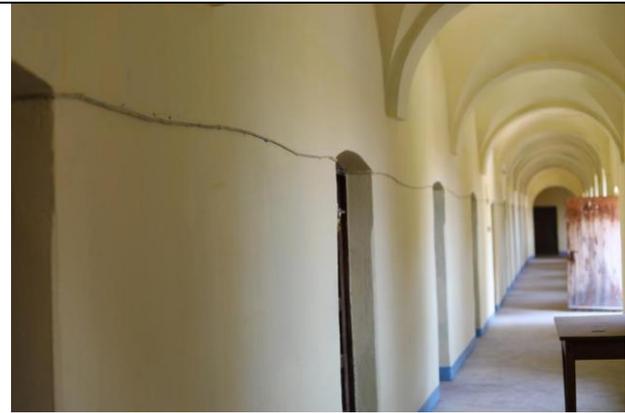
Before rehabilitation of wiring system

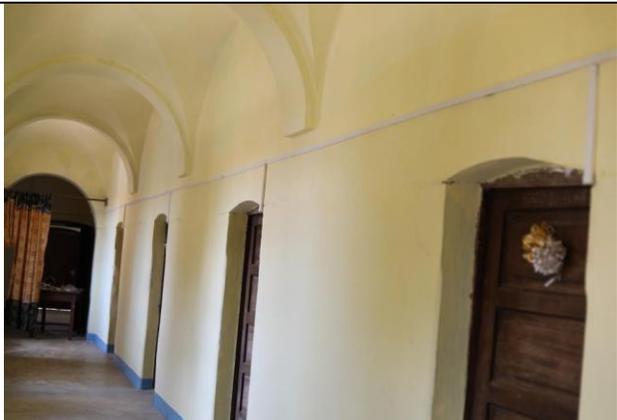
After rehabilitation

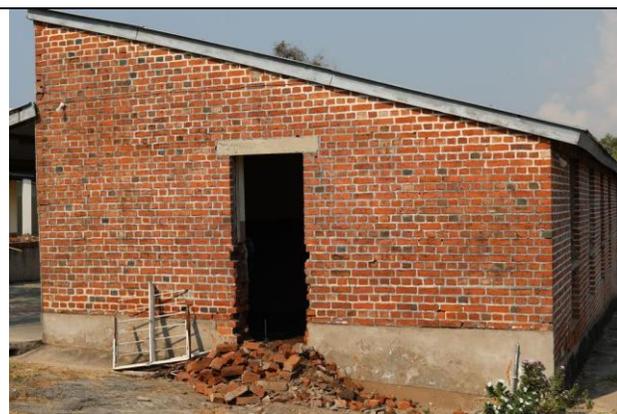
Before rehabilitation- surgery toilet block (4 stances)

The surgery ward originally had two (2) abandoned toilet stances that were no longer functional. Through collaboration between the project team and the hospital director, it was agreed to add two (2) additional stances to accommodate both genders. As a result, the surgery ward now has a total of four (4) toilet stances, comprising two (2) for females and two (2) for males. Overall, the rehabilitation and expansion of the surgery ward toilets were completed to a satisfactory standard.

In addition, waste pits, consisting of a septic tank and a soak-away pit, were successfully constructed to receive wastewater from the surgery toilet block. These pits were constructed at an approximate distance of 24 meters from the rehabilitated toilet block. Consequently, a total of five (5) inspection chambers were constructed along the drainage line to ensure easy access for inspection and maintenance in the event of blockages.

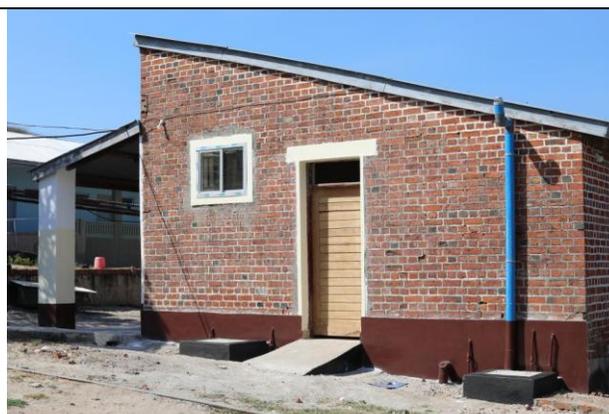
Rehabilitated toilet for surgery toilet

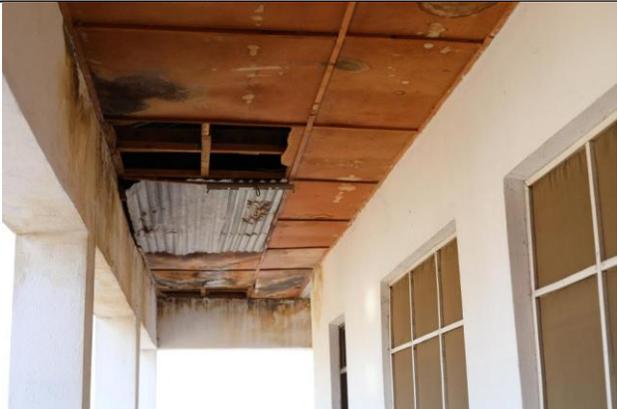
Before rehabilitation- corridor to CTC toilet block (4 stances)

The CTC toilet block currently consists of four (4) stances, of which two (2) are for public use and two (2) serve as private wards. In cooperation with the hospital administrator, the project agreed to designate the private wards specifically for priests/bishop use and hospital staff use.

The private wards were equipped with all essential facilities, including water heaters, handwashing basins, and showers. Aluminum doors were installed in the private ward toilets to enhance durability and hygiene. The priest's ward toilet was fitted with a sitting toilet pan, while the hospital staff ward was installed with a squatting pan, in accordance with user preferences.

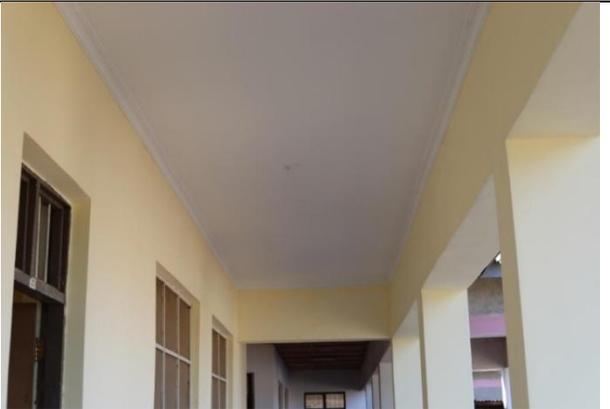
Rehabilitated latrines for CTC toilet

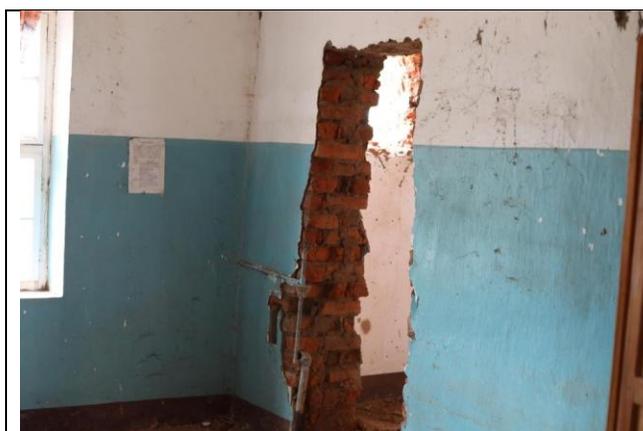
Extending toilet stance at medical office

Initially, the medical office (X-ray unit) did not have a toilet facility. SAWA, in cooperation with the hospital administrator, agreed to rehabilitate the office by partitioning the space to create one (1) toilet stance, a registration office, and a rehabilitated X-ray shooting room.

The rehabilitation works included the construction of three (3) wastewater chambers and connection of drainage pipes with a total length of 18 meters. The medical office was further improved through skimming and painting work, as well as installation of a handwashing basin.

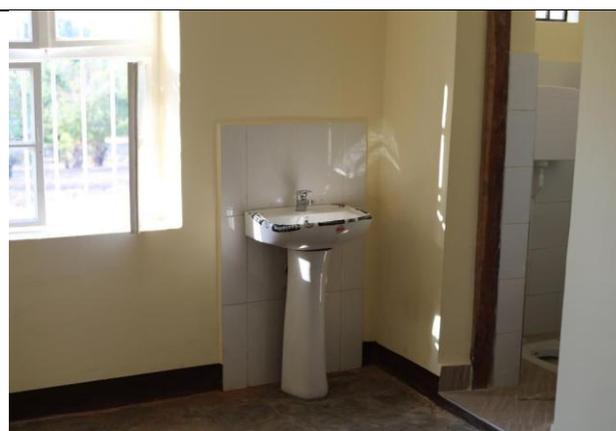
Installed hand washing basin at medical office

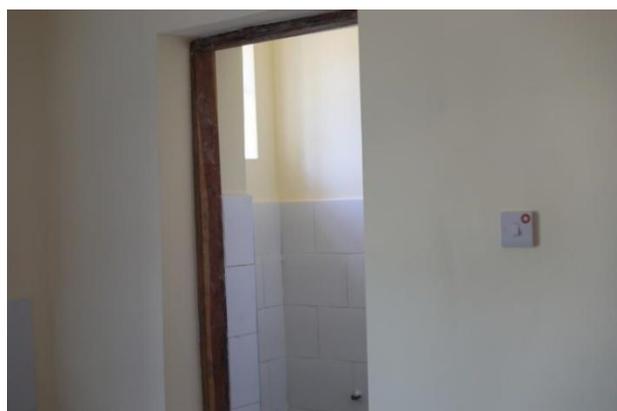
Extended toilet stance (medical office)

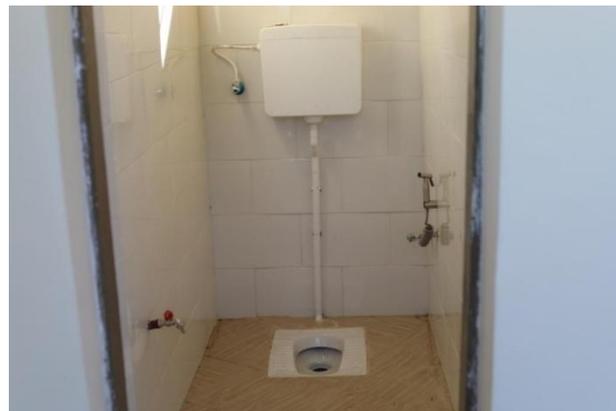
Rehabilitated medical office

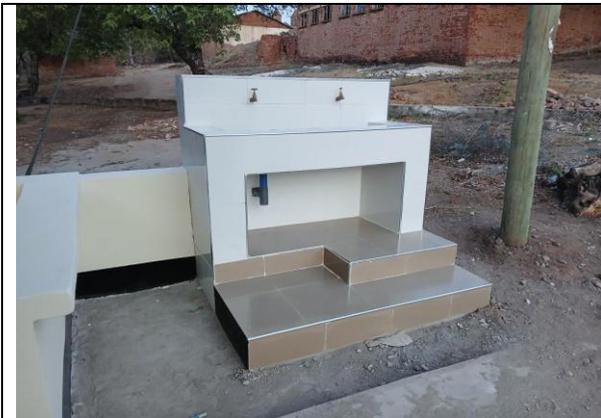
Constructed handwashing station at the reception entrance

Two (2) concrete group handwashing stations, each fitted with two taps, were constructed at the reception entrance and the emergency gate to ensure easy access to handwashing facilities and promote good hygiene practices.

The handwashing stations were designed and installed to ensure inclusivity, allowing convenient use by both children and adults.

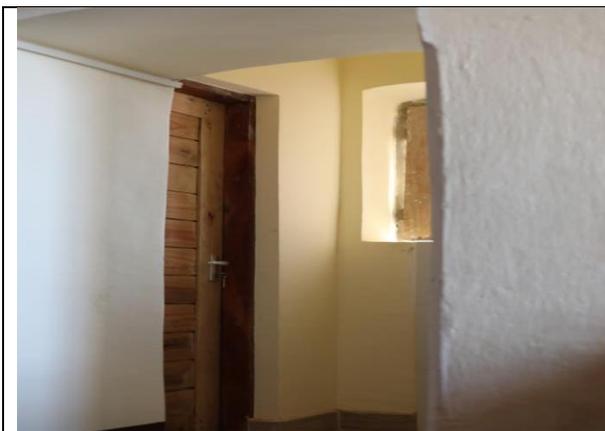
Extended toilet block at the church!

The construction of the toilet block inside the church for priests' use was successfully completed. The activities carried out included connections to clean water, installation of a handwashing basin, connection of wastewater systems to the septic tank and soak-away pit, and construction of a wastewater chamber.

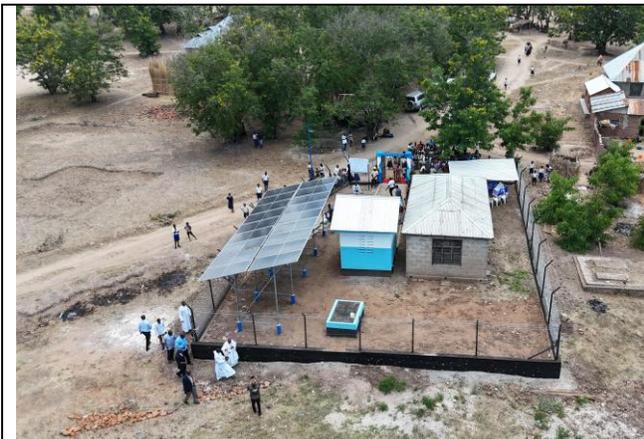
Aerial view of the power house

A powerhouse (pump house) was constructed to the required standards to safely house and protect the pumping equipment and control systems. The control panel was installed inside the powerhouse, ensuring secure and efficient system operation. In addition, the powerhouse also serves as an office space for keeping operational records used by pump attendants.

Overall, the construction quality meets the required standards, and the structure is functioning effectively for its intended purpose.

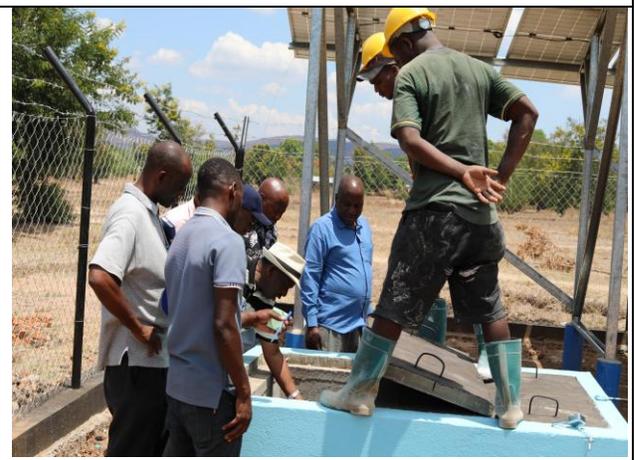
Constructed Borehole chamber

In close cooperation with Lituhi Parish, the project successfully developed a new water source (borehole) following the completion of a geophysical survey conducted to identify a suitable drilling site with high groundwater potential. Based on the survey findings, borehole drilling and construction were carried out successfully.

The borehole was drilled to a depth of 92 meters and has a yield of approximately 22,000 liters per hour, producing potable water that is sufficient to meet both the current and projected future water demands of Lituhi Parish and the surrounding community.

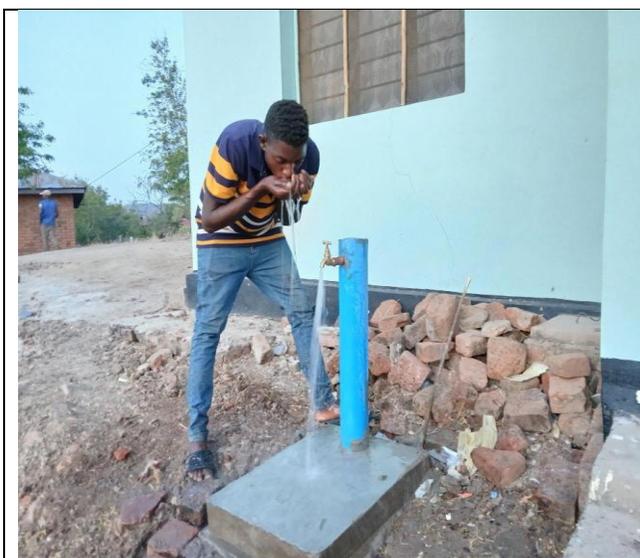
Constructed water point at Mr. Ndomba's house

- A total of 682 meters of 50 mm HDPE Class C pipes were laid from the constructed borehole to the hospital and parish storage tanks.
- The project replaced **110 meters** of the main distribution line using 50 mm HDPE Class C pipes. Previously, the distribution network consisted of a 1.5-inch steel pipe laid along the middle of the road. This pipe was severely dilapidated, characterized by frequent leakages, and was beyond repair.
- Construction of four (4) valve chambers, including two for the pumping main (new and old main lines) and two for the distribution main.
- Pipe laying and connections for a new distribution line, involving a total of 601 meters of distribution network, extending from the existing feeder line to one institution (Lituhi Primary School) and five (5) household connections.

Under this arrangement, the project contributed to distribution pipes, gate valves, and construction of water points, while beneficiaries contributed by excavating over 300 meters of trenches, purchasing water taps, and providing other necessary fittings.

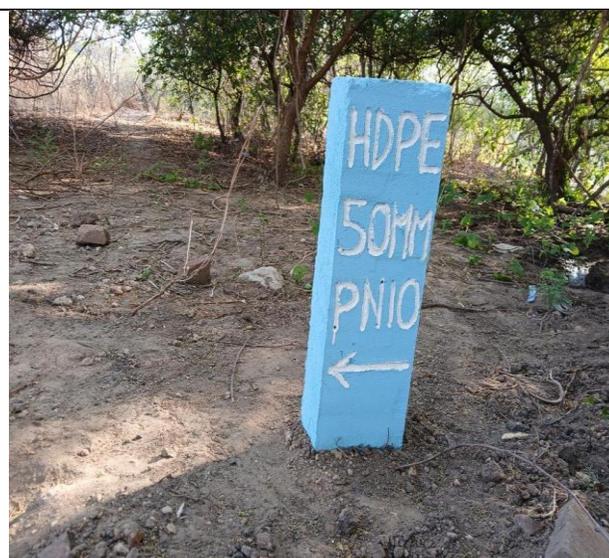
Installed pipe line marker's post

- vii. **Casting and installation of pipeline marker posts** along the entire pipe network to clearly identify the pipeline routes and minimize the risk of accidental damage.
