## IMPLEMENTATION DESCRIPTION REPORT

### "Rainwater harvesting in the community of Villa Olivença, Sao Paulo de Olivença, Amazonas, Brazil"

**Executing organization:** REDE ASSA (REDE Agua Segura e Saúde)

**Funding Organization:** WEFTA (Water Engineers for the Americas & Africa)

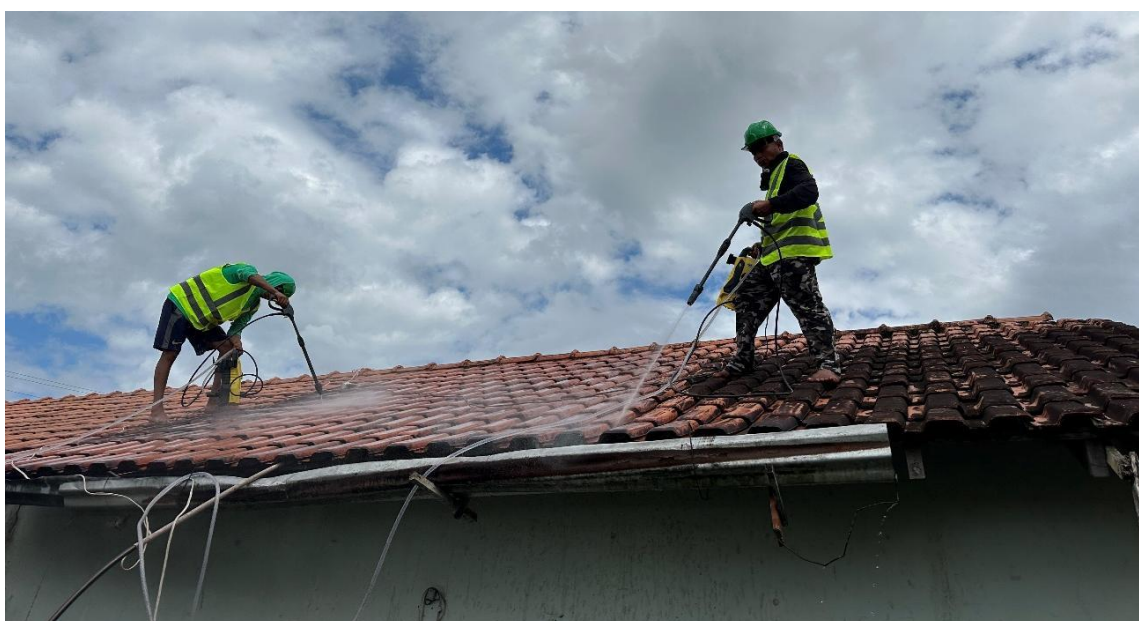
*Image 1.6. Technical staff removing softened dirt with the use of pressure washers, Villa Olivença.*

- **Phase 1: Diagnosis and Surface Preparation.** Exhaustive physical evaluation of the ceilings. On ceramic roofs, a deep wash was applied using high-pressure washers combined with industrial chemical descalers to remove biomass and aged dirt. In homes with other roofs, manual and adapted mechanical cleaning was conducted.

**Structural Support Challenge:** During pressure dirt removal, the hidden weakness of the interior structure (timbers and ribs) caused fractures in the supports, forcing the subsequent phases to be temporarily stopped.

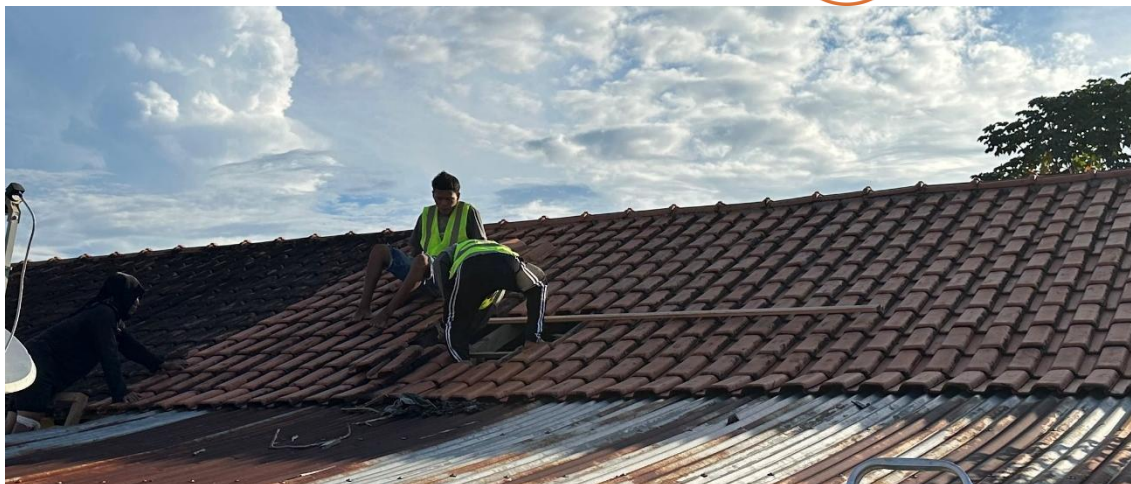
*Image 1.7. Technical staff conducting the repair on the roof structure and arranging the tiles before painting, Villa Olivença.*

- **Phase 2:** Structural Reinforcement and Conditioning. Corrective repair of carpentry when detecting collapsed or broken wood and support ribs due to the passage of time. After stabilizing the structure, two airtight layers of drunken liquid blanket were applied using specialized painting equipment with airless technology, guaranteeing a uniform and long-lasting seal.

**Mitigating Action:** A line of work oriented towards corrective carpentry was immediately integrated, reinforcing the internal structure as an essential prerequisite to ensure the support of the ceramic roof and the gutters.

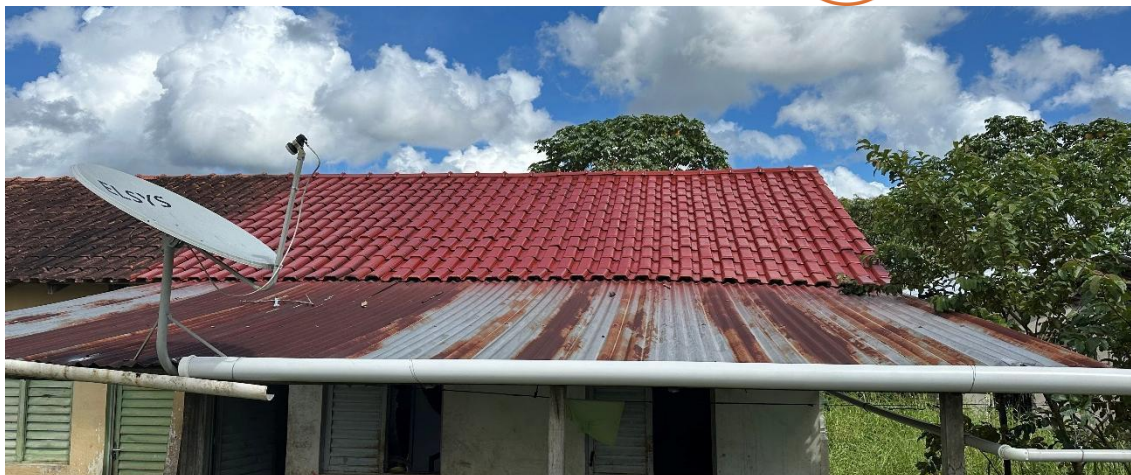
*Image 1.9. View of the roof after the 2 coats of paint with liquid blanket and comparison with the roof without maintenance, Villa Olivença.*

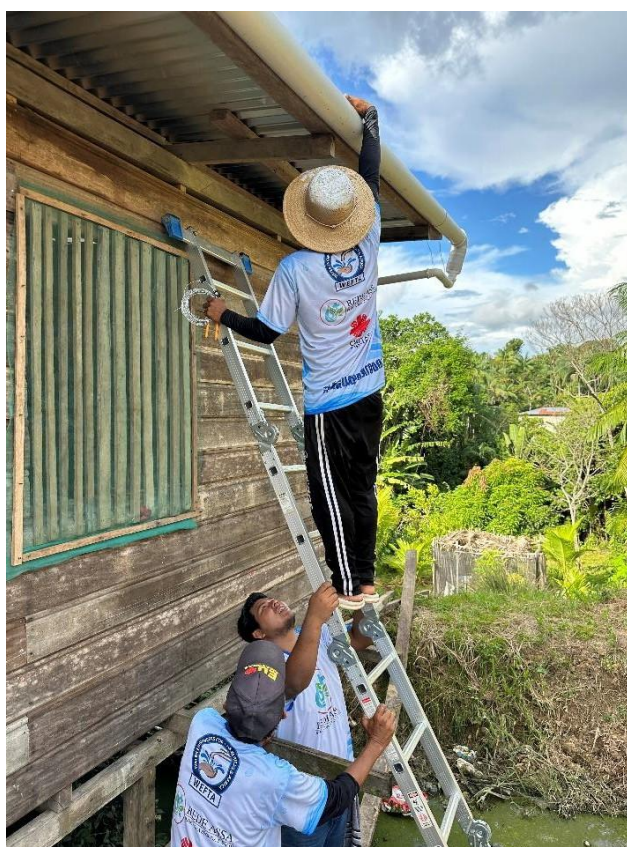
*Image 1.10. Technical staff installing the gutter on the roof of a house, Villa Olivença.*

- **Phase 3:** Installation of Capture and Storage Systems. Assembly of perimeter gutters and networks of high-strength conduction pipes. The filtering system was configured in a staggered manner: leaf retention filter, trap for the discarding of the first rains (removal of initial dust), and a coarse filtration module composed of activated carbon and gravel. The final storage was solved by means of plastic tanks of 500 liters per house.

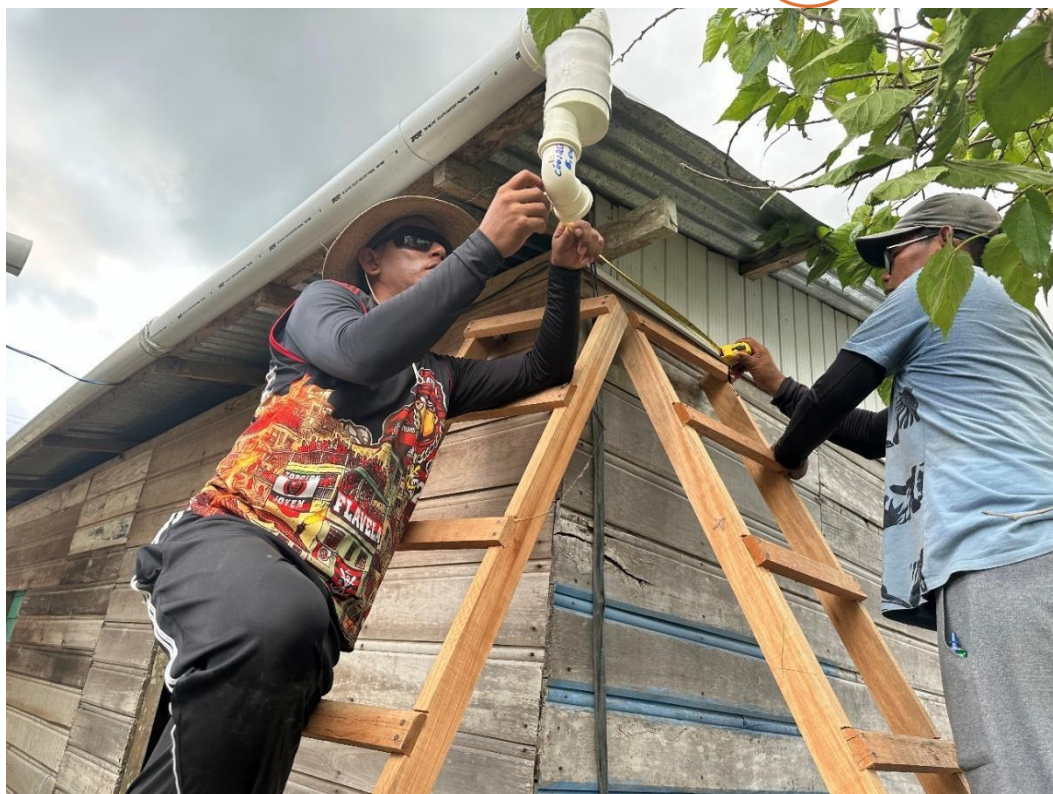
*Image 1.11. Technical personnel installing the fittings and routing pipe to the filtration system, Villa Olivença.*

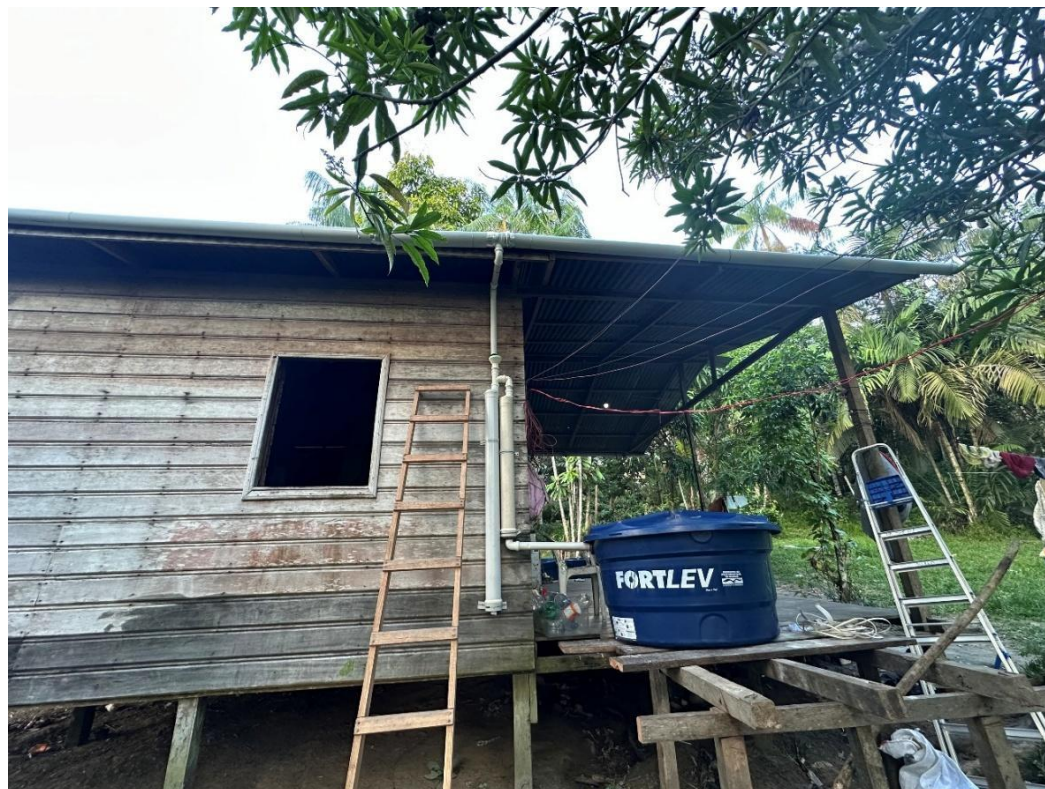
*Image 1.12. Filtering system and connection to the storage tank, Villa Olivença.*

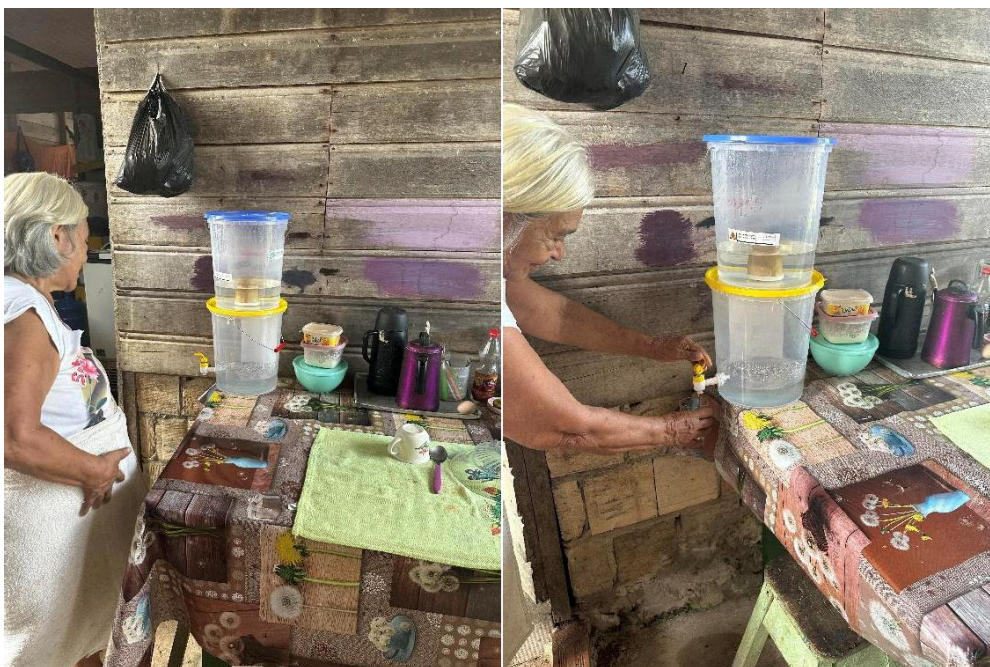
*Image 1.13. Water filtration and purification system for direct consumption, Villa Olivença.*

- **Phase 4: Water Treatment and Safety Assurance.** To mitigate any residual health risk and certify safe human consumption, a domestic triple-action filter candle system (mechanical filtration, activated carbon and colloidal silver sterilization) was delivered and installed at the point of use of each home.

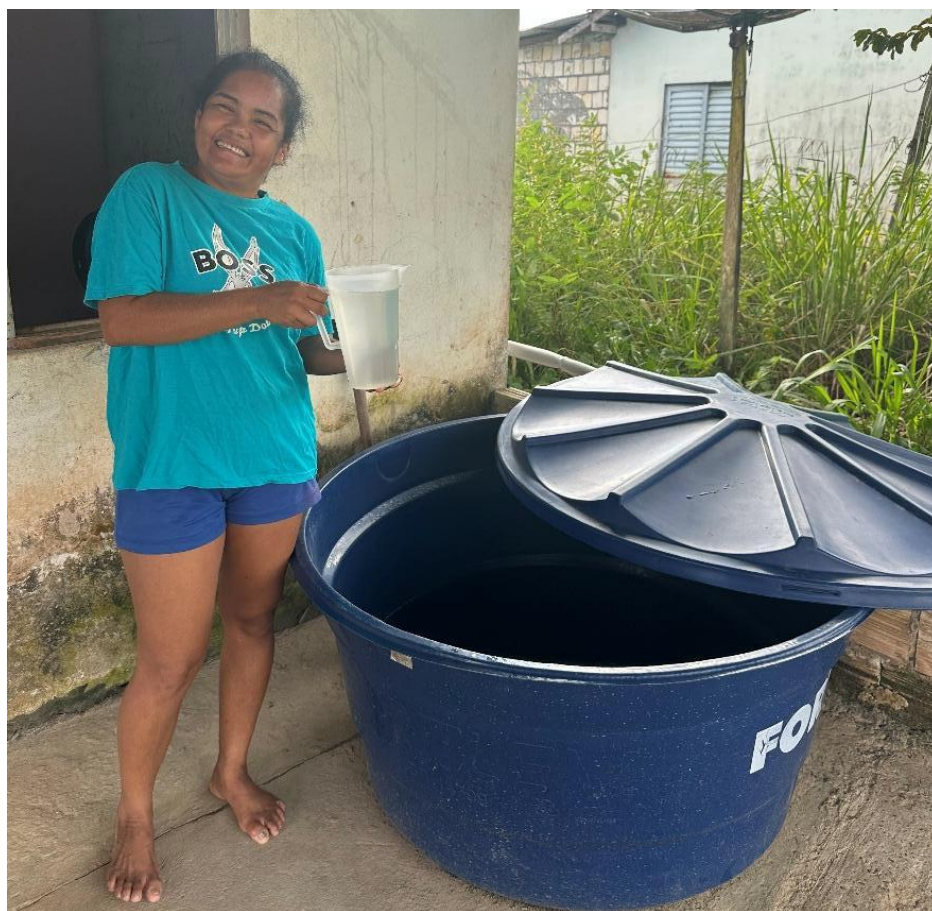
*Image 1.14. Beneficiary showing the clean water stored in her tank, Villa Olivença.*
