# Quebrada Pastor

## Current State of Systems - Project Overview

## PROJECT MANUAL

August 2026

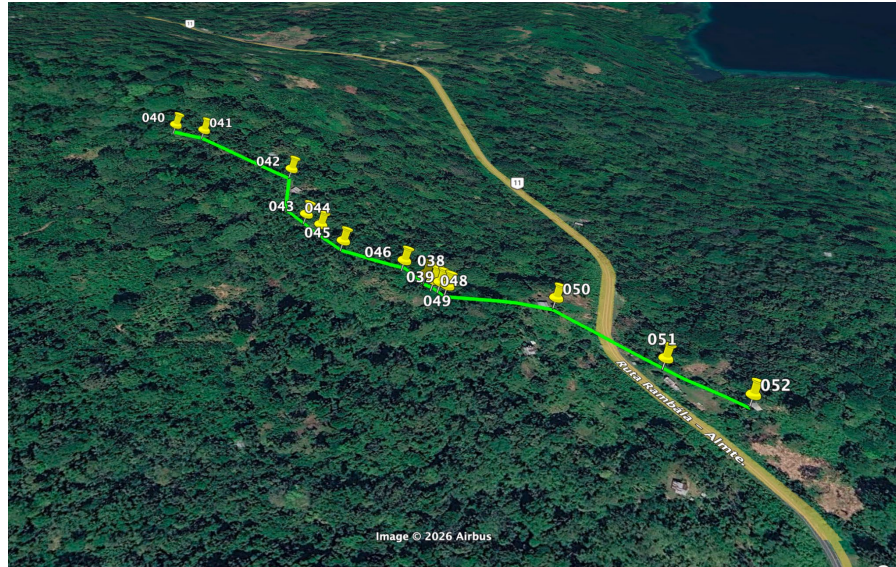
Figure 14: Carrisal System Pipeline

The Carrisal system is purely residential and serves the houses along the line, as shown in Figure 14. It is a smaller system than Mario Lopez, and the community does not anticipate its expansion in the near future. The water

committee and users of the line noted that they run into issues with the system where sometimes houses will go without access to water or have very limited water flowing out of their taps. The community believes that natural wear and tear to the pipe, as well as weather events, greatly affects the integrity of the pipe as it sits right above ground.

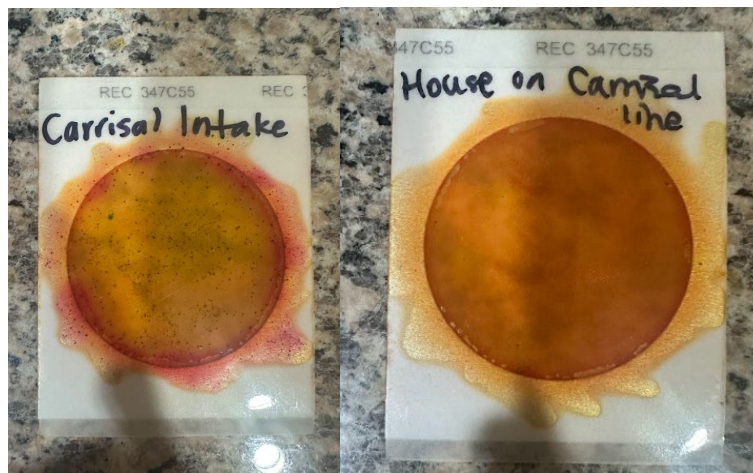
Figure 15: Carrisal Intake and Carrisal House REC Tests

The sample taken at the intake exhibits too many coliform colonies to count. However, the house on the Carrisal line sampled from a family's tap does not show any signs of E.Coli or coliform. Therefore, the intake does not adhere to Panamanian drinking water standards, but the family tap does. Both samples are compliant with the national allowable nitrate and nitrite levels.

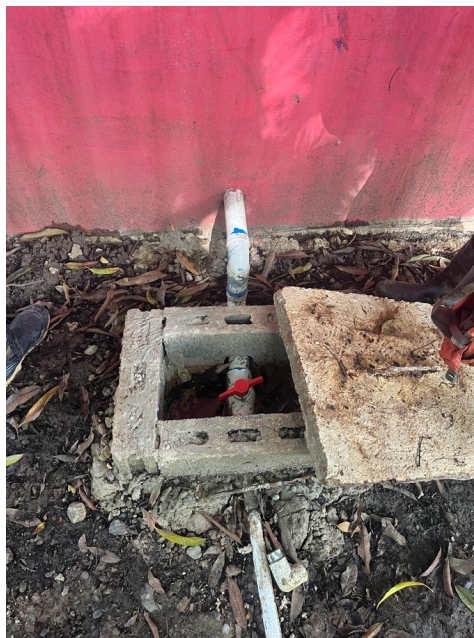
*Figure 21: Carrisal tank intake, valve half open to control flow*

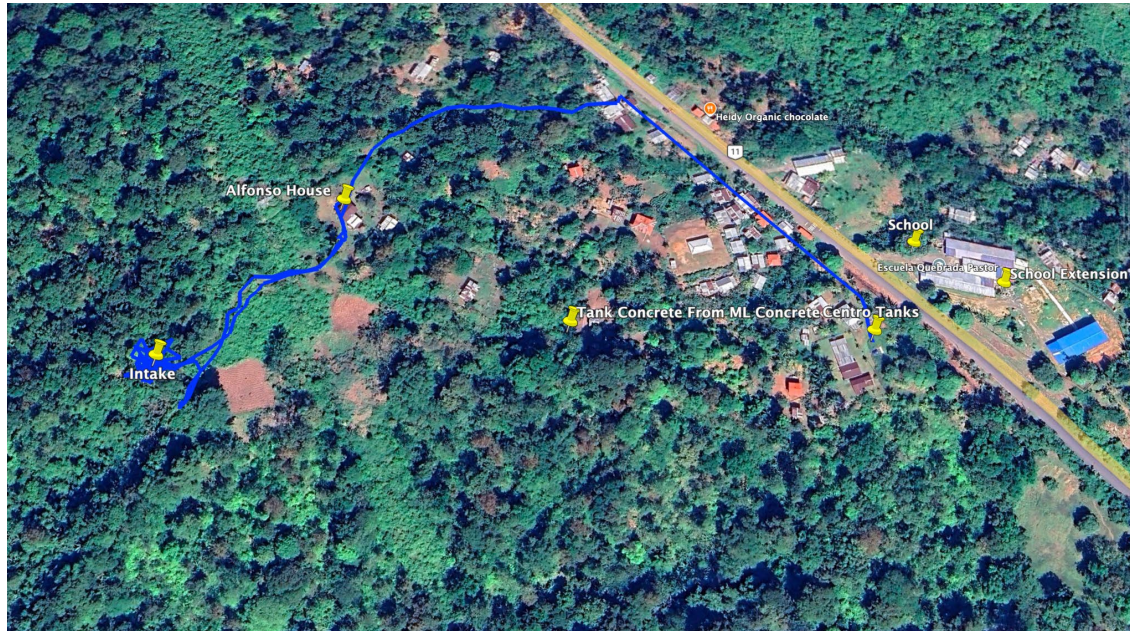
Figure 24: Alfonso Lopez System Pipeline

The Alfonso Lopez system consists of a spring intake structure located near Alfonso Lopez's home. The proposed pipeline will span from the proposed intake to the Centro tanks, where it connects to feed the school distribution lines. The main purpose of this system is to serve as a dedicated school water supply, functioning independently of the other shared community water systems.

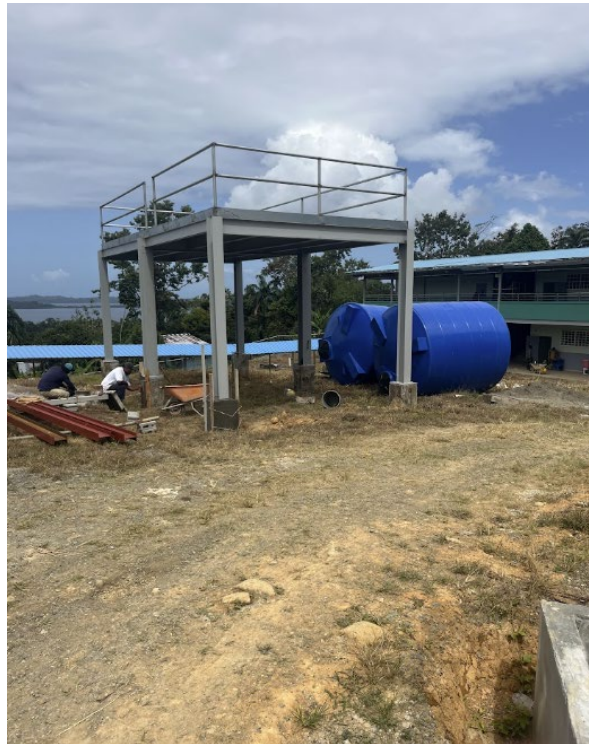
*Figure 30: Proposed Platform for Storage Tanks*

Currently, the school is utilizing two temporary water tanks while the secondary school remains under construction. The two temporary tanks were supplied by the Ministry of Health (MINSa) to fulfill the water demand at the school. In the future, the tanks shown in Figure 30 will be moved onto the platform shown in the same image.

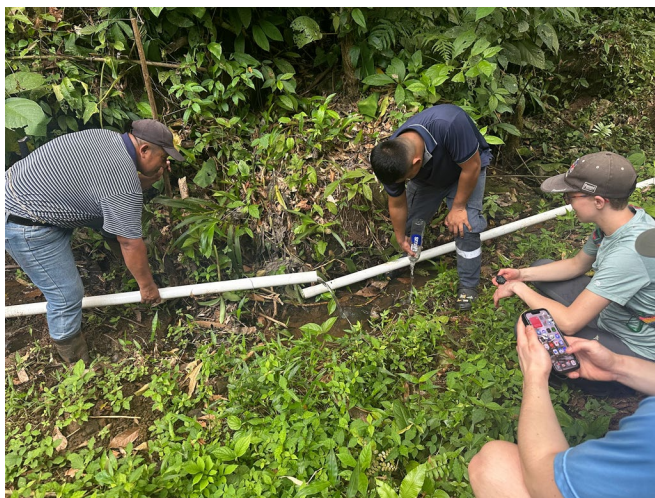
*Figure 35: Flow Rate Testing at Rio Oeste*

To help with system improvements, the team assisted in gathering ballpark flow rates using a one-liter plastic bottle and a stopwatch. The average flow rate was determined to be 0.29 L/sec or 17 L/min.
