## COMPLETION REPORT FOR BMMT HEALTH CENTRE - MASANGA

| <b>Name of Project:</b> | Improvement of WASH Infrastructure |
| <b>Location:</b> | Tarime DC, Mara Region |
| <b>Subject:</b> | Completion Project Report |

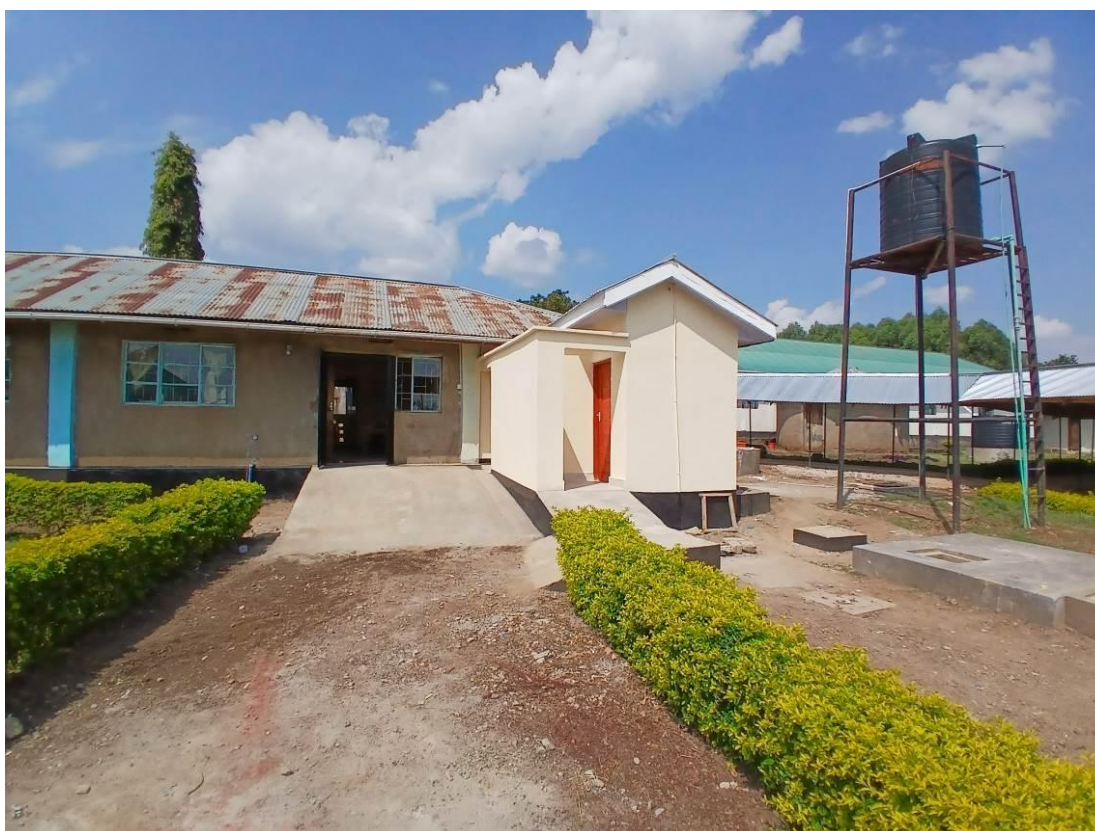
*On 18<sup>th</sup> of July 2026, Masanga health centre in Tarime DC, photo shows among of the constructed infrastructures (staff toilet block) for BMMT HC. Photo captured by Franco*

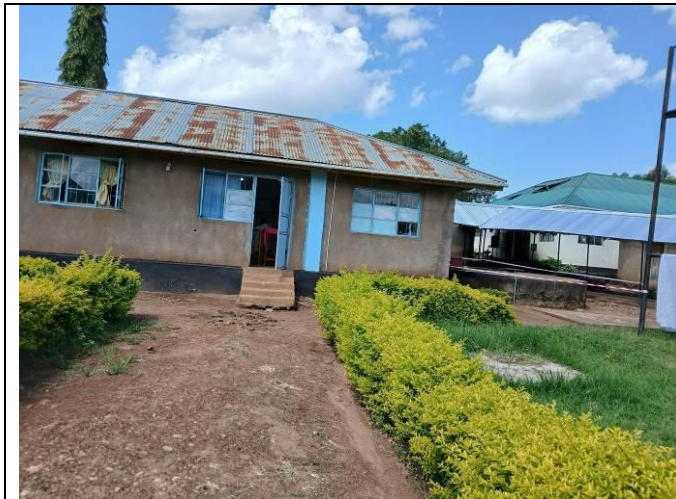
Initially, staff were using an existing single-stance toilet facility shared by both male and female staff. During the needs assessment, the assessment team identified the facility as inadequate and recommended the construction of a new two-stance toilet block to provide appropriate and separate sanitation facilities for male and female staff.

*Situation before construction*

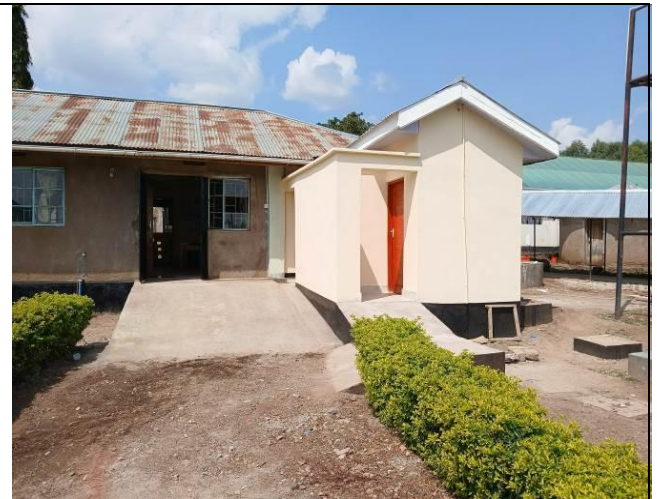
The recommended two-stance staff toilet block has been successfully constructed and completed, including the installation of medium-sized handwashing basins and other necessary sanitary fittings. The new facility has improved access to safe, convenient and appropriate sanitation facilities for both male and female staff.

*After completing construction*

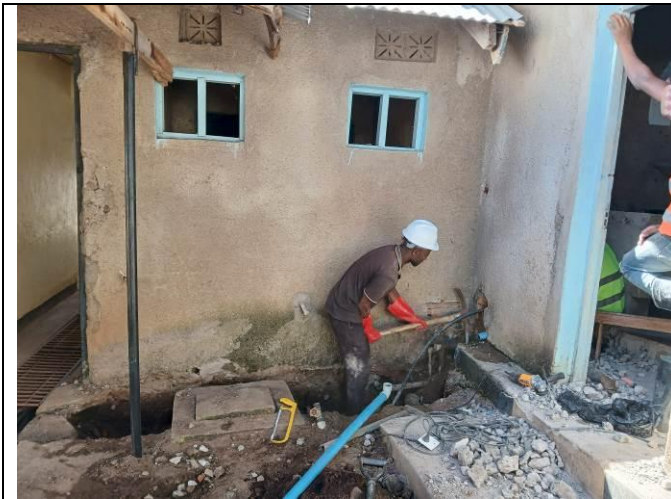
*Before Renovation IPD toilet block (outside)*

- Demolition and removal of the existing floor finishes
- Installation of new ceramic toilet pans
- Installation of water shower to each stance and two water heaters.
- Installation of internal water supply and wastewater plumbing systems
- Internal and external re-plastering of walls
- Installation of gypsum boards and PVC boards where required
- Wall and floor tiling
- Skimming and painting of internal and external surfaces
- Installation of aluminium windows
- Repair and installation of the existing four doors
- Installation of a new door for the PWD-accessible toilet stance; and
- Construction of wastewater inspection chambers to facilitate proper wastewater management and maintenance.

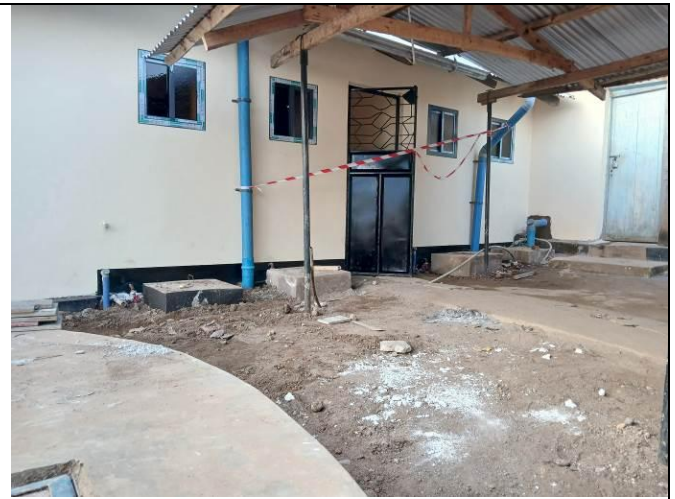
The rehabilitation of the IPD toilet block has been successfully completed, providing five functional toilet stances, including a dedicated PWD-accessible stance. The intervention has significantly improved sanitation, accessibility and convenience for patients admitted to the IPD wards and contributes to a safer and more dignified healthcare environment.

*Renovated toilet block with five stances for IPD*

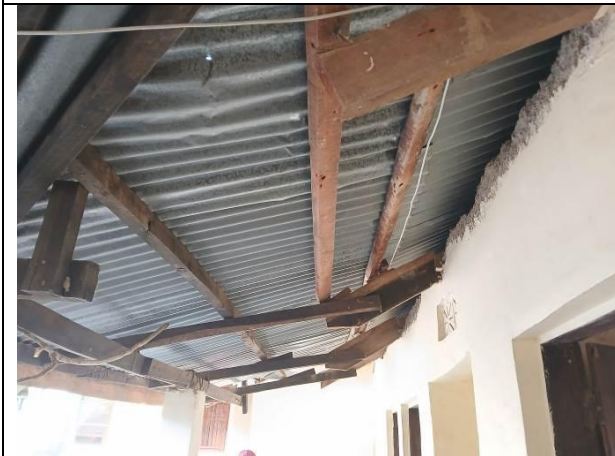
*Before renovation of IPD toilet block's corridor*

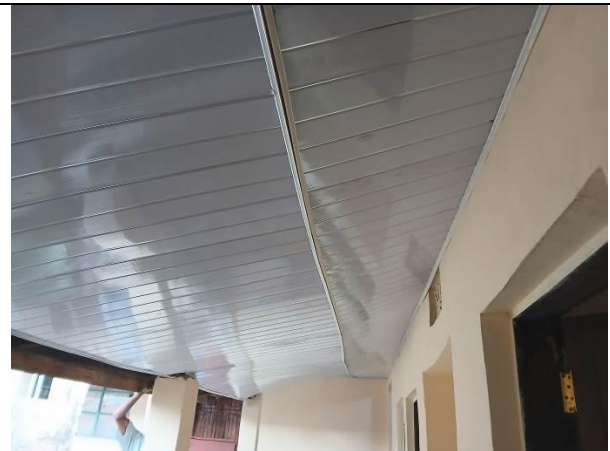
*Renovated corridor*

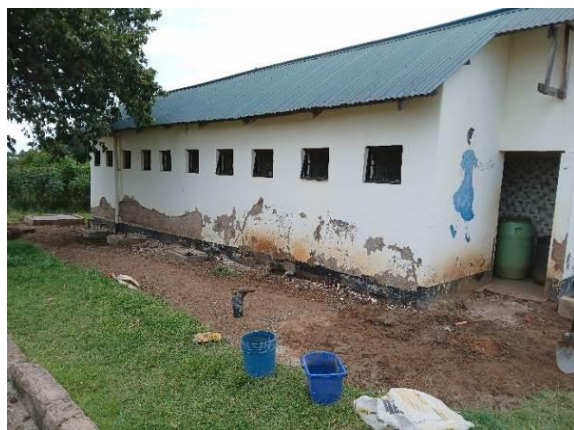
During the assessment, several challenges affecting the functionality and condition of the facility were identified. These included peeling and deteriorated paintwork, damaged water supply infrastructure, inadequate ventilation due to insufficient vent pipes, and lack of a reliable water supply within the toilet block. These challenges affected the proper use, cleanliness and overall hygiene of the facility.

*Before rehabilitation*

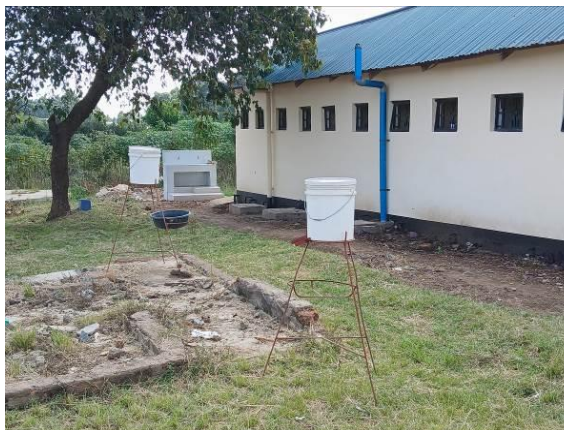
The rehabilitation works have been successfully completed, significantly improving the functionality, accessibility, cleanliness and overall hygiene conditions of the OPD toilet block.

*After rehabilitation*

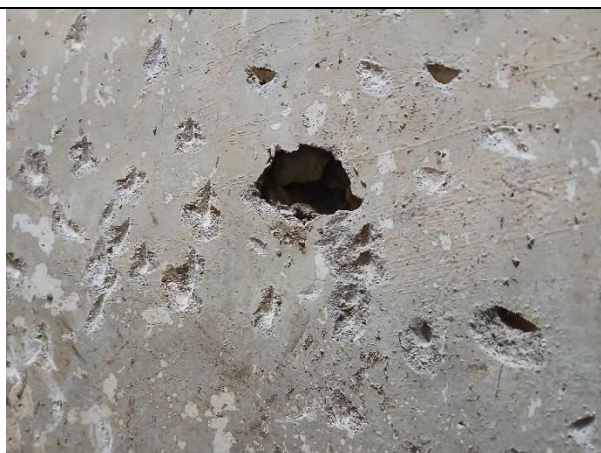
Initially, five underground rainwater storage tanks were identified as requiring rehabilitation due to leakage, which significantly affected their ability to retain harvested rainwater. A detailed inspection was conducted to establish the causes of the leakage and determine the appropriate rehabilitation measures. The assessment revealed that several tanks had cracks in the walls, while others had holes and damaged sections in the floor and walls.

Observed holes in the tank walls

Based on the findings, rehabilitation works were undertaken to restore the structural integrity and watertightness of the affected tanks. The works included casting a new concrete floor slab of approximately 130 mm thickness and applying a new cement and water proof -sand plaster layer of approximately 50 mm thickness to the internal walls. The repaired surfaces were properly finished to minimize water leakage and improve the tanks' capacity to retain harvested rainwater.

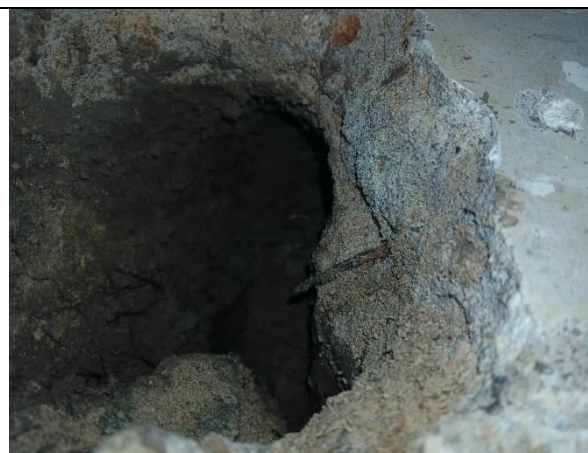
Observed holes in the base floor

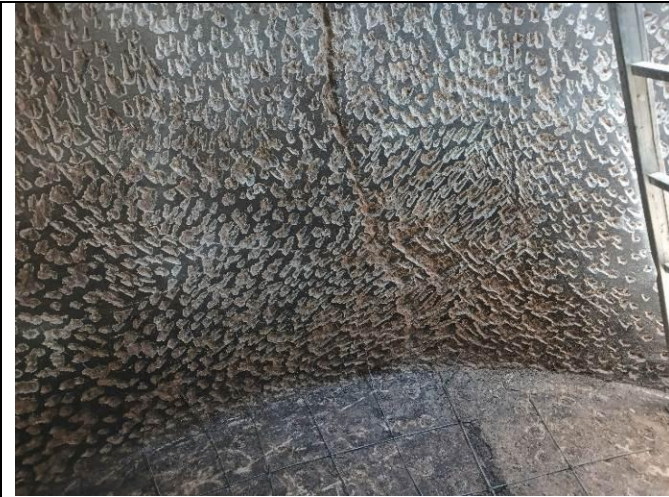
Observed cracks in the tank walls

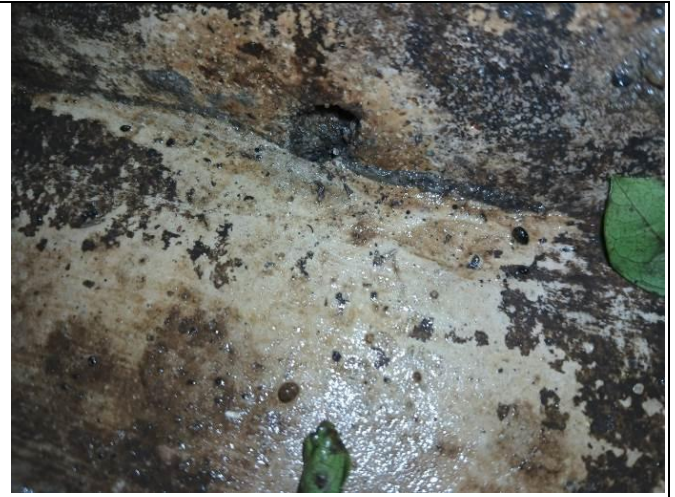
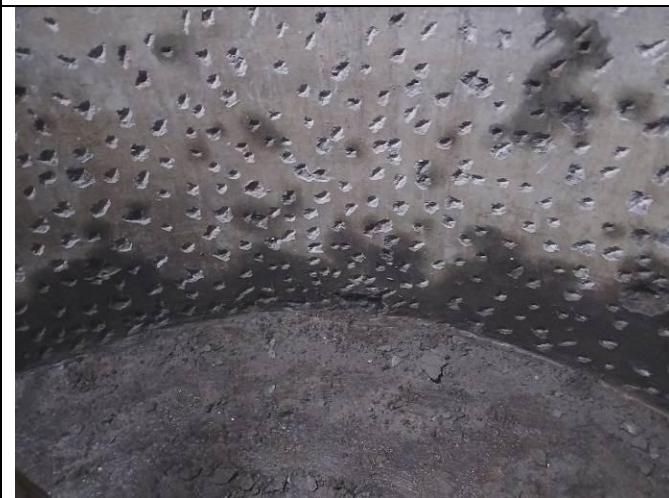
Preparation of surfaces ready replastering and floor

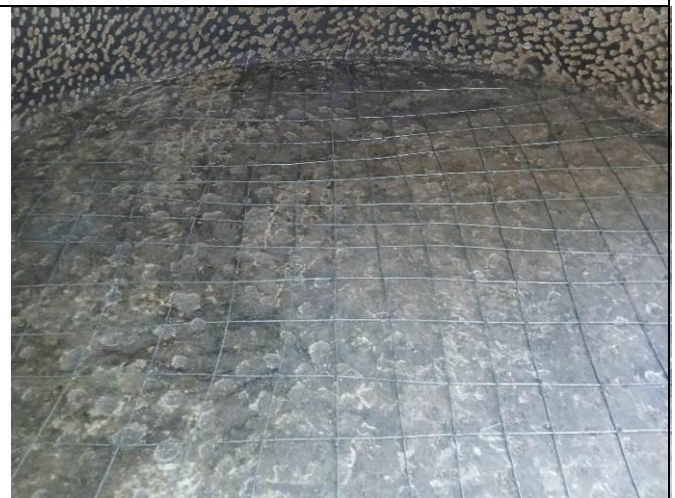
Reinforcements before concreting work

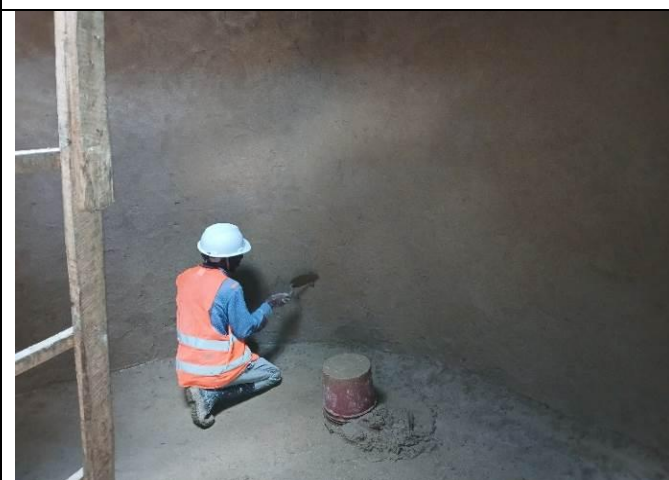
applied new plaster coat and reinforced concrete floor

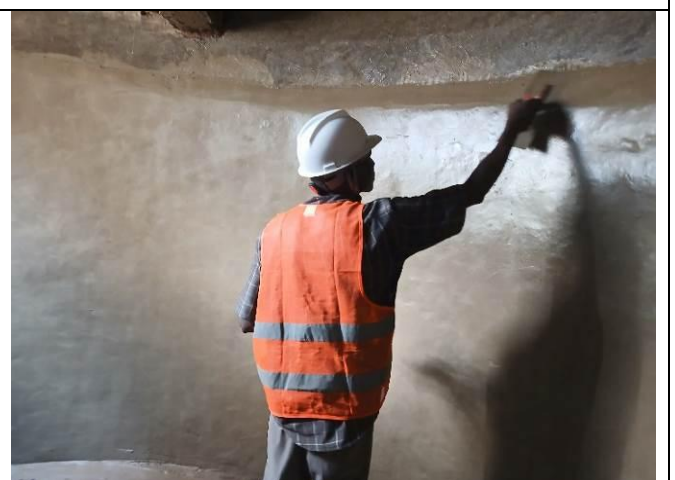
Finishing work of the applied plaster

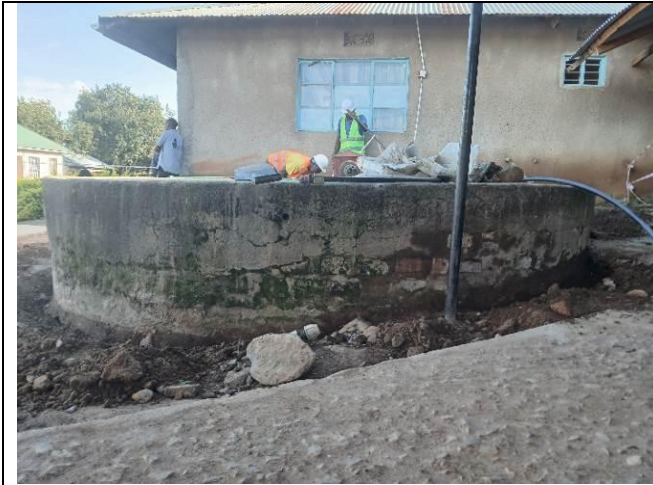
Before rehabilitation

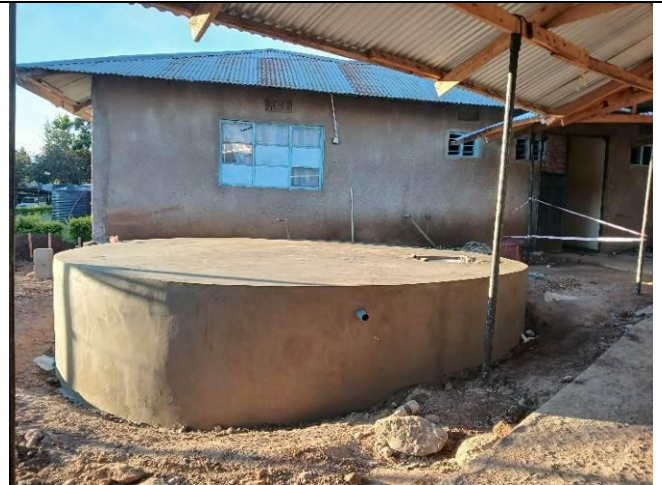
After rehabilitation

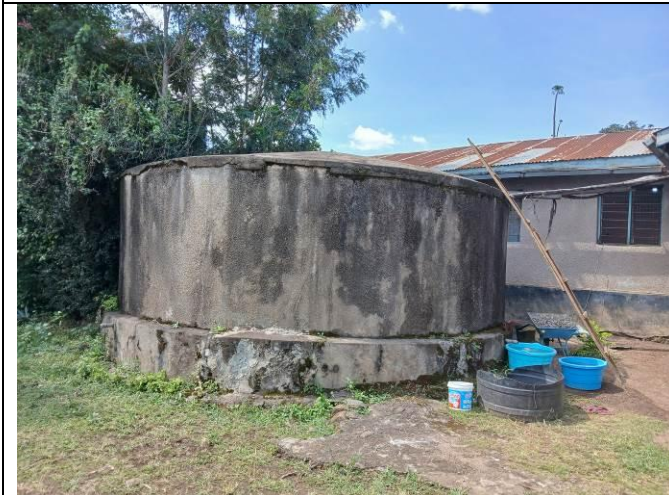
During implementation, two additional tanks were identified as having similar leakage problems, one located at the Priest's residence and another at St. Catherine Primary School. Following discussions with the relevant stakeholders, it was agreed to include these two tanks in the rehabilitation program. This decision was considered appropriate because the tanks were part of the existing rainwater harvesting systems, and their poor condition meant that significant amounts of harvested rainwater were being lost.

Before renovation (at the priest's house)

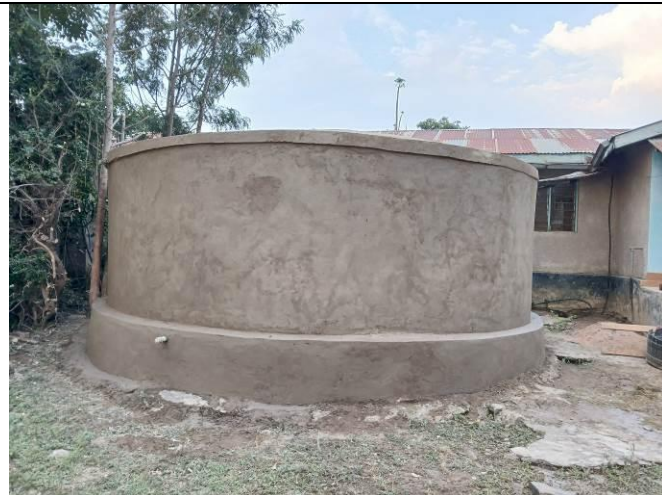
After renovation of on-ground storage tank

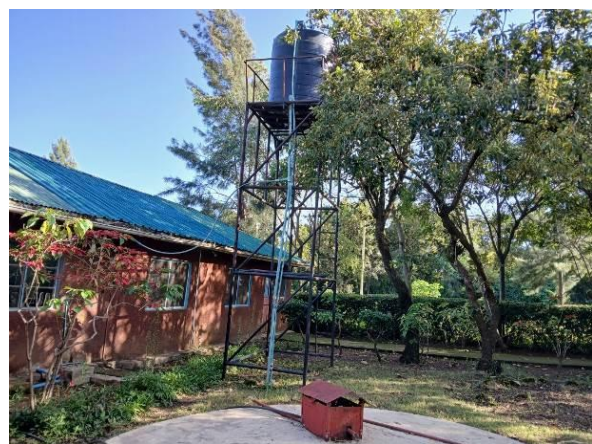
The infrastructure rehabilitation works did not include any repairs to the Sisters' house. However, as the project activities progressed, the Sister in charge requested us to assess the water supply situation at the house. The assessment revealed that the existing water supply infrastructure was outdated and had significantly deteriorated. In addition, the existing 2,000-litre water storage tank was too small to meet the water demand of the house.

*Existing storage tank 2000L on 6m tower*

Based on the assessment findings, we recommended constructing a three-metre-high tank tower to support a 5,000-litre plastic water storage tank. This would provide adequate storage capacity and allow the existing 2,000-litre tank to be used for other purposes. We also recommended replacing and upgrading the existing water supply pipe to a one-inch diameter to improve water flow and pressure throughout the house.

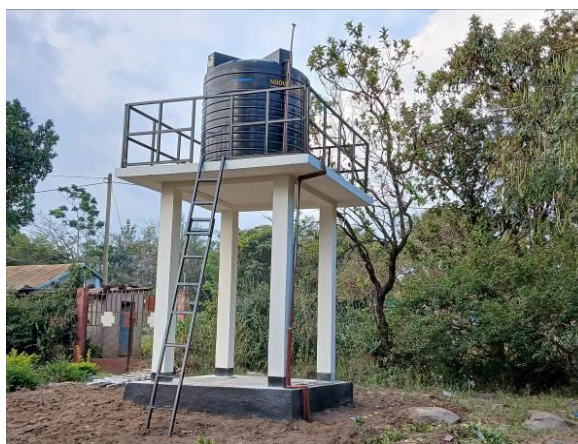
Following discussions and agreement on the proposed improvements, the project proceeded with the recommended works. A three-metre-high tank tower was constructed, and the necessary plumbing works were completed. The project also installed a centralized solar water-heating system, which supplies hot water to all twelve bedrooms, thereby significantly improving the water supply and living conditions for the sisters.

*Constructed 3m tank tower*

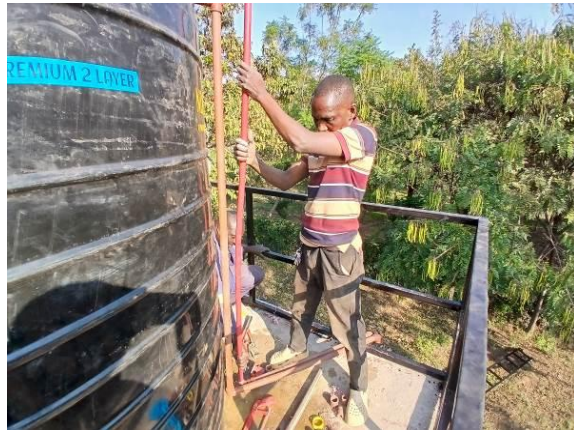
*Plumbing works at the tank*

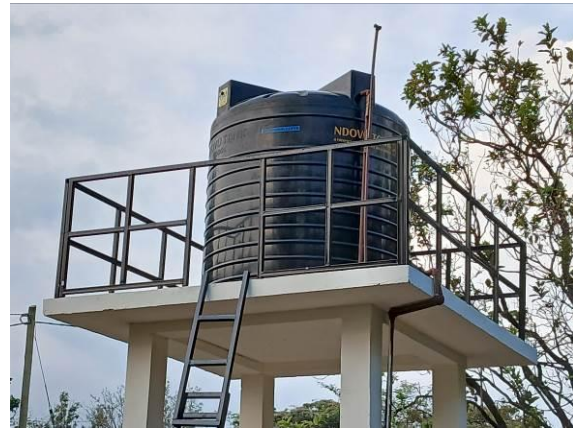
*Installed tank 5000L*

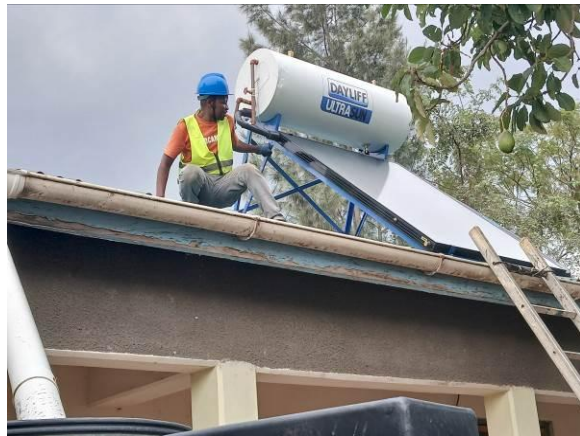
*Installation of 200L solar water heater*

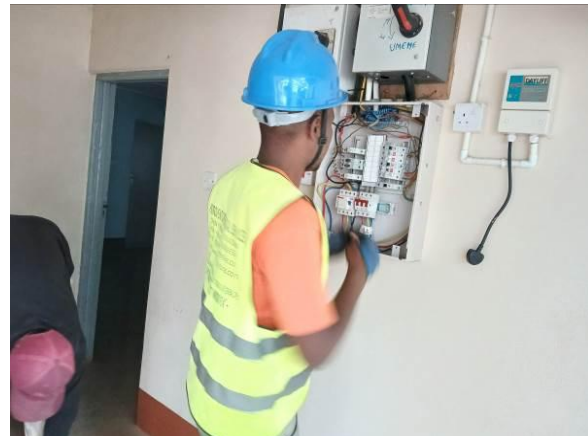
*Electrical connection of solar water heater*

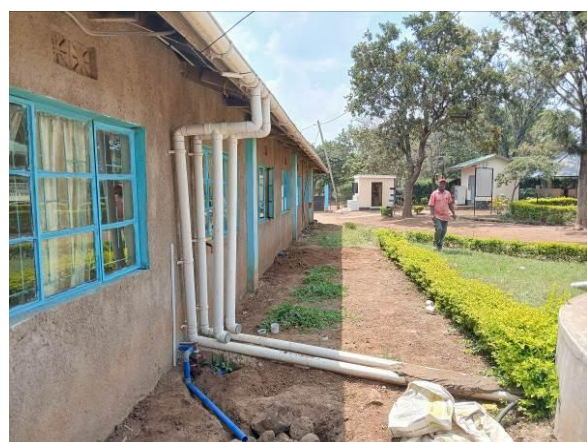
The existing rainwater harvesting systems were not equipped with first-flush devices to prevent the initial, potentially contaminated runoff from entering the storage tanks. In collaboration with the water infrastructure operators, the project identified all locations where first-flush systems were required. The project subsequently installed first-flush devices at all identified sites, thereby improving the quality and safety of harvested rainwater entering the storage tanks.

*Installed first flush system*

- In preparation for the rainy season, the tank inlet and first-flush system should be properly checked and the appropriate plugs or outlets opened to allow the initial runoff, which may contain dirt and other debris, to be discharged before clean rainwater is directed into the tanks. This will help maintain the quality of harvested rainwater and prevent unnecessary accumulation of debris in the storage tanks.
- During the monitoring visit, some cases of improper use of installed facilities, particularly water taps, were also observed among patients. Healthcare workers were therefore strongly encouraged to continue providing regular awareness and hygiene education to patients and other facility users on the proper use and care of the installed facilities. This will help reduce misuse, minimize frequent breakdowns, and extend the lifespan of the infrastructure.

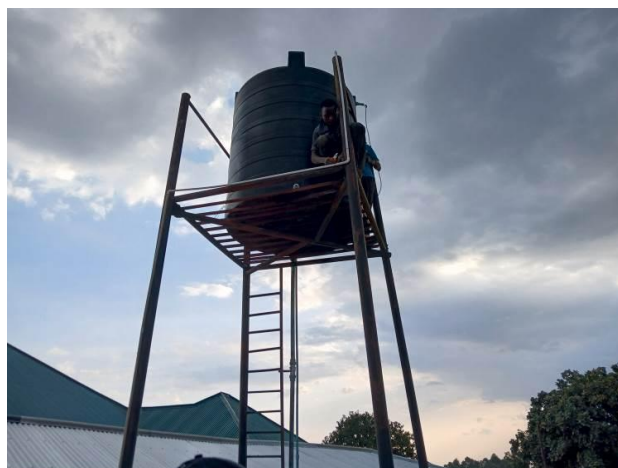
The project successfully rehabilitated several water pumps that had remained out of operation for an extended period due to a lack of maintenance. In addition, two new pumps were procured and installed on the existing water supply infrastructure to improve water availability and reliability.

Connection  
of sensor  
of the new  
installed  
pump

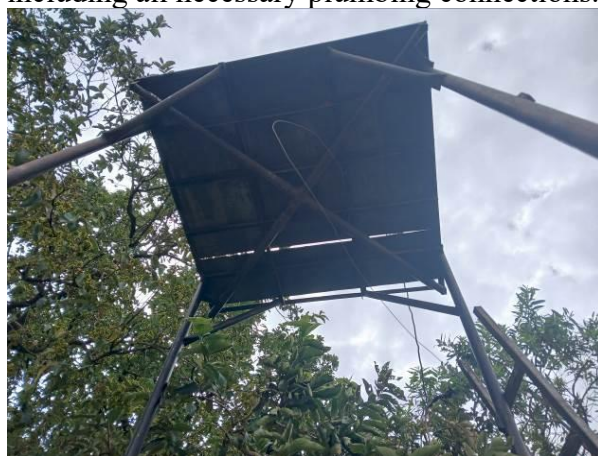
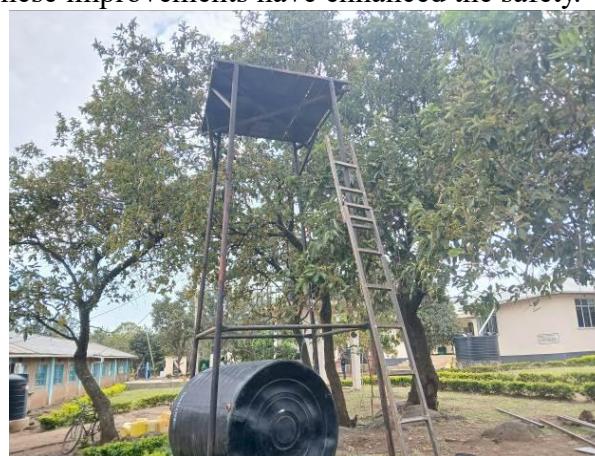
The project successfully rehabilitated an existing six-metre-high steel tank tower, which had an inadequate support base for the plastic water storage tank. The condition of the base posed a risk of cracking or leakage of the tank due to uneven support and the pressure exerted by the stored water. In addition, the tower lacked a protective tank guard, creating a risk that an empty plastic tank could be displaced or blown off the tower during strong winds, potentially resulting in damage.

To address these risks, the project strengthened and improved the tank support base by welding a 3 mm thick steel plate onto the existing structure to provide a stable and secure platform for the tank. A protective tank guard was also fabricated and installed to prevent the tank from being displaced or falling from the tower.

Furthermore, the project procured and installed a new 2,000-litre plastic water storage tank, including all necessary plumbing connections. These improvements have enhanced the safety.

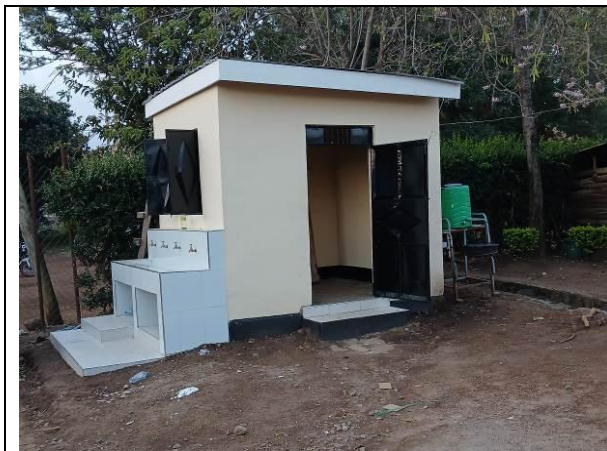
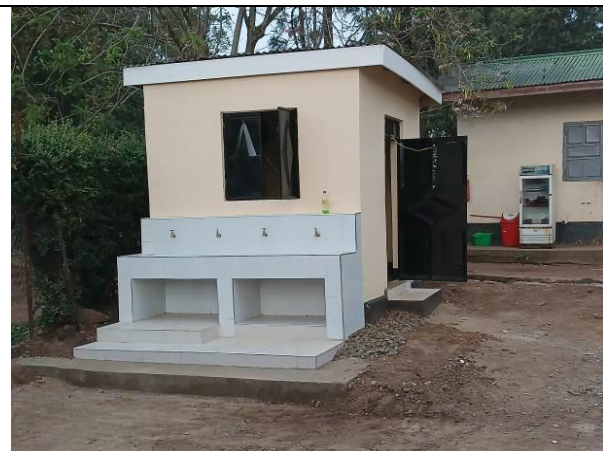
The project constructed a group handwashing station equipped with four taps, two positioned at a suitable height for children and two for adults, at the main entrance gate. The facility was strategically located to ensure easy access and encourage regular handwashing practices among all users. The design considered the needs of both children and adults, promoting convenience, accessibility, and inclusivity.

Constructed Group hand washing station

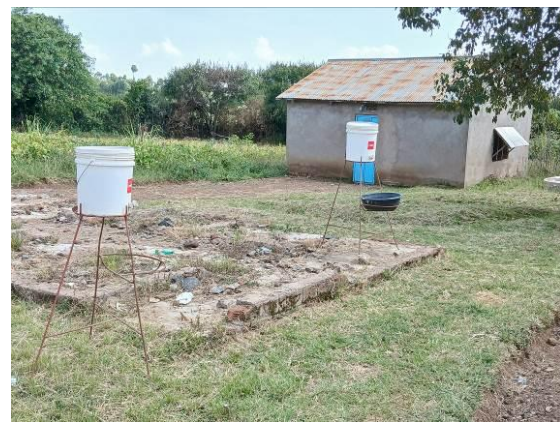
Buckets that were being used before

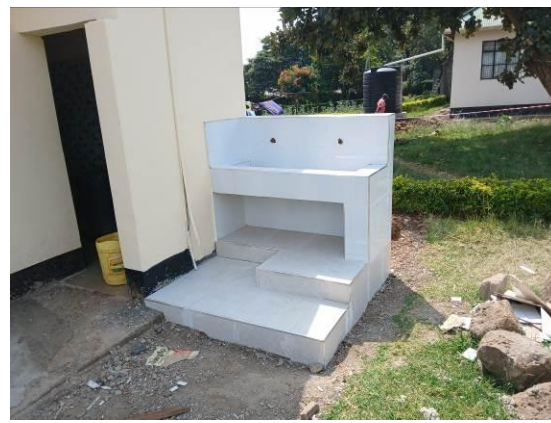
Regarding the OPD toilets, instead of installing conventional ceramic handwashing basins, the project, in collaboration with BMMT, constructed two concrete handwashing stations, one for women and one for men. Each station is equipped with two taps, with one tap positioned at a suitable height for children and the other for adults. This arrangement improves accessibility and convenience for users of different age groups while promoting proper handwashing practices.

Constructed hand washing stations

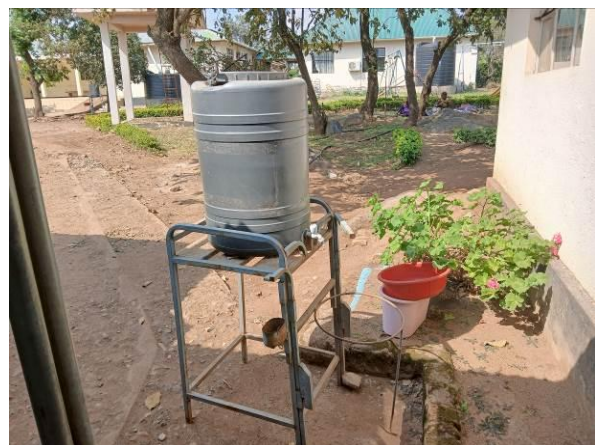
Before intervention

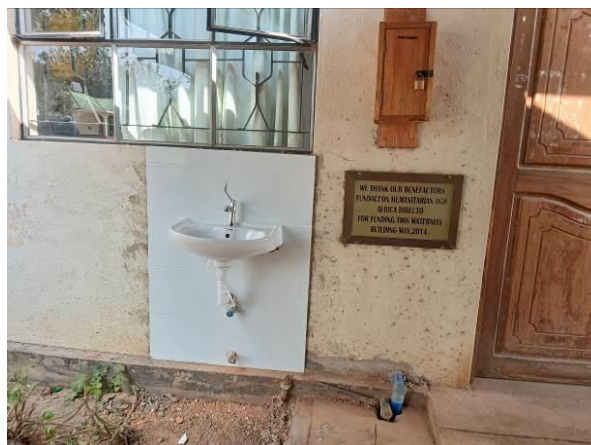
A total of 34 handwashing basins were installed at all identified points of care to ensure that healthcare workers, patients, and other users have convenient access to handwashing facilities and can always observe proper hand hygiene practices. Of the 34 basins, two were wall-mounted while 32 were pedestal-mounted.

After intervention

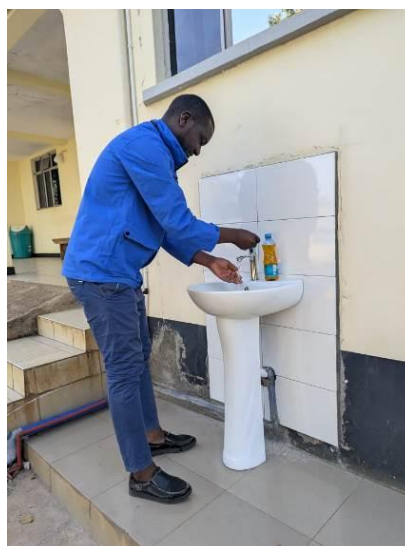
New installed wash hand basin (pedestel) at the dream building

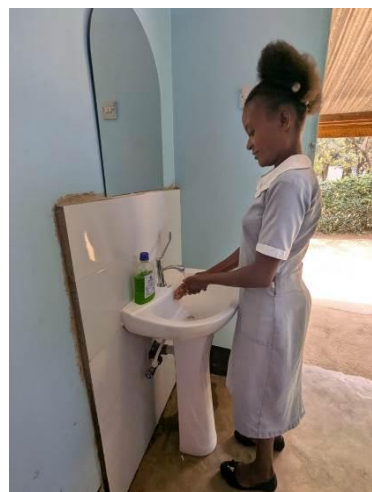
Installed wash hand basin (pedestel) at the emergency room

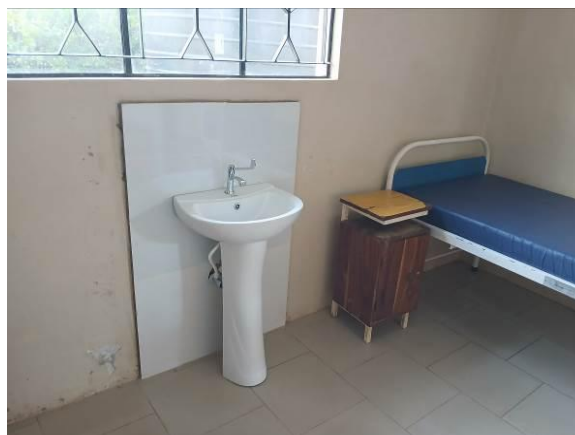
Installed wash hand basin at surgical ward

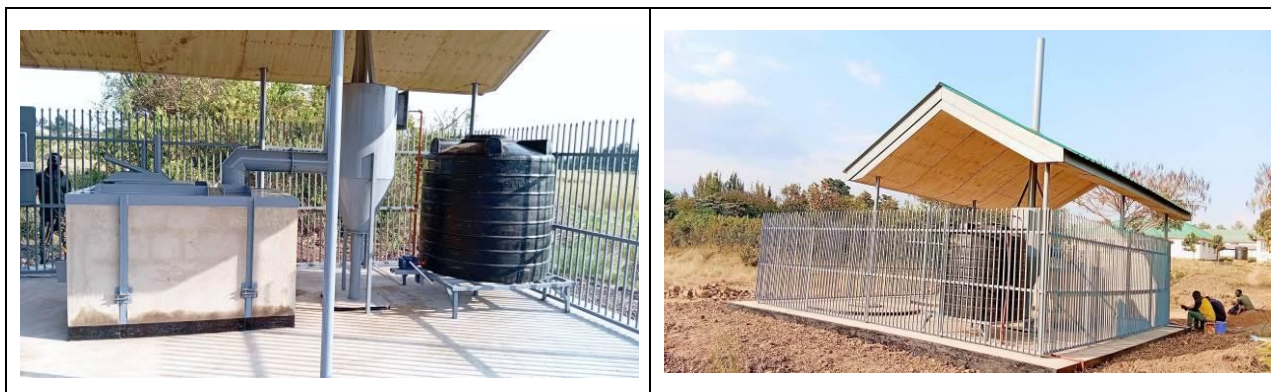
The construction of the incinerator has now been successfully completed. This intervention has addressed a long-standing healthcare waste management challenge and provides the facility with an appropriate system for the safe and effective disposal of healthcare waste, while also supporting its efforts to meet the requirements of a district-level hospital.

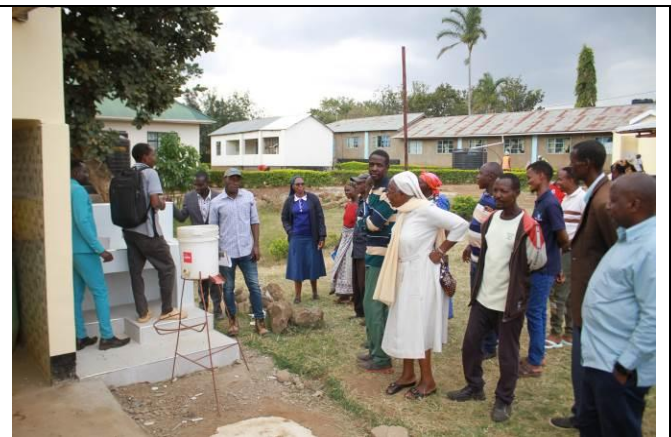
*Inspection at the constructed hand washing station*
