Re: Letter of Report for San Luis Talpa, project site in El Salvador.

The purpose of this letter is to summarize our site visit to your San Luis Talpa project site and provide you with our findings and recommendations.

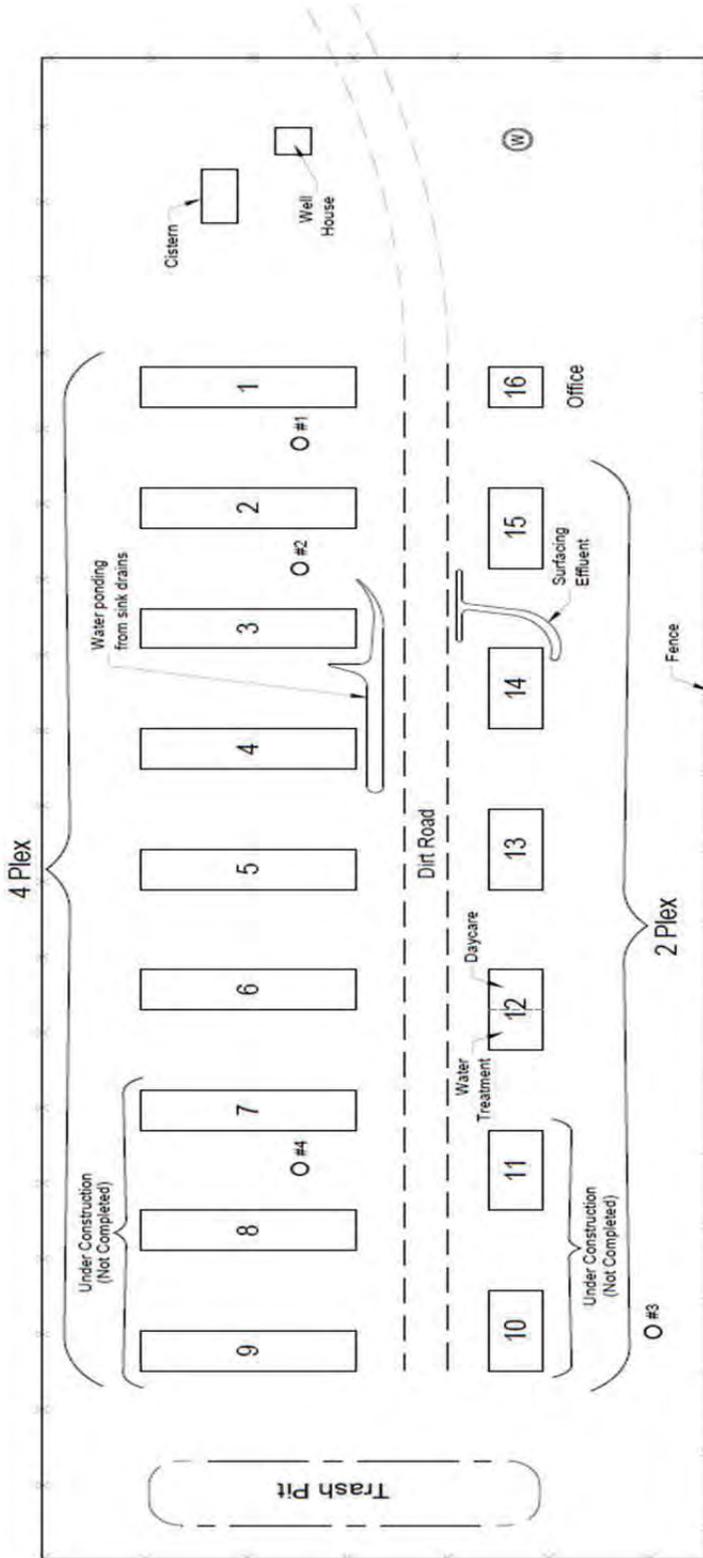
Appendix A Site Sketch

There was ponding water between buildings 2 & 3 and 3 & 4 and along the dirt drive in front of buildings 3 & 4 (see appendix A) Project Site Sketch. Upon further inspection it was determined that some of the sink drains from building 3 had been disconnected from the septic system and were draining directly onto the ground (see appendix B for pictures). Both the shower and toilet still drain to the septic system which appears to be functioning properly. We recommend reconnecting the sink drains to the septic tanks.
