## Trip Report for WEFTA Visit to VHP Projects in Bench Maji Zone, Ethiopia

### April 2019

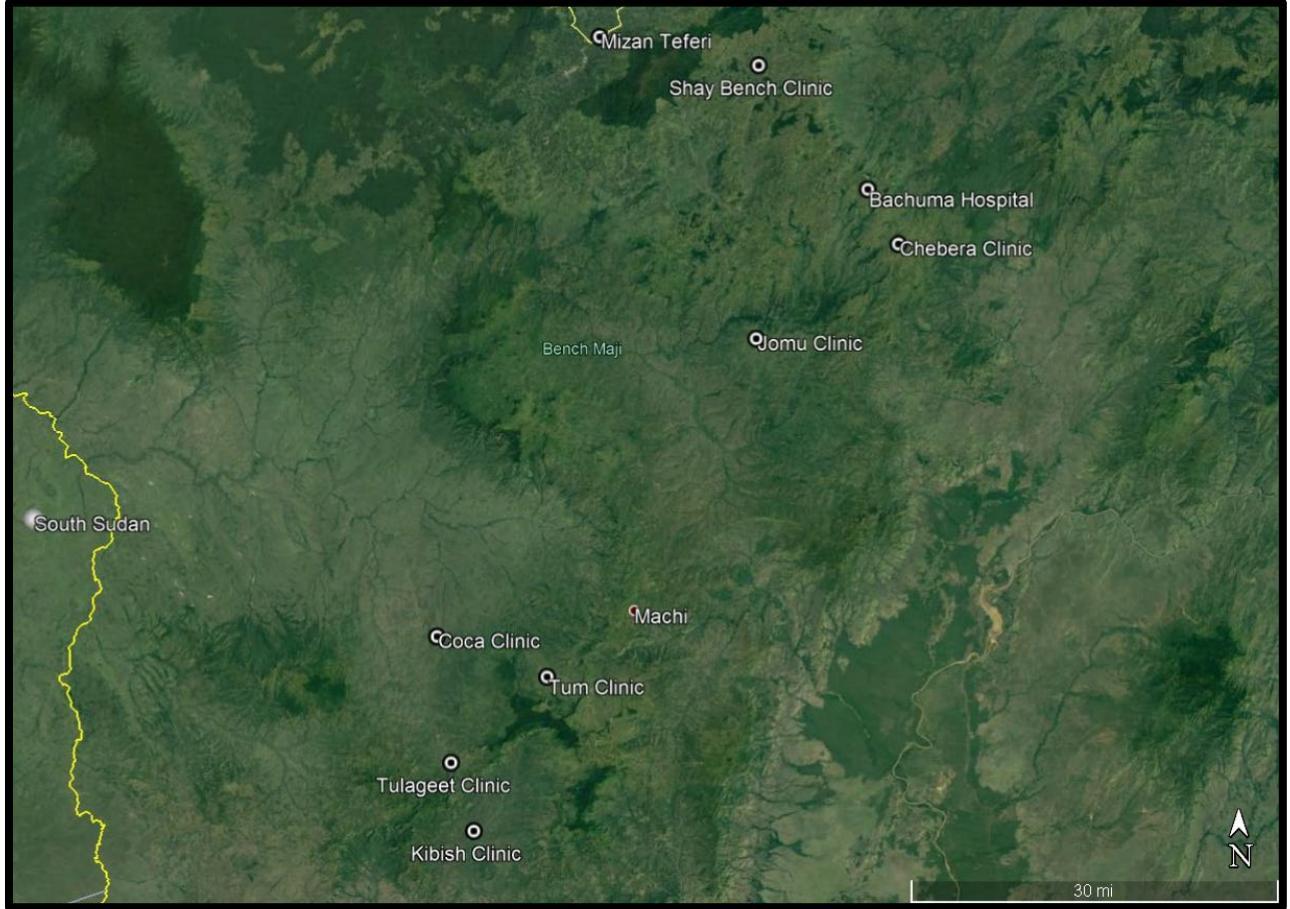
Figure 2 shows the location of health clinics and hospitals visited, as well as Mizan Teferi.

Fig. 2 - Map of Bench Maji showing clinics and hospitals visited

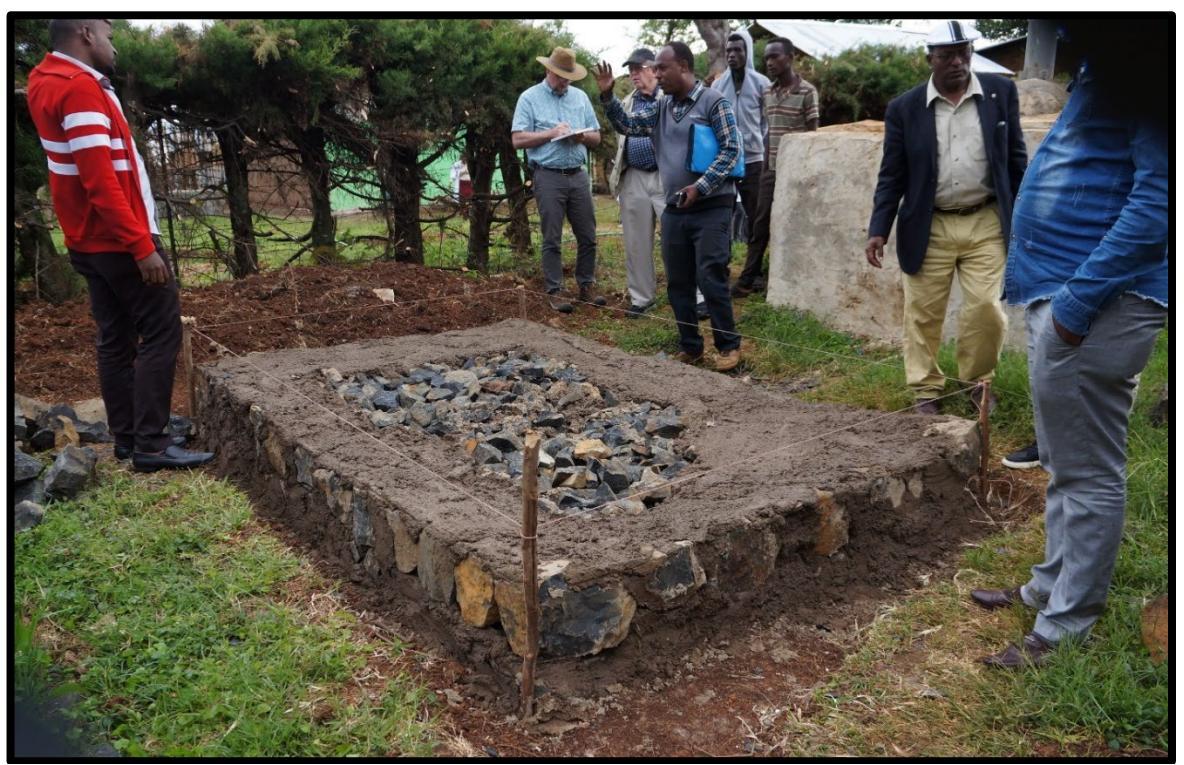
With the VHP team, we visited the Shay Bench clinic in the afternoon of April 22, 2019. Water supply for the clinic will be from the town water system. A 10,000-liter tank was present at the clinic, and the foundation for the tank had been constructed (see Fig. 3). Water will likely be available from the town system two to three times per week. A hand-dug well equipped with an Afridev Pump is present and functional at the clinic and will be used as a back-up supply. The Afridev Pump is a conventional lever action handpump. It is designed for heavy-duty use, serving communities of up to 300 persons. The maximum recommended lift is 45 m. The Afridev Pump is a public domain pump defined by Rural Water Supply Network (RWSN) specifications. The Afridev Pump is fully corrosion resistant, easy to install and has excellent potential for community-based maintenance; the pumps are common in Ethiopia. A new clothes-washing basin had also been recently constructed in association with the new maternity waiting area and latrines.

Fig. 3 – Shay Bench tank foundation and hand-dug well (at right)

A placenta pit and medical waste incinerator had been recently constructed and looked to be in good condition. An unfenced pit near the incinerator was in use for trash disposal. It is recommended that the fence be extended to surround this pit.

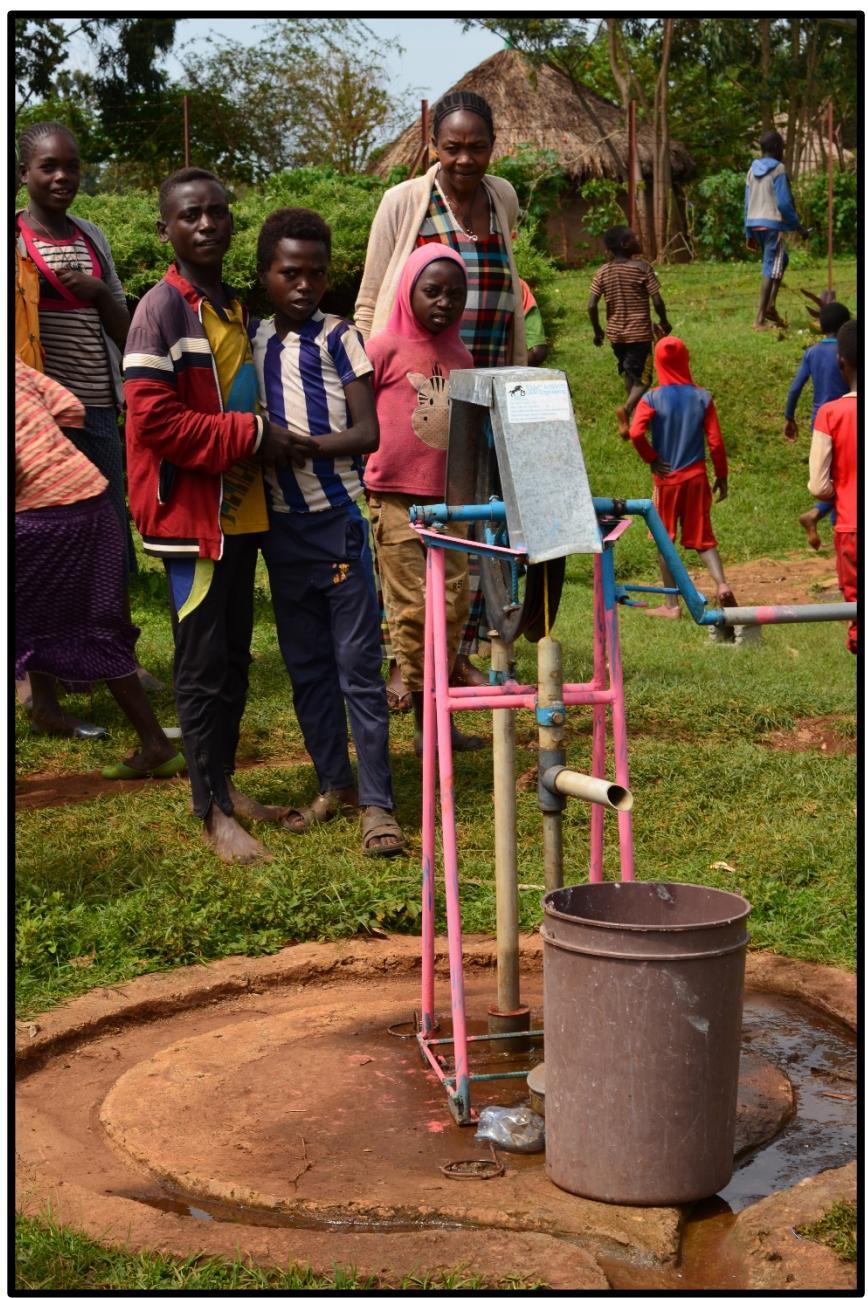
The Chebera health clinic was visited in the morning of April 23, 2019. Water supply for the clinic is currently provided by a single hand-dug well equipped with a hand-cranked rope pump. The well is reported to be 8 meters deep. The well provides water for most of the year, but at times dries up at the end of the dry season. Two additional wells have been dug at the facility, both encountered hard bedrock at approximately 6 meters and could not be advanced to groundwater. A 10,000-liter tank has been installed at the site, but is not plumbed to a water supply.

Fig. 4 – Chebera clinic hand-dug well and rope pump

WEFTA recommends the evaluation of a rain catchment system to provide water to the clinic. A preliminary evaluation (Appendix A) of the area of rooftop available and the likely rainfall of the area indicates a rain catchment system made up of rooftop gutters plumbed to a storage tank would be a viable water supply. We recommend the construction of a ferro-cement tank for water storage, as the existing fiberglass tank may cause stored water to be unacceptable to users due to warm water temperature.

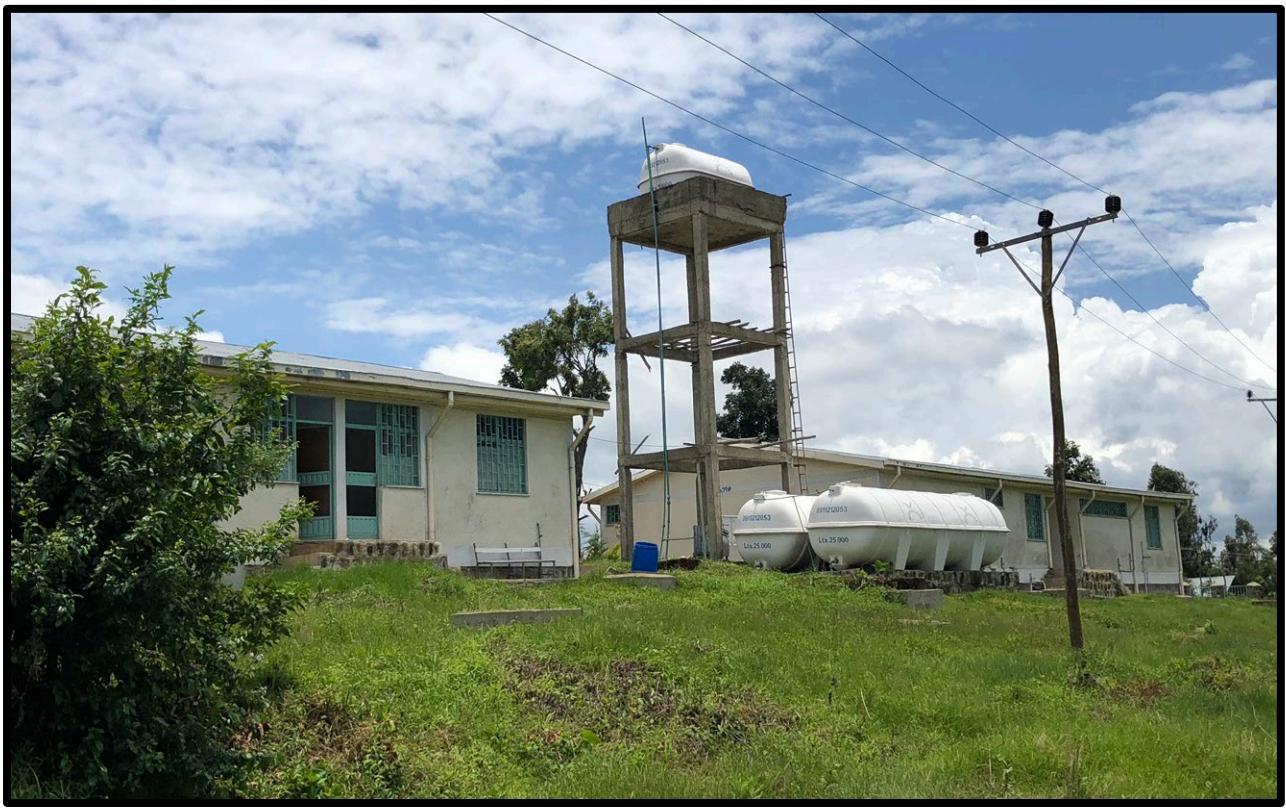
Bachuma Hospital was visited by the WEFTA/VHP/AEID team in the afternoon of April 23, 2019. The hospital is a large, regional facility, of which only the maternity portion of the facility has been put into use. The facility was constructed in 2011-2012. The remaining facility is not in use because of the lack of water supply. The facility has adequate water storage, with two 25,000-liter tanks at ground level and one 5,000-liter elevated tank, equipped with an electric transfer pump to move water from the ground storage tanks to the elevated tanks for gravity distribution to the hospital. The facility also has a series of septic tanks for graywater disposal (but reportedly not fecal matter) on the north margin of the hospital property.

Fig. 5 – Bachuma Hospital water storage tanks

The hospital is connected to the Bachuma town water system, which does not provide adequate water for the facility. This system is discussed further below. The distribution piping from the town water system to the hospital is leaking (approximately two liters/minute) where it is present in the road near the hospital. Though the leak is ongoing, repairing the leak would not provide adequate

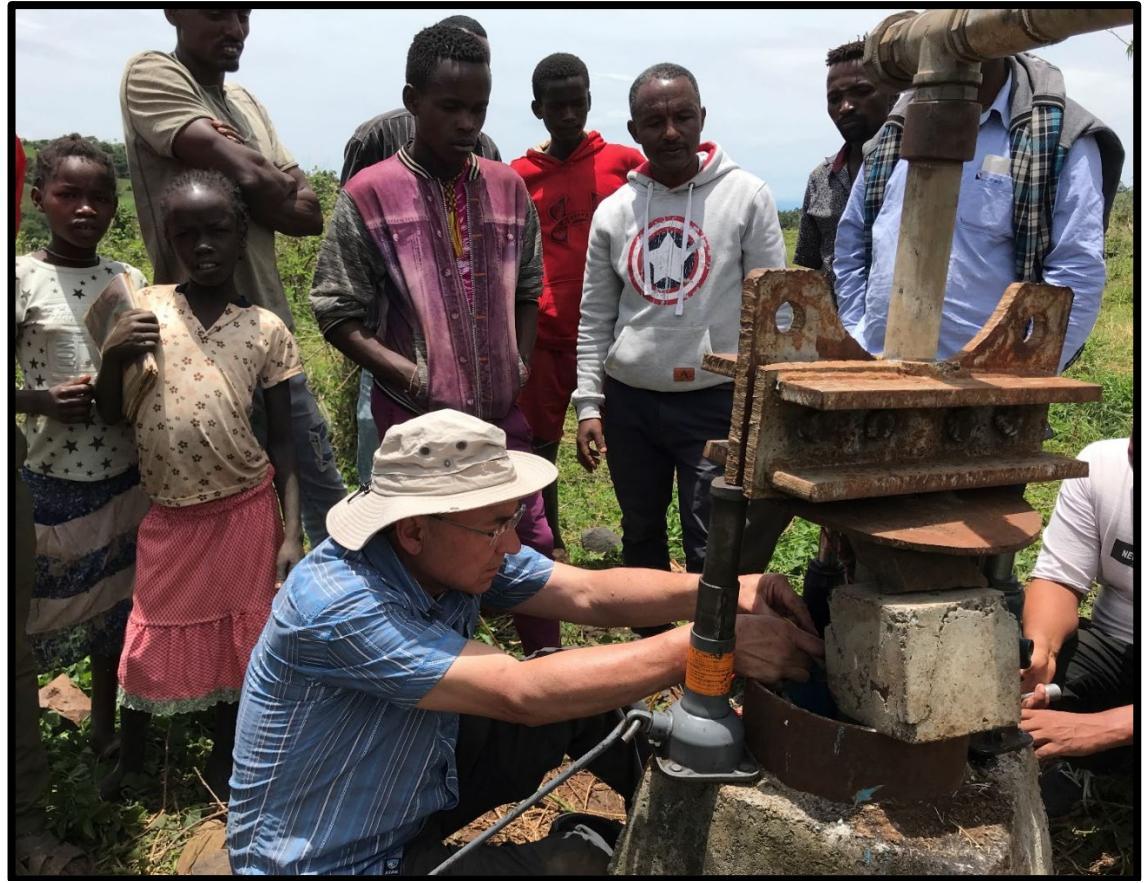
The WEFTA/AEID team returned to the Bachuma Hospital on April 24 to evaluate a nearby well. A camp was constructed sometime prior to 2011 approximately half a mile south of Bachuma Hospital by the Chinese government to house workers constructing infrastructure. The camp was equipped with a supply well, which is still present at the camp, but has not operated since approximately 2013. It was reported to be 102 meters in depth, with the pump set at 96 meters. During our investigation, the wellhead was elevated using two steel pipes and approximately ten strong men to lift the pump and drop pipe. Once lifted, the wellhead was propped open with a concrete block, and lifted further using two hydraulic jacks, to the point that the pump wires were accessible. Depth to water was measured at approximately 40 feet using a steel tape and chalk, and an attempt was made to determine the total depth of the well. The steel tape was not able to be lowered beyond 150 feet, which may represent the total depth of the well, or an obstruction that the tape was not able to pass.

We completed evaluation of the pump resistivity to determine that the pump is likely three-phase. Based on this determination, we connected the pump to two separate generators available at the site to attempt to put it into operation, which was not successful. Based on further evaluation, it appears the pump is no longer functional.

Fig. 6 – Evaluating Chinese Camp well

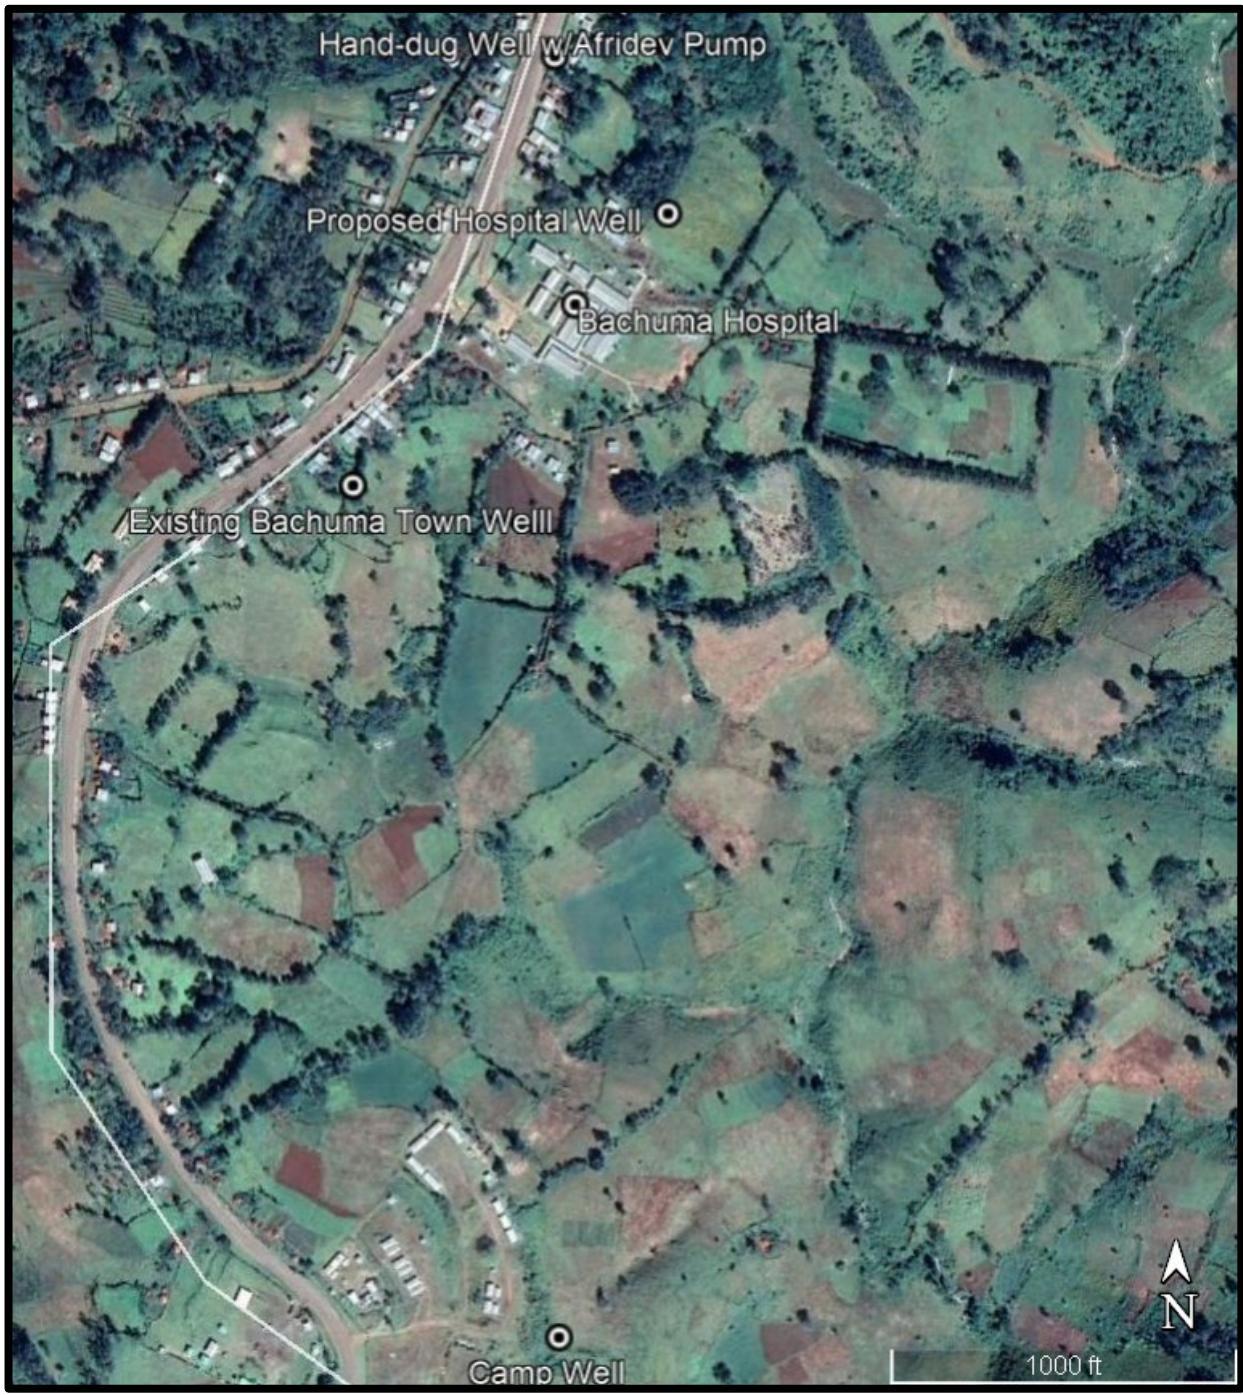
The Bachuma Hospital area, existing wells and the proposed new well are shown in the figure below.

Fig. 7 – Bachuma Hospital, proposed new well and nearby wells

Based on evaluation of the stated alternatives, WEFTA recommends installation of a new supply well on the Bachuma Hospital site. WEFTA has reviewed the AEID proposal to construct the well, and has worked with AEID to determine that the well will be provided power from the existing transformer on the Bachuma Hospital site.

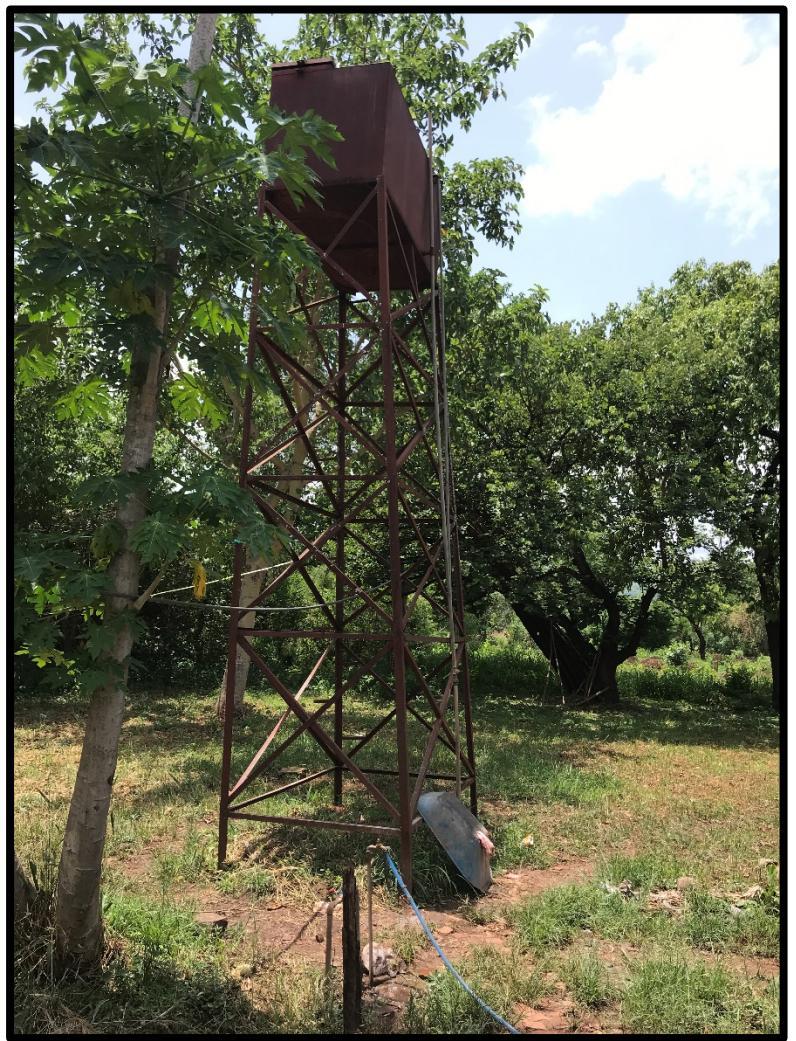
WATER ENGINEERS FOR THE AMERICAS Trip Report – April 2019 Ethiopia tank and distribution line, which was functional and in use during our visit. It is reportedly connected to either a spring or well source. The Kibesh facility had a photovoltaic electrical system on-site to provide power for refrigeration. This part of the system was not functional.

Fig. 8 – Functioning elevated water storage tank and tapstand at Kibesh Clinic

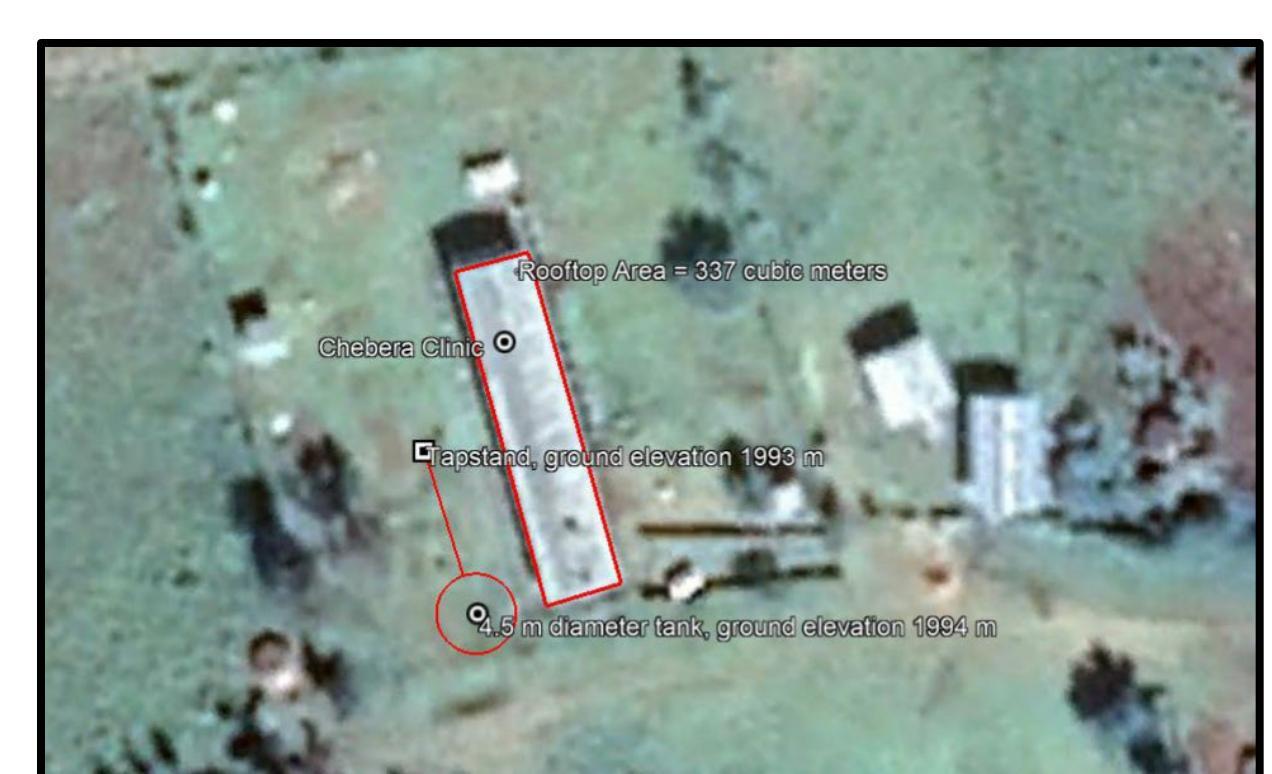
The Chebera Clinic building rooftop covers an area of 337 cubic meters, based on measurements from Google Earth, shown in the figure below.

Figure A1 - Chebera Clinic showing conceptual rain catchment layout

WEFTA recommends construction of a 30,000-liter masonry tank on the southwest corner of the Chebera Clinic, equipped with an opening on top large enough to allow a person to enter and clean the tank, and a drain pipe for flushing during cleaning. Existing rain gutters on the Chebera Clinic (shown below) should be re-graded in order to allow rainfall to flow into newly installed pipes or gutters directed into the tank. The system should be designed in order to allow the first flush of water during a rainstorm to be wasted, in order to minimize contamination of the water. The system should be equipped with a gravity-flow tap stand, located to the north (down-slope) of the tank.

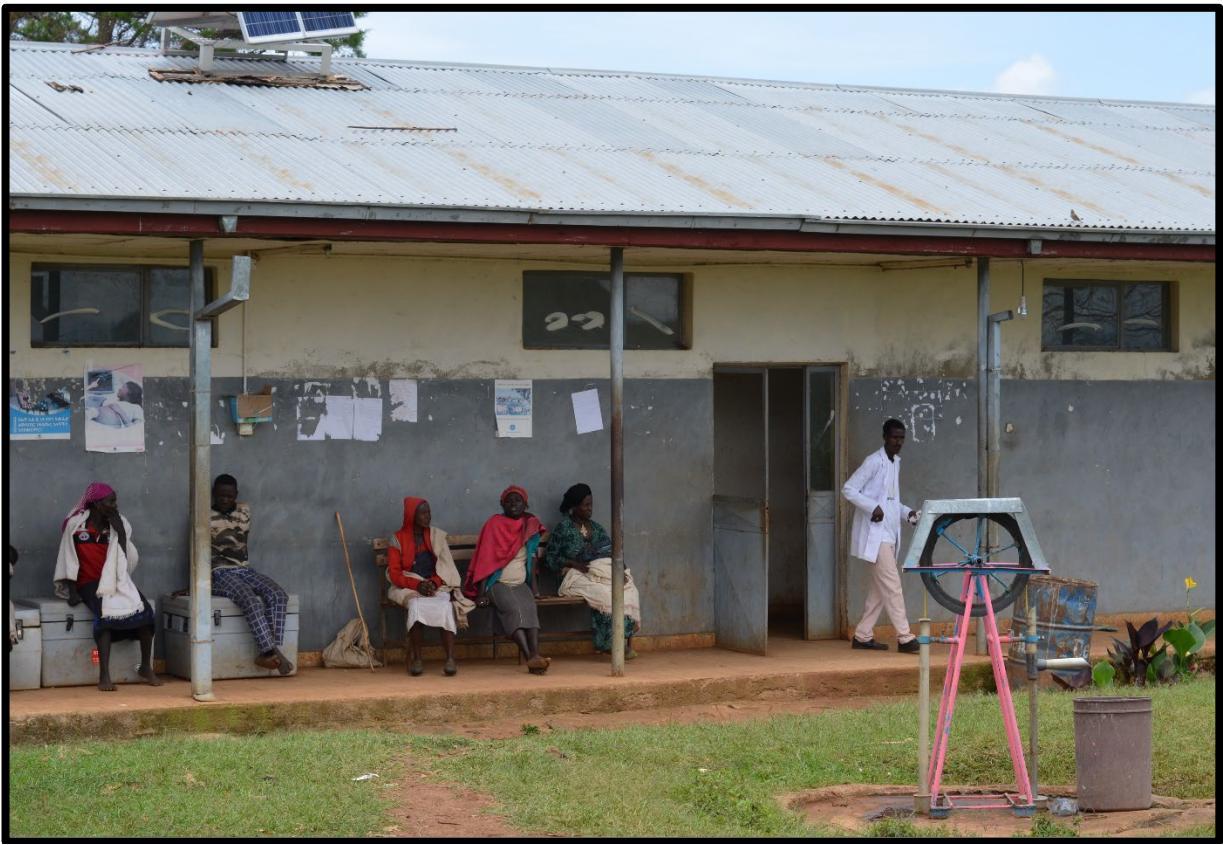
Figure A2 - Chebera Clinic existing rain gutters
