# WEFTA Trip Report Honduras 23 July to 6 August 2021

# By Andrew Robertson, P.E.

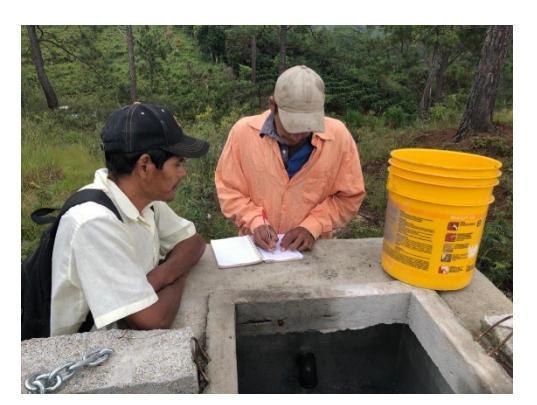
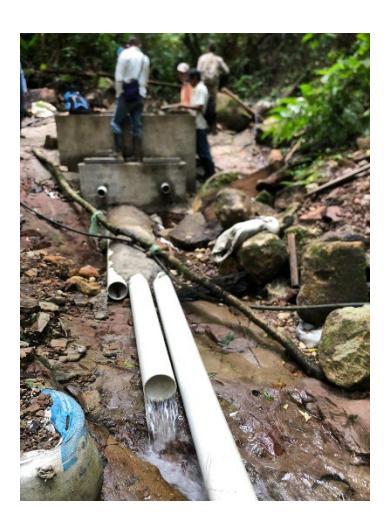
The upper reaches of the pipeline were flowing at 93 gpm, which dropped to 86 gpm

a few kilometers down the line at the flow splitter box (roughly halfway down the line). We observed a local coffee farmer taking water from the pipeline at one of the air valves. The volume of water he was taking was not that much, but the process of tapping the line damaged the system. Unfortunately, this individual is a local bigwig, so the community will have to tread carefully.

The problem appears to be water thieves stealing water from the air valve connections, then leaving the air valve isolation valves closed after they leave. This causes air locking in the pipeline, which reduces its capacity. Community doesn't mind so much people taking water, as long as they don't mistreat the pipeline or close the valves.

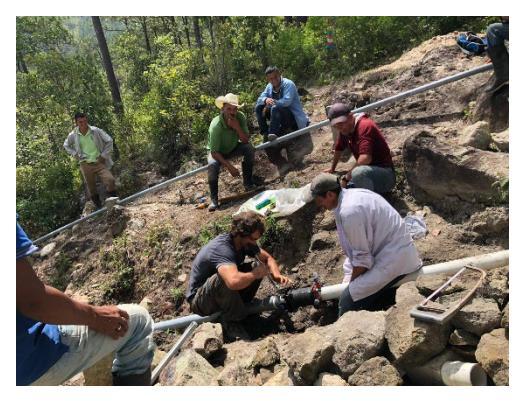
The Achille's Heel of this project has always been the galvanized steel to PVC transitions before and after the Rio Guadalupe crossing. The only parts available in Honduras to make this type of transition is a PVC threaded fitting that screws into a steel threaded coupling. But threaded PVC is notoriously fragile. Martir reports that these PVC fittings have to be replaced roughly every 1-2 weeks because they only last that long before they develop stress fractures, start to leak, and eventually break completely.

Core and Main of the USA donated 4 mechanical joint sleeves that will

make the steel-to-PVC transition without threaded PVC parts and without putting undue stress on the PVC pipe. This morning we installed the MJ sleeve and conducted a training for operators from all 3 villages to learn how to do the installation.

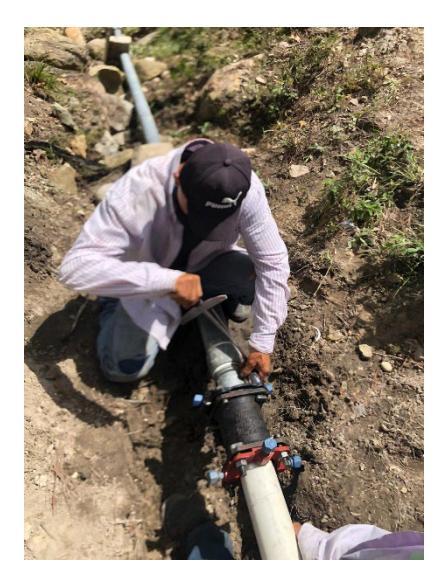
Upon removing the old broken fitting, we inspected the interior of the steel pipe. Perfectly clean: no scaling, no corrosion. We measured the pH of the water in the pipe. pH = 7.2

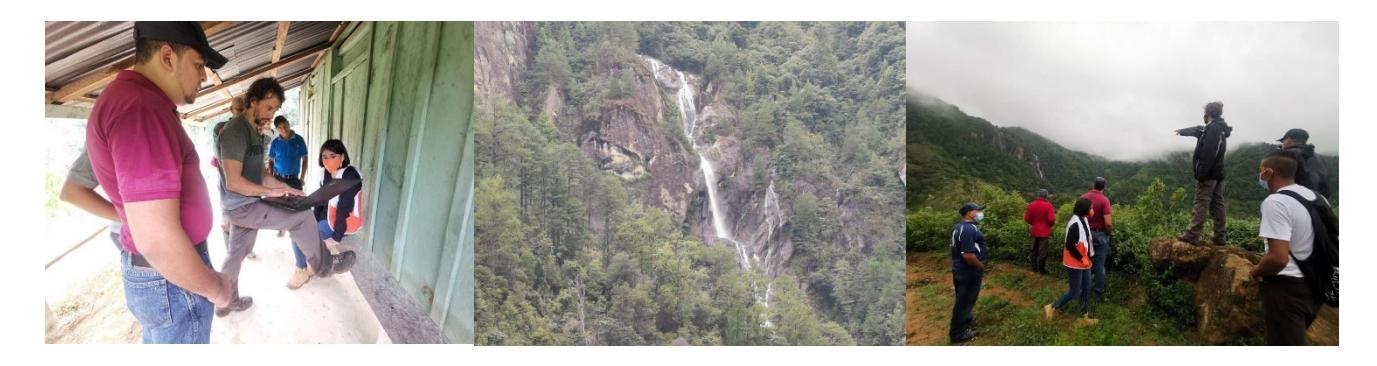
Andrew went to visit project with VM. Project will provide water supply to four (4) villages from small dam near large and impressive waterfall. VM has a transmission line design that is not feasible and not affordable. Villages have been working for 12 years to try to get a water project approved.

We drove/ walked the entire line and picked up GPS points, then marked points on possible alternative routes. I noticed the design did not seem to match what we were seeing in the field. After the site visit, I plotted out SANAA's horizontal survey alignment and it did not match the GPS points at all, nor did it make any sense. There appears to be a massive survey bust in SANAA's topo survey. Also, the alignment itself is not feasible, but there appears to be a possible alternative. I analyzed the problems with the survey and followed up via email to VM with a proposed re-alignment. VM said they would work with SANAA to have the new alignment surveyed and send to me for review and hydraulic design.

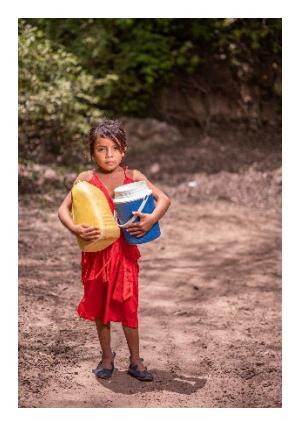
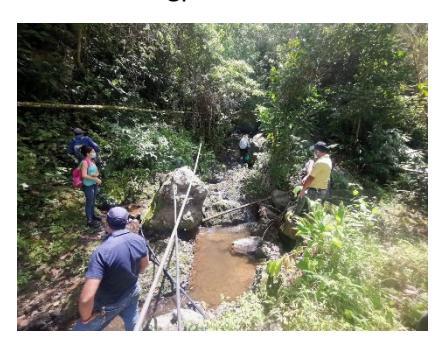
The project will bring water supply to three villages – Guanacastillo, El Rodeo, and El Tamarindo – serving approximately 282 families in total. The water supply will come from a stream up in the Yuscaran Biological Reserve and require ~15 km of gravity transmission line to reach all three villages. We measured flow rate at the stream. It was not possible to capture all the water in the flow measurement, but it appears flow rate is on the order of 200 gpm. Note that this

measurement was taken downstream of existing water intakes for other villages, so this represents the water available. Estimated average flow rate required for population is ~71 gpm (based on 282 families x 6 per family x 30 gpcd x growth factor of 2.0).
