WEFTA GUATEMALA TRIP April 14-20, 2012

Site Review – Macalajau WEFTA Funded Project

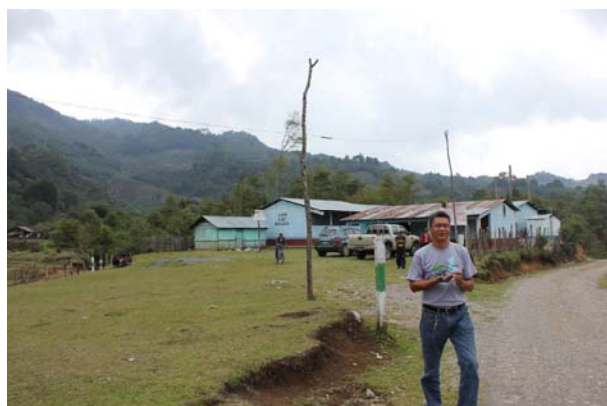
First home we visited has a new, vented wood stove, concrete floor, and Ecofilter water filters. This family has installed rain catchment system and cisterns, but there are only a few families who have been able to afford the catchment and cisterns. They also showed us their new latrine.

The latrines have been constructed out of sturdy lumber, providing stability and a locking, closing door for privacy. Latrine trenches were constructed dug to depth of 2-3 meters and sand and gravel layer at bottom to act as minor filter. Each latrine takes community approximately 1 week to construct

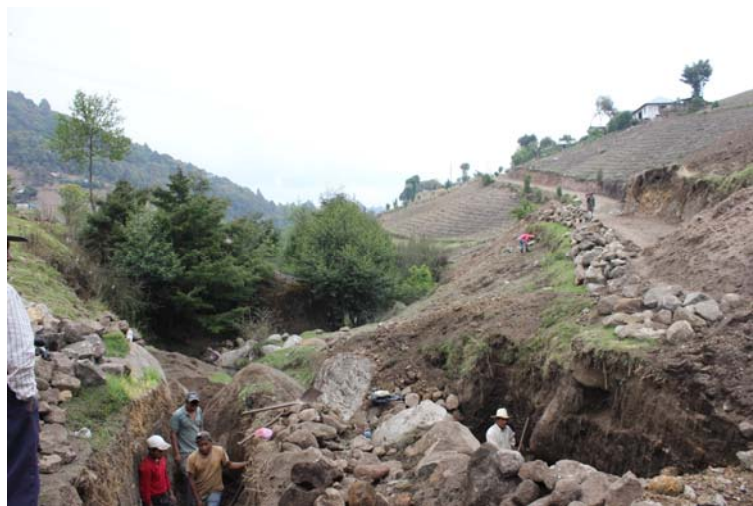
The community working in Ixcamal

After the meeting, we visited the water project site where the villagers are busting out existing, dry spring box and attempting to dig down a new one for better water. Community has been working on the project for 1 week.

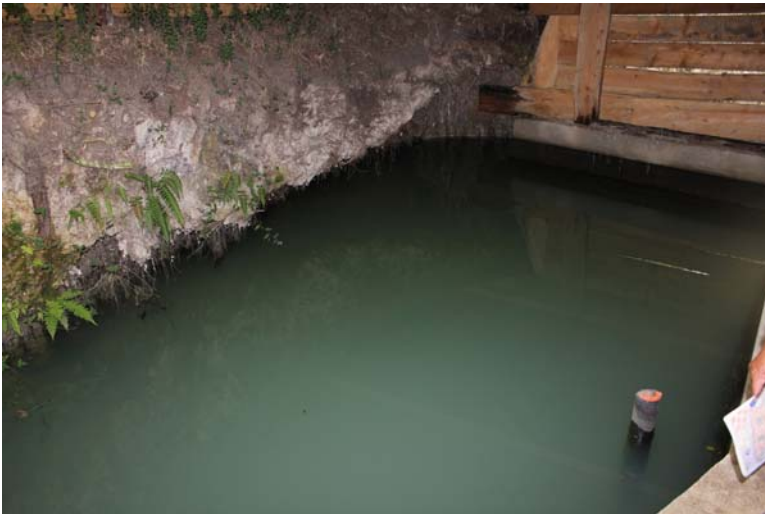
Santa Rosa enclosed well, still contaminated

Santa Rosa la Laguna currently utilizes shallow, open wells near the lake and in the center portion of the village as their main sources of water. The village currently has three wells—two of the wells are open to the air—these are unprotected from the elements, and animals and other debris often enters the wells. One recently constructed well has been covered to protect the water, which prevents debris and wildlife from entering the water source, but this does nothing to address the contamination of the groundwater.

It appears that the most viable option to address the water problems of Santa Rosa la Laguna involve the installation of a rain water catchment system. The frequency of precipitation in the area would allow this system to provide ample drinking water to the community. This option, weighed against the expense and risks of the other alternatives, appears to be the most effective means of helping the community.
