Trip Report for WEFTA Visit to El Salvador

September/October 2015

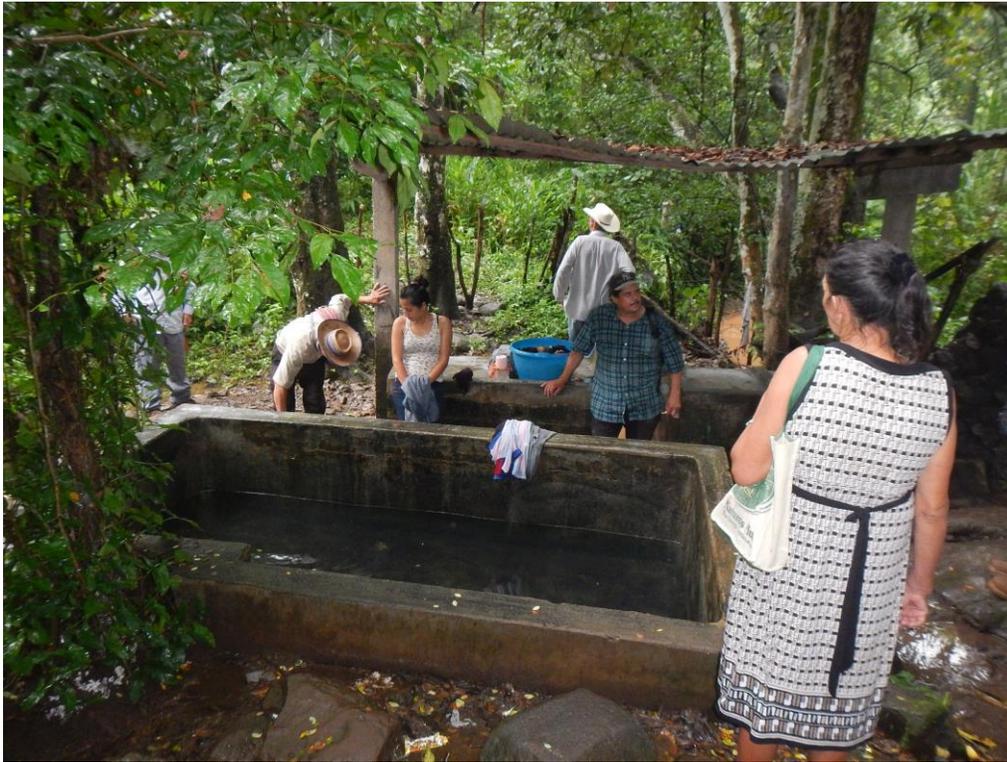
Local residents in Valle Nuevo washing clothes in a spring-fed pila

Valle Nuevo would like a water supply system separate from Santa Marta, and asked the WEFTA crew if it would be possible to construct a new well and storage system to connect to their existing water distribution system. Given the hydrogeology of the area, it would not be practical to drill a single well with adequate production. A system of shallow wells could be constructed with a combined capacity that might be adequate. Water quality testing by WEFTA indicated that the shallow groundwater is likely acceptable as a drinking water source (see Appendix A for water quality testing results). However, it would be prohibitively expensive to construct a shallow groundwater pumping/treatment/transmission/storage system adequate to serve the community (likely greater than \$300,000 USD).

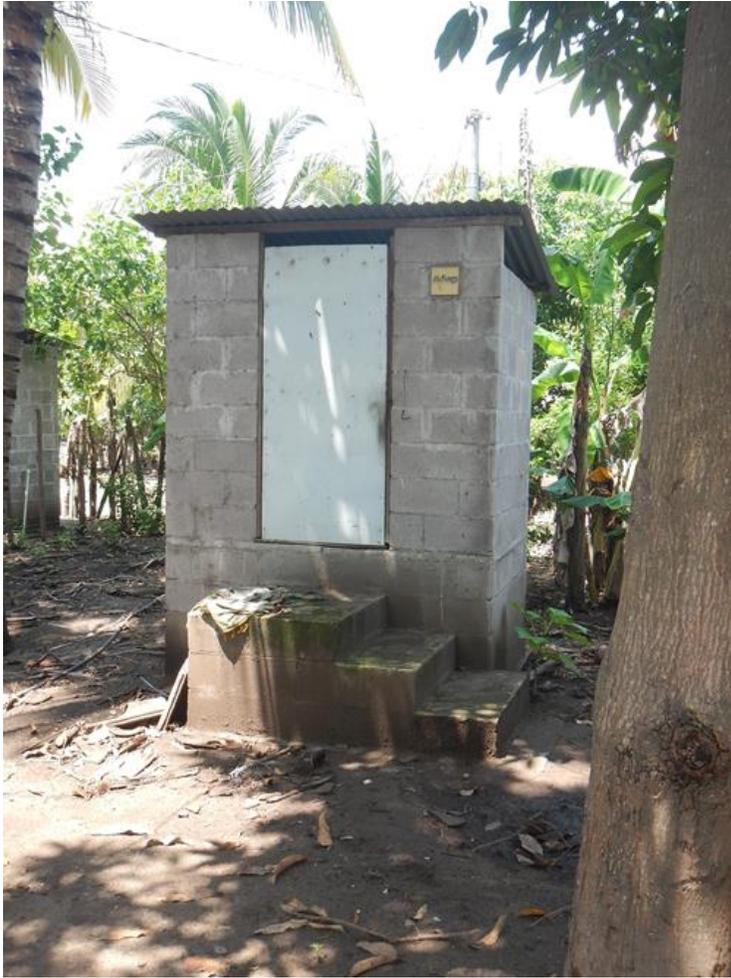
Composting toilet on Isla La Calzada

1. The water in the existing distribution system appears to be appropriate for potable uses. The residual chlorine in the treated water should be checked periodically to assure that residual chlorine is not elevated (greater than 2.0 mg/L). If so, the chlorination system should be adjusted.
2. The water distribution system should be extended and the residents hooked up to the system so that the entire community could be served by the system.
3. Existing standard pit toilets should be replaced with composting toilets as soon as practicable.

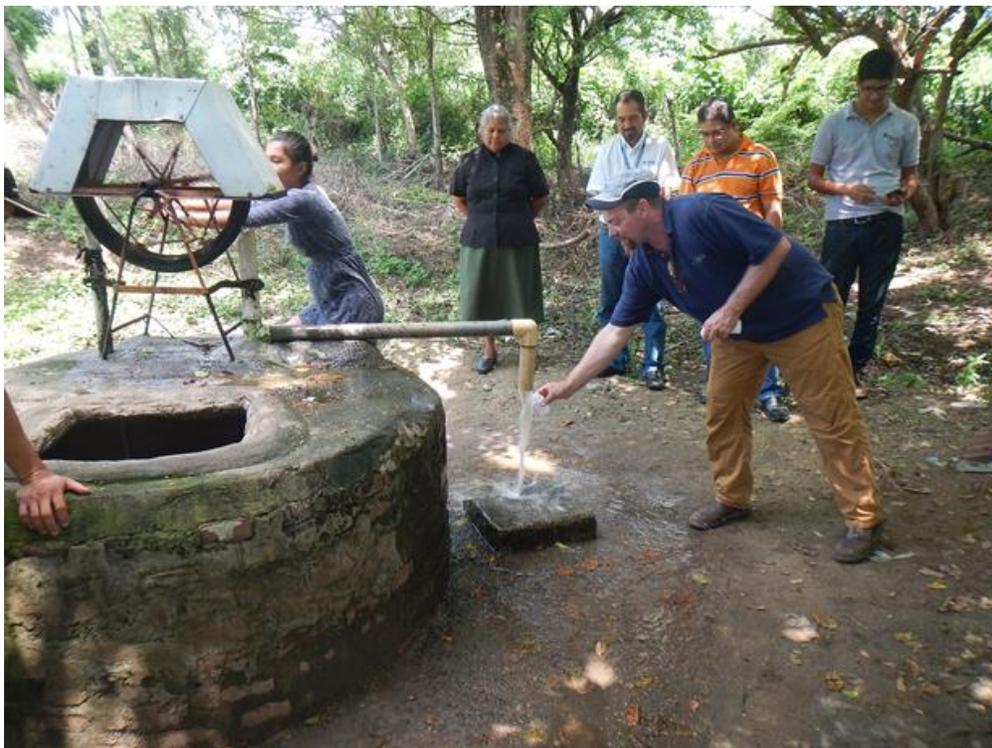
Scott McKitrick collecting a water quality sample from a hand-dug well in Tepeagua

Water quality testing indicated that water from the hand-dug well near the Lutheran Church contained an elevated concentration of nitrate (24 mg/l $\text{NO}_3\text{-N}$, EPA Maximum Contaminant Level 10.0 mg/l). Given that the well is open to the land surface, there is potential that the elevated nitrate concentration is related to contaminants entering the well through the wellhead, and not an indication of more widespread groundwater contamination. A second well sampled near the soccer field approximately 1,000 feet south of the well at the Lutheran Church did not contain an elevated nitrate concentration. Analytical results of other parameters from both wells were not elevated, indicating that groundwater in the vicinity of the proposed well is likely to be acceptable as a potable water source.
