WEFTA - BOLIVIA TRIP REPORT

July, 2011

ORURO-AREA MINING CONTAMINATION (local partners CEPA & CORIDUP)

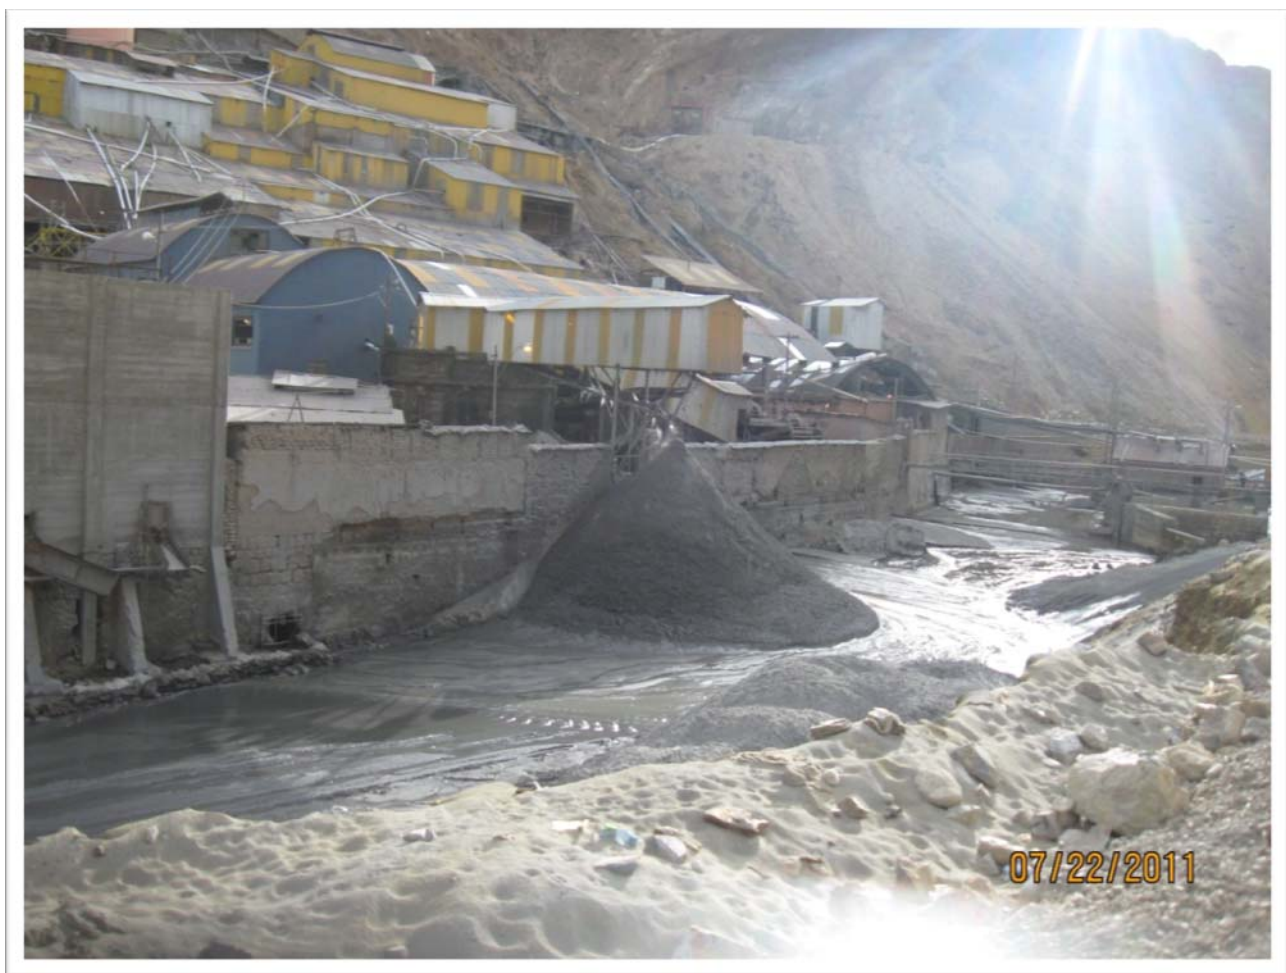
The Posokoni Mine discharges water to facilitate underground mining. This water is likely low pH, based on its yellow-orange iron coloring.

Figure 1 – Santa Elena Mill with tailings deposited in Huanuni River at Posokoni Mine

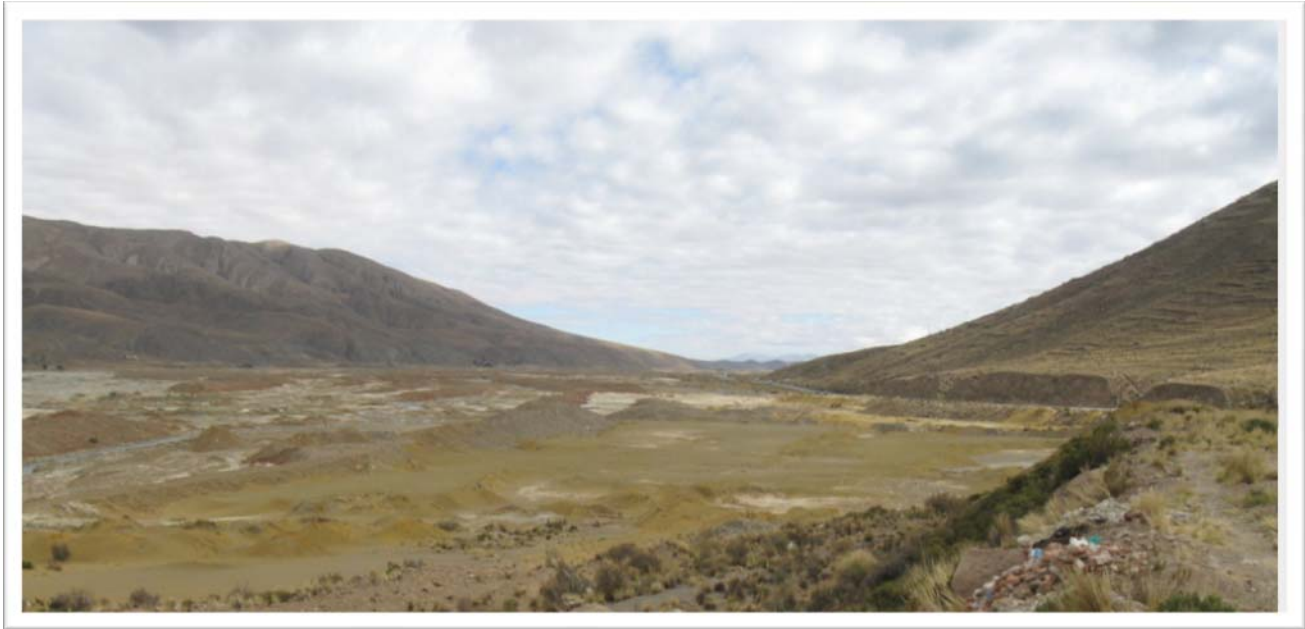
A review of aerial photography indicates the Huanuni River is impacted for a distance of in excess of 30 kilometers down-stream of Huanuni, and likely impacts Lago Uru Uru and Lago Poopo, where the Huanuni River flows into the lakes. Tailings have also been deposited outside the watershed, both above the mine and to the east of the Huanuni River.

Figure 2 - Huanuni River, all yellow-brown material is acid generating tailings

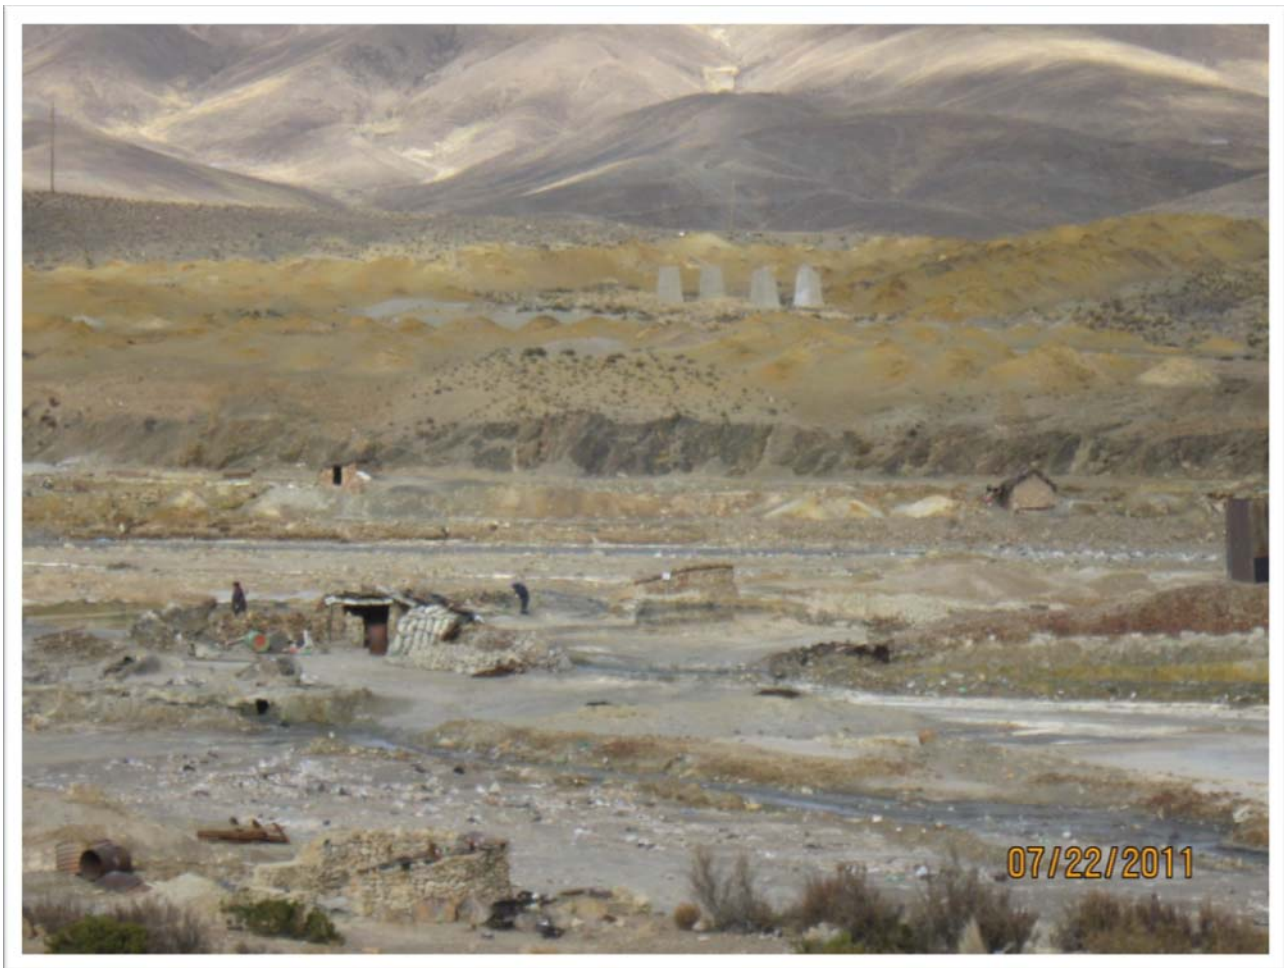
Figure 3 - view to East across Huanuni River (much trash) to tailings deposited on banks of river

The scale of mine-related contamination in the Huanuni area is staggering. Addressing the problems can be broken into two processes: 1) stopping the deposition of tailings into the river; and 2) addressing historical contamination.

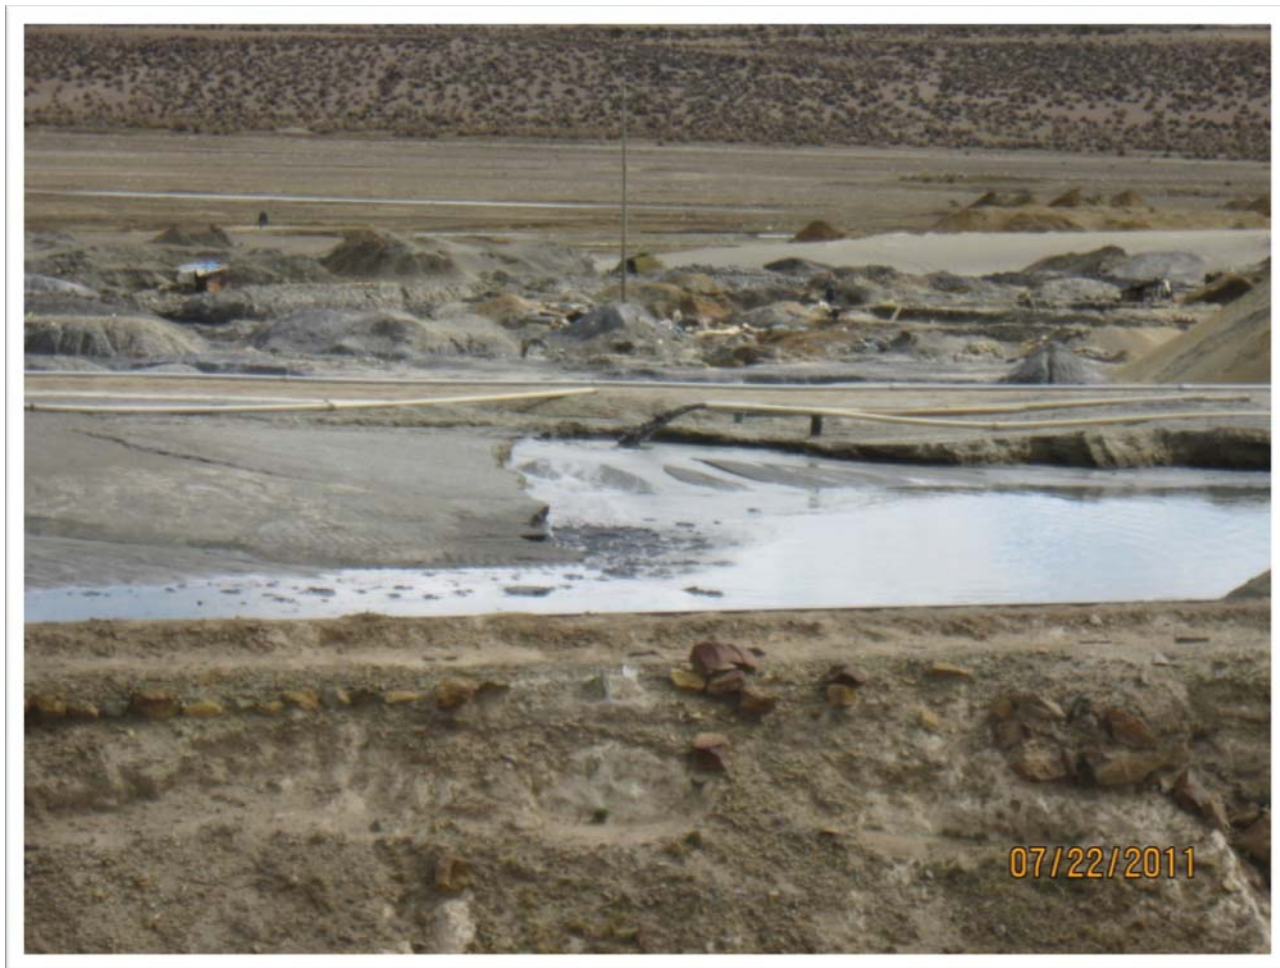
Figure 4 - Machacamarca millsite tailings discharge with Huanuni River in background

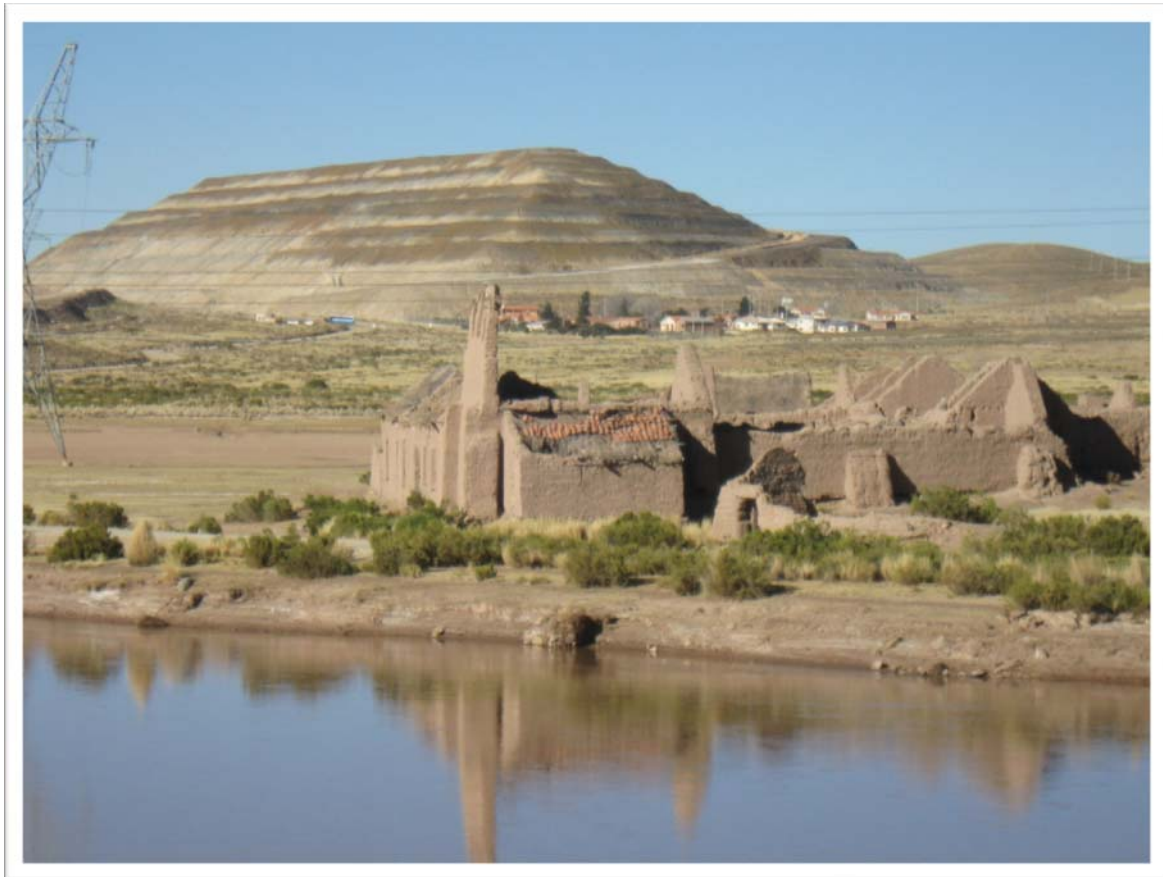
Kori Kollo is an open pit mine, with a total depth of approximately 270 meters. The mine is located proximal to the Desaguadero River, in places as close as 60 meters from the river. After mining, the pit was allowed to re-fill with water. Several small pits have been excavated since mining ceased in the main Kori Kollo pit, the most recent being the Llallaguita pit. The first ore extracted from the deposit was oxidized and amenable to heap leaching. Heap leaching is the process where ore is crushed and piled on HDPE (plastic) lined pads, dilute cyanide solution is discharged onto the crushed ore to dissolve gold and silver, and the precious metals are removed from solution using either carbon or other process. Cyanide solution is then recycled to the leach pads. Precious metals are smelted and poured into bars (dore, a mix of gold and silver), which are exported for refining. The Llaguita ore is oxide, and is therefore being processed in this manner. Heap leach pads take tens of years to complete precious metal leaching. Following leaching, several years are required for the leach pads to “drain down”. Oxide ore may contain small amounts of pyrite and may generate ARD and mobilize heavy metals. The spent ore will also contain residual cyanide.

Figure 5 - Kori Kollo cyanide leach pad with historic hacienda and Desaguadero River in foreground

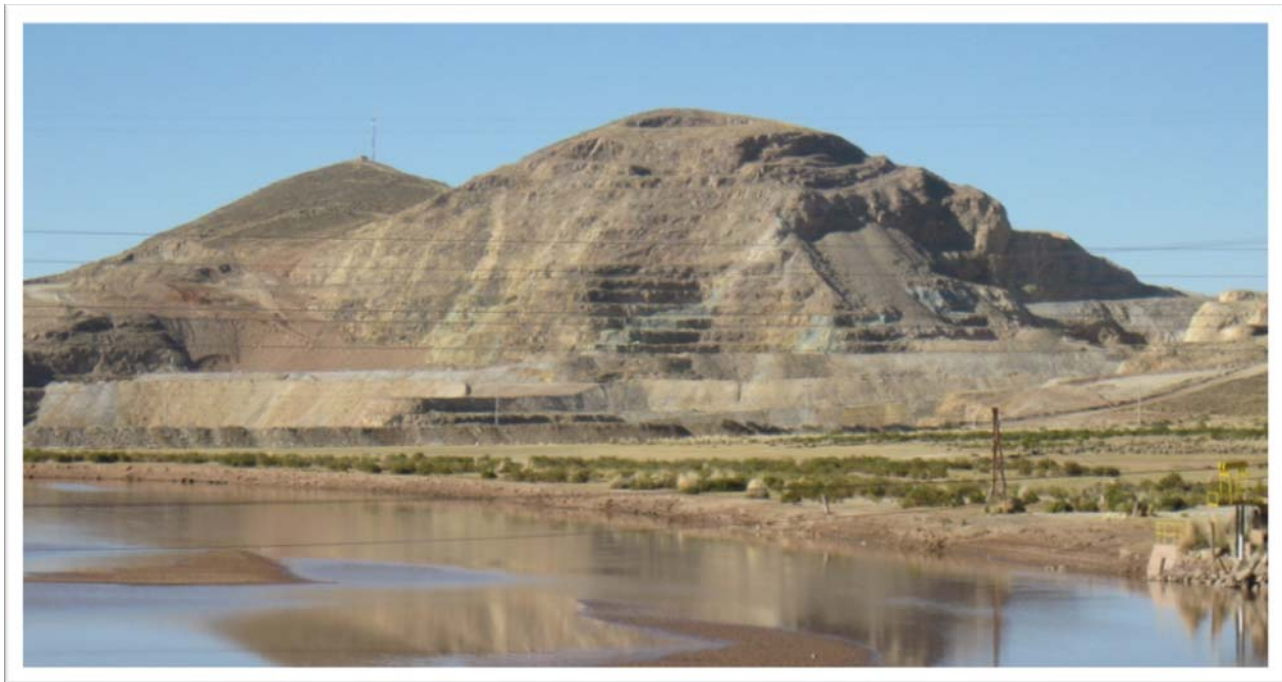
Following completion of mining of the oxide portion of the deposit, development of the underlying sulfide ore body was completed. The sulfide mineralogy of the deposit required a different metal recovery technology, known as carbon in leach (CIL). In this process, ore is ground to a fine powder using a crusher and large ball mills. Ore is then mixed with cyanide solution in large tanks. Once precious metals have been mobilized into solution, carbon is added to the solution to precipitate precious metals onto the carbon. The carbon is then separated from the waste rock (tailings). The carbon is acid rinsed to remove contaminants, and smelted to form dore, which is exported for refining. Tailings at Kori Kollo were discharged to a large, circular tailings impoundment approximately 2,400 meters in diameter. The tailings impoundment was constructed with a clay liner, overlain by oxide material. The tailings are pyrite-bearing, and have the potential to generate ARD and mobilize heavy metals. The tailings also contain residual cyanide.

Figure 6 - Kori Kollo Mine with Desaguadero River in foreground, pumping station on right

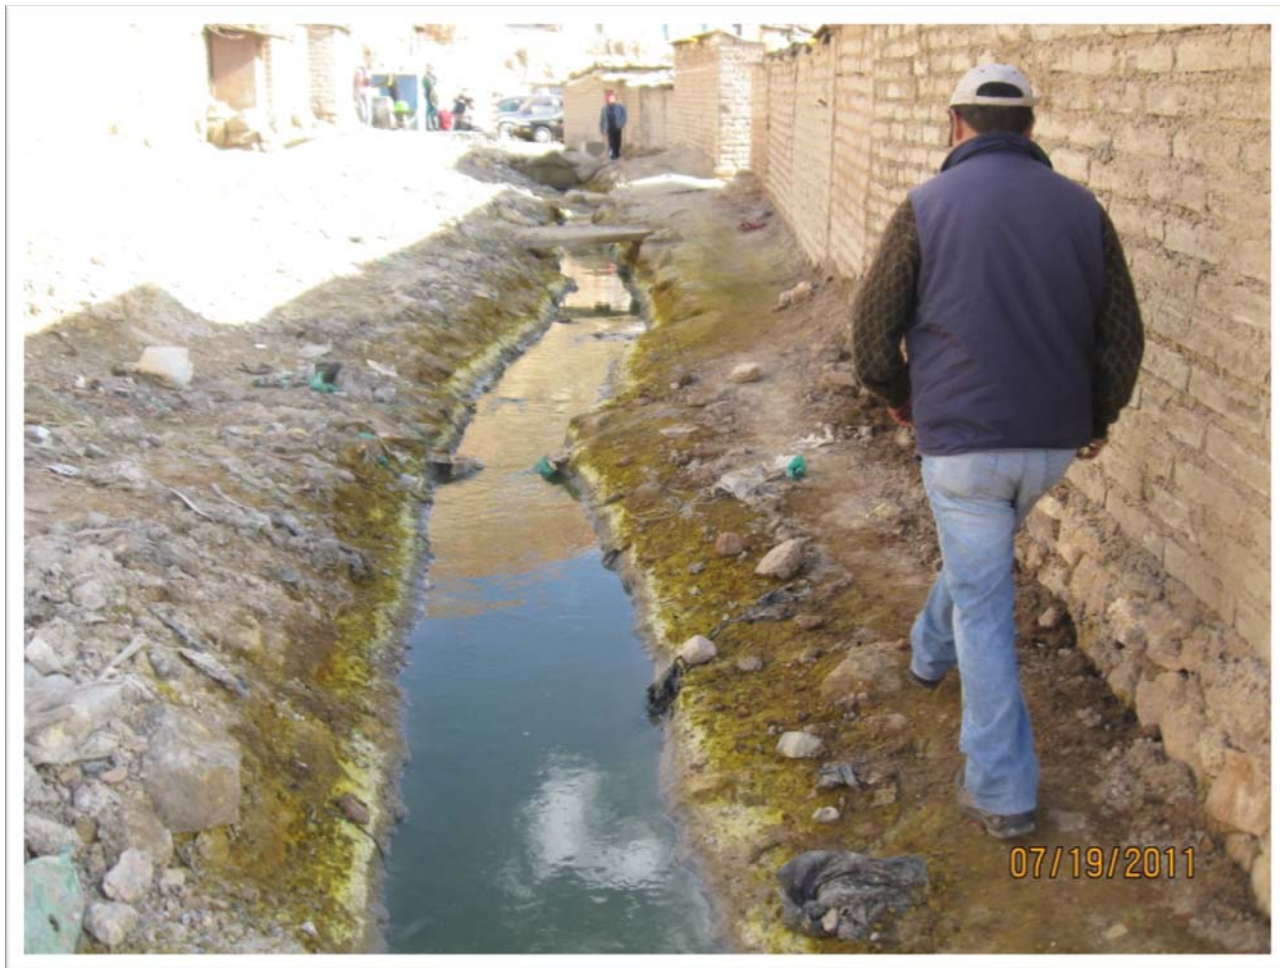
We visited the San Jose Mine, which is located at the top of the hill within Oruro. It is a collective-run underground mine. Water is pumped from the mine and discharged directly into a ditch that flows into Oruro. Water flows at 25-50 gpm, and has a pH of 1 to 1.5 (extremely acidic). The banks of the ditch have yellow elemental sulfur precipitate, consistent with low pH water. A European engineer has proposed to put this discharge into pipes to convey it through town, then buffer it in some sort of wetland.

Figure 7 - Drainage from San Jose Mine, yellow material is elemental sulfur precipitated from pH 1 water

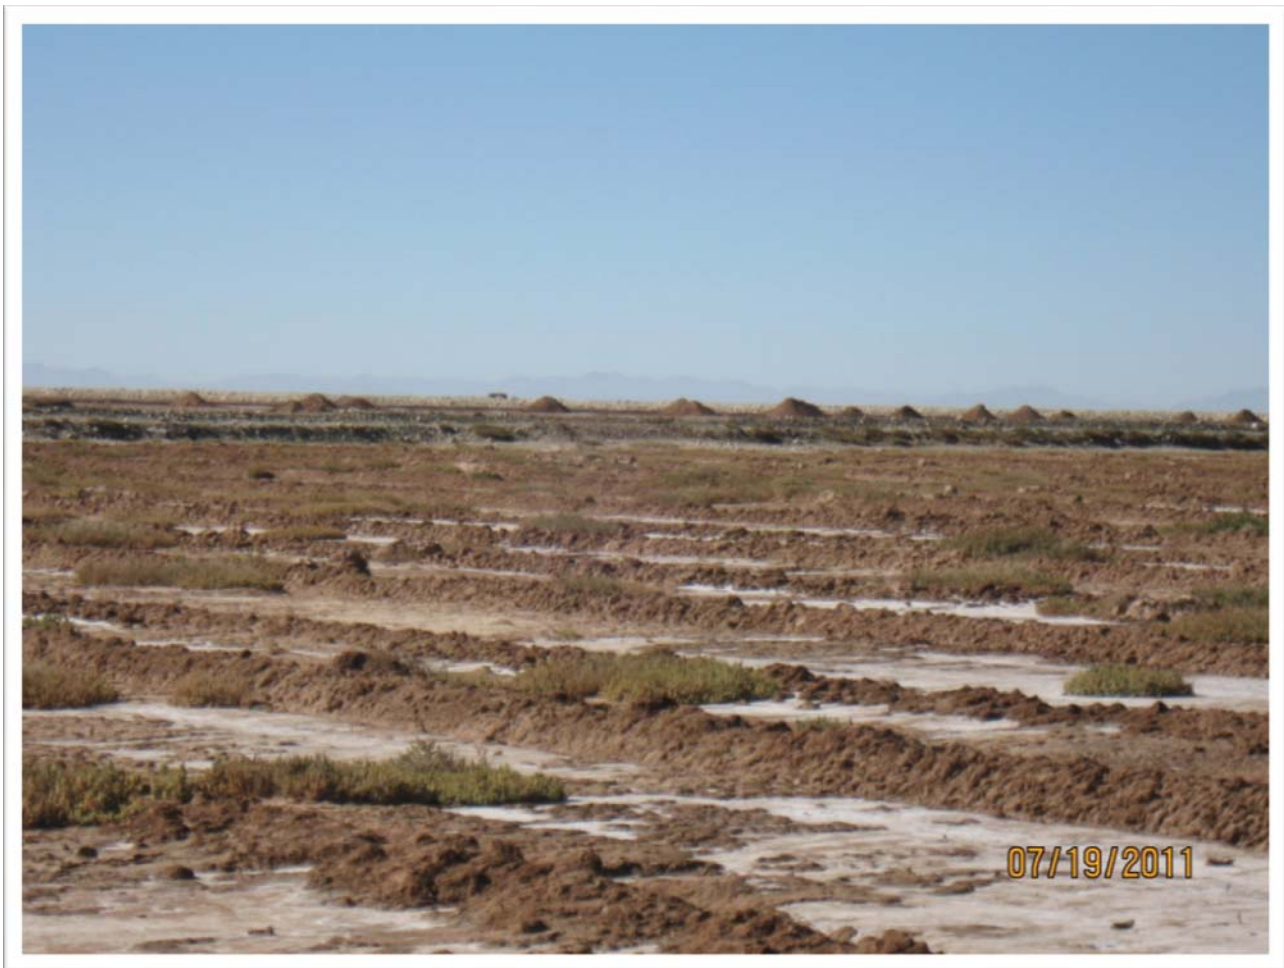
Figure 8 - soil being removed for use as tailings cover, note salt

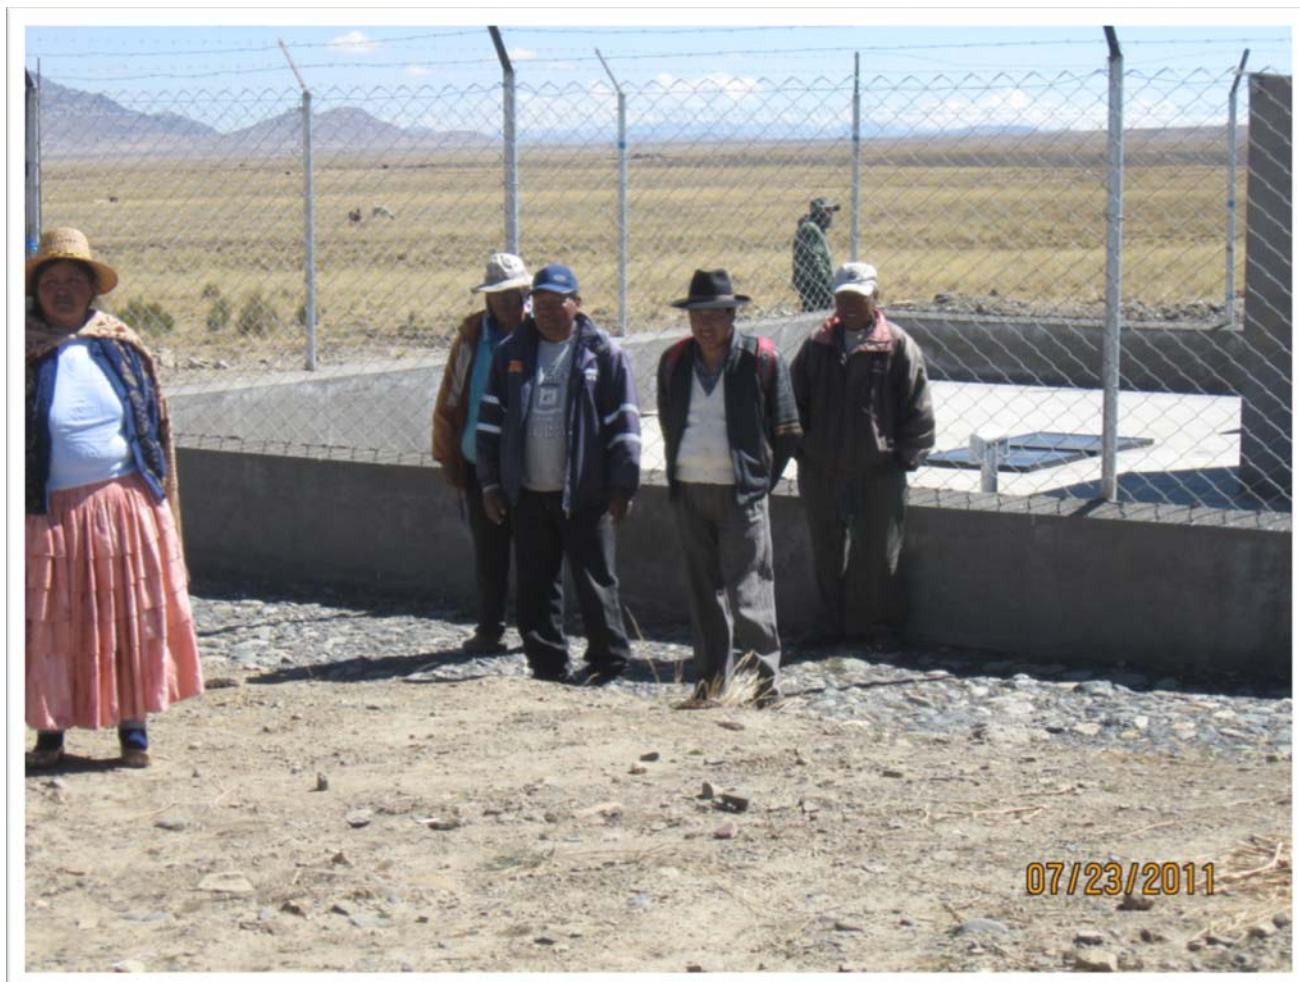
I spent a single day with Suma Jayma. We inspected the water system at Machacamarca, which is now complete. The system looks great. It is made up of a surface water collection system, storage tank, chlorination system, distribution piping, and tap stands.

Figure 9 - Machacamarca water storage tank with security fence

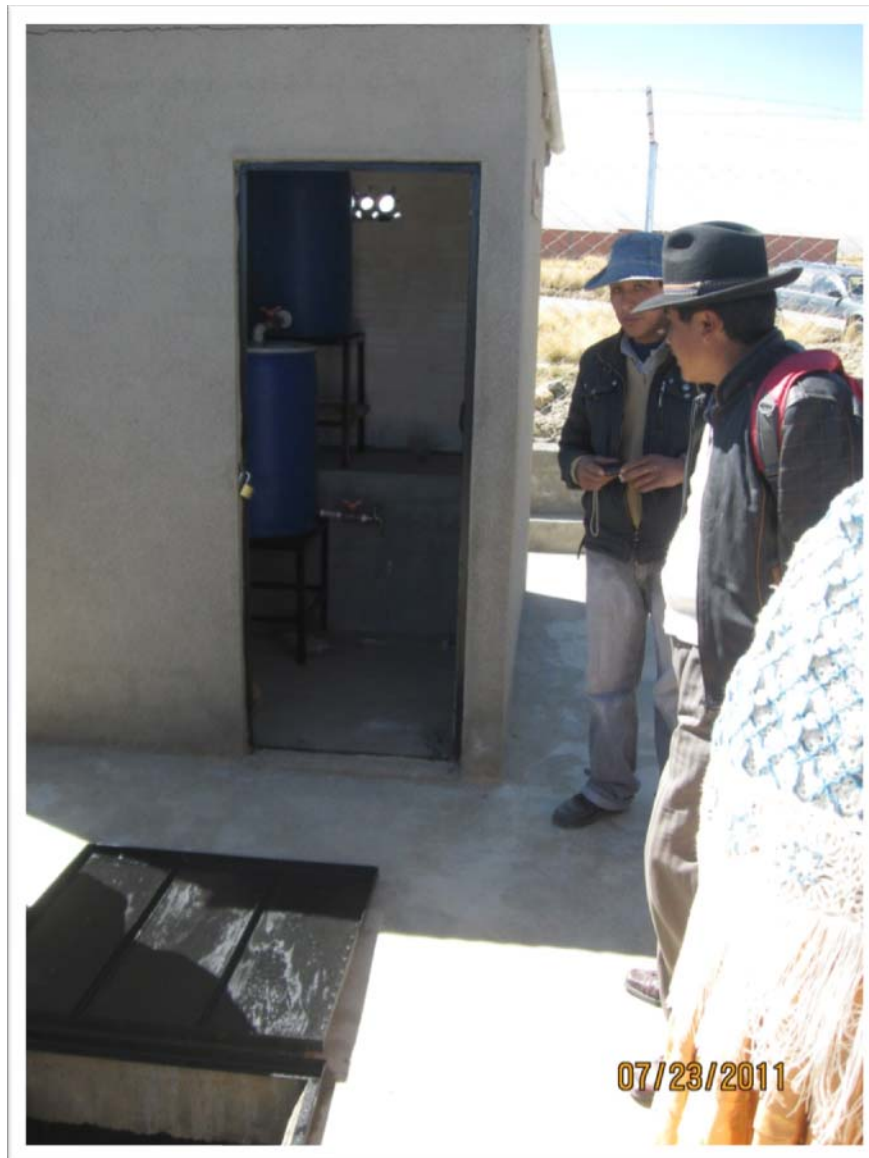
Figure 10 - Machacamarca water storage tank with chlorination system in structure
